## HMS EREBUS UNDERWATER ARCHAEOLOGICAL SURVEY 2018

Charles Dagneau and Jonathan Moore  
Underwater Archaeology Team, Parks Canada

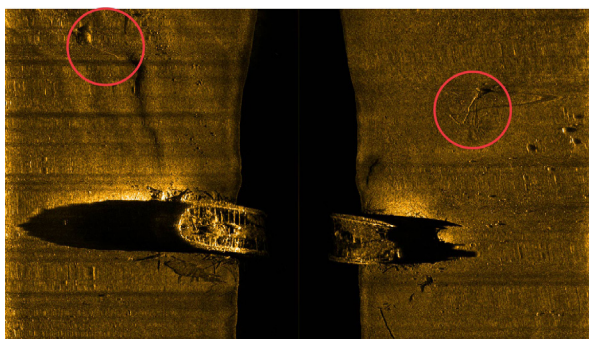
Figure 4.4: Side-scan sonar transect image of HMS *Erebus* showing northwest and northeast mooring anchors (red circles). North is up (Sonar image: R. Harris, Parks Canada).

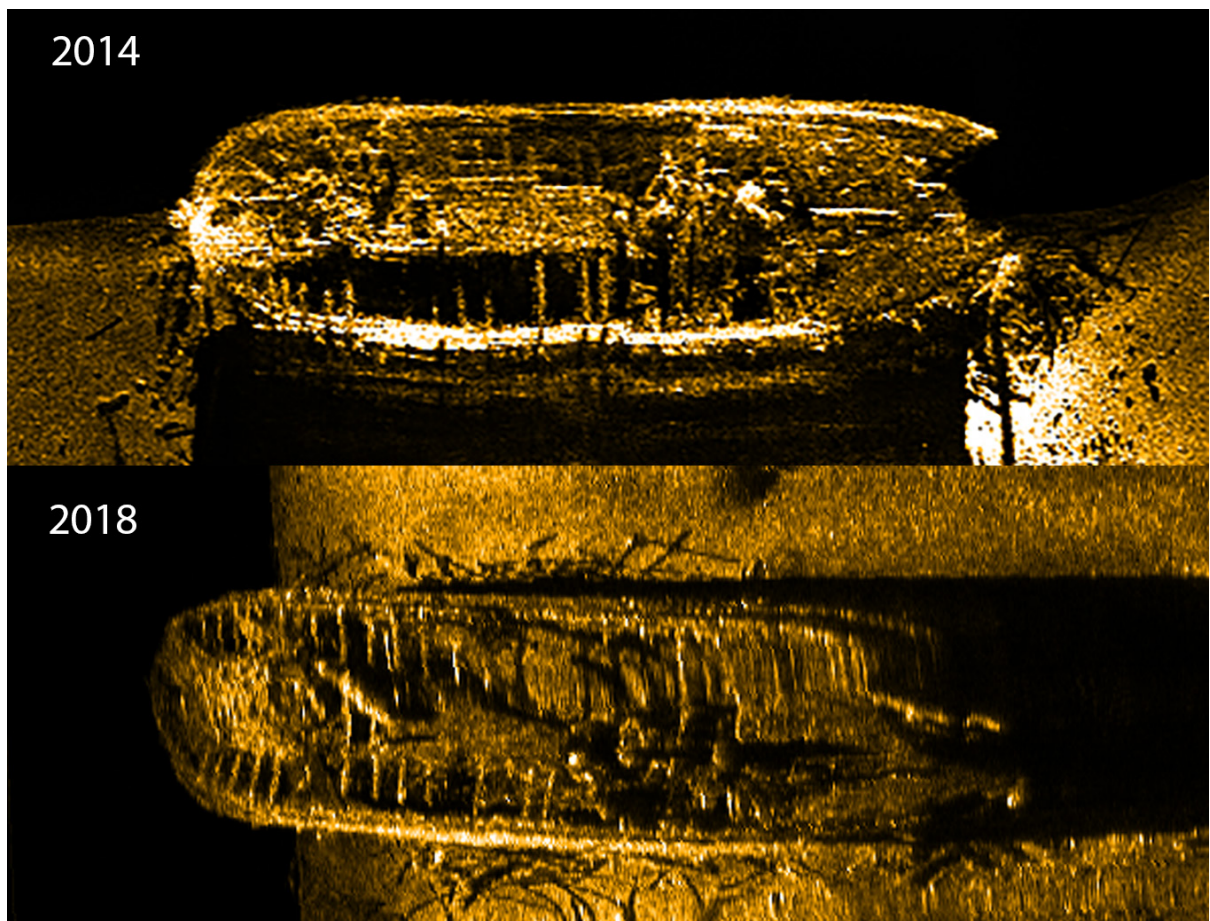
The fieldwork on HMS *Erebus* focused on a general site evaluation and targeted artefact mapping and recovery. Two inspection dives and a side-scan sonar survey were devoted to detect any major changes to the site, including its structure, and the surrounding debris field. As observed in previous years, a few loose timbers have moved here and there as recently as 2017. These are all normal changes for this fairly dynamic site. No significant changes to the debris field immediately around the hull were observed, other than the movement of a few loose planks. More surprising is the fact that, over the last year, a 14 m-long section of upper deck originally located between the bow and the main hatch on the starboard side was detached from the deck beams, flipped upside down, and moved some 8 m aft, with a slight clockwise rotation. This movement significantly changed the areas of lower deck that are now exposed (Figures 5.1 and 5.2).

Figure 5.1: Side-scan sonar image showing HMS *Erebus* upper deck and beams in 2014 (top) and 2018 (bottom). On the bottom image, the recently exposed deck beams can be observed on the starboard side bow, next to the displaced windlass. North is up and the bow is to the left (Sonar images: R. Harris, Parks Canada).

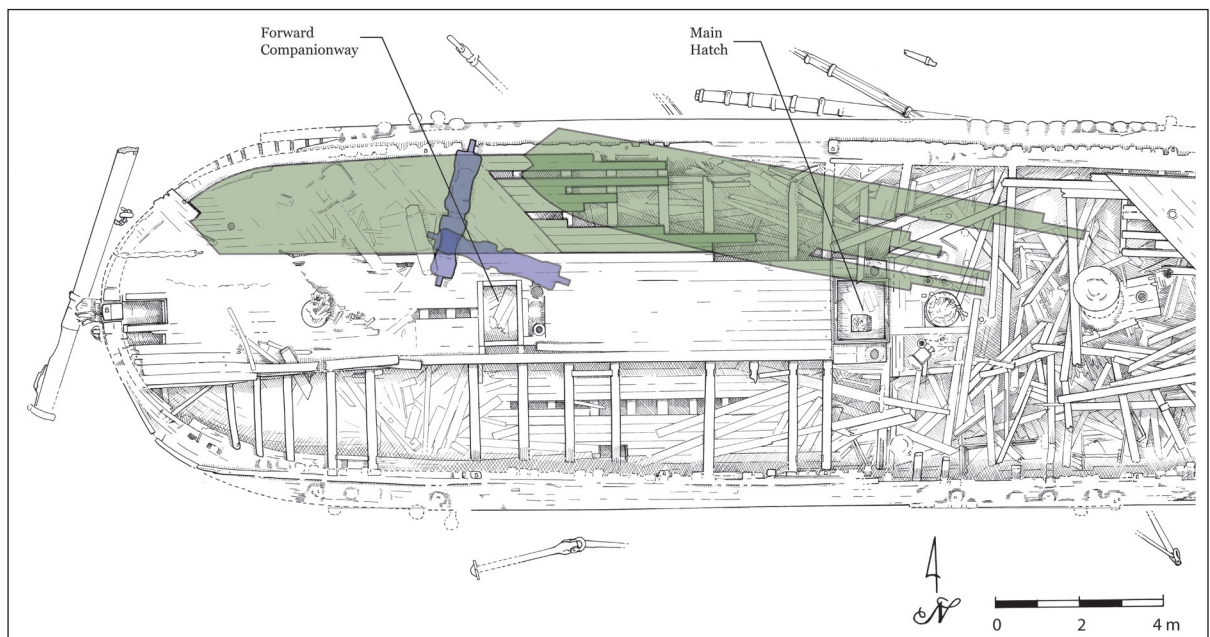
A portion of the double-planked decking is damaged, exposing some of the fearnought (a thick wool felt) used as a waterproofing agent between the upper diagonal and lower longitudinal planking (now upside down). The windlass has moved as well, and its outboard end has rotated approximately 90 degrees clockwise and is now aligned fore-and-aft, probably due to the same factors that displaced the starboard deck section. (Figures 5.3 and 5.4). The windlass has rolled free and is now clear of any corrosion, debris and anchor chain. Lengths of stud-link chain that once ran from the windlass to the stem seem to have fallen inside the hull to the lower deck. This important change possibly created by swell, is fairly recent, as the section was still in place in 2017. Interestingly, this new detached starboard section is a mirror image of the port side section found detached in the debris field upon site discovery in 2014.

The thicker and stronger king planks on the central longitudinal axis of the hull are still in position. This major change affecting the hull structure may or may not have been caused by unexpectedly intense ice conditions this year. In any cases, it illustrates that the site is even more dynamic than previously expected; it reaffirms the need to consider controlled dismantling and/or shoring of the different upper deck sections of HMS *Erebus* not playing any structural role (Dagneau 2018; Moore et al. 2017:125–126).

Figure 5.2: Approximate movement of the detached starboard, double-layered upper deck section. The deck piece has moved approximately 8 m towards the stern and rests upside down, and the windlass rotated approximately 90 degrees clockwise (Image: C. Dagneau; Base Drawing: C. Pillar, Parks Canada; 89M-2019-101-1).

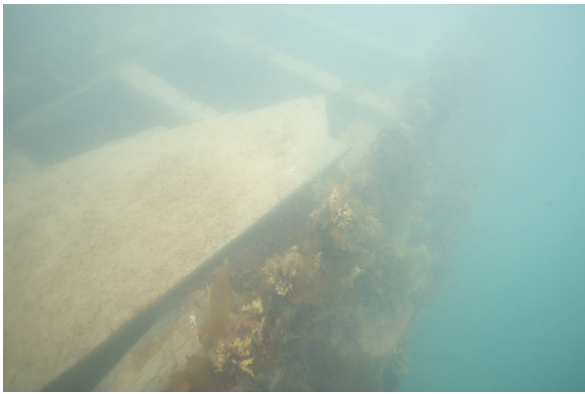
Figure 5.3: Forward end of the detached upper deck section. The longitudinal (originally lowermost) planking is now facing up, while the (originally uppermost) diagonal planking is facing down (Photo: R. Harris, Parks Canada; 89M09510EF).

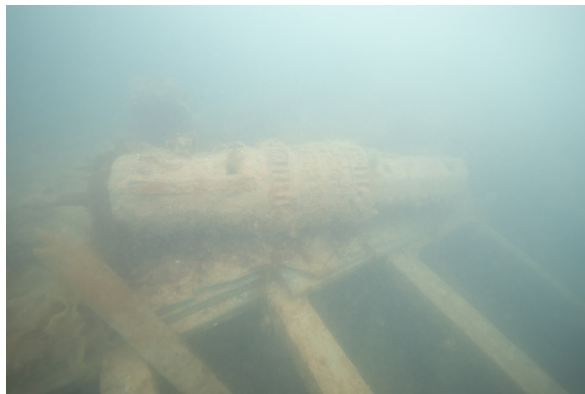
Figure 5.4: *Erebus*' windlass and newly-exposed upper deck beams and a carling, in the starboard area next to the forward companionway (Photo: R. Harris, Parks Canada; 89M09503EF).
