# PEACE-ATHABASCA DELTA

## Technical Studies

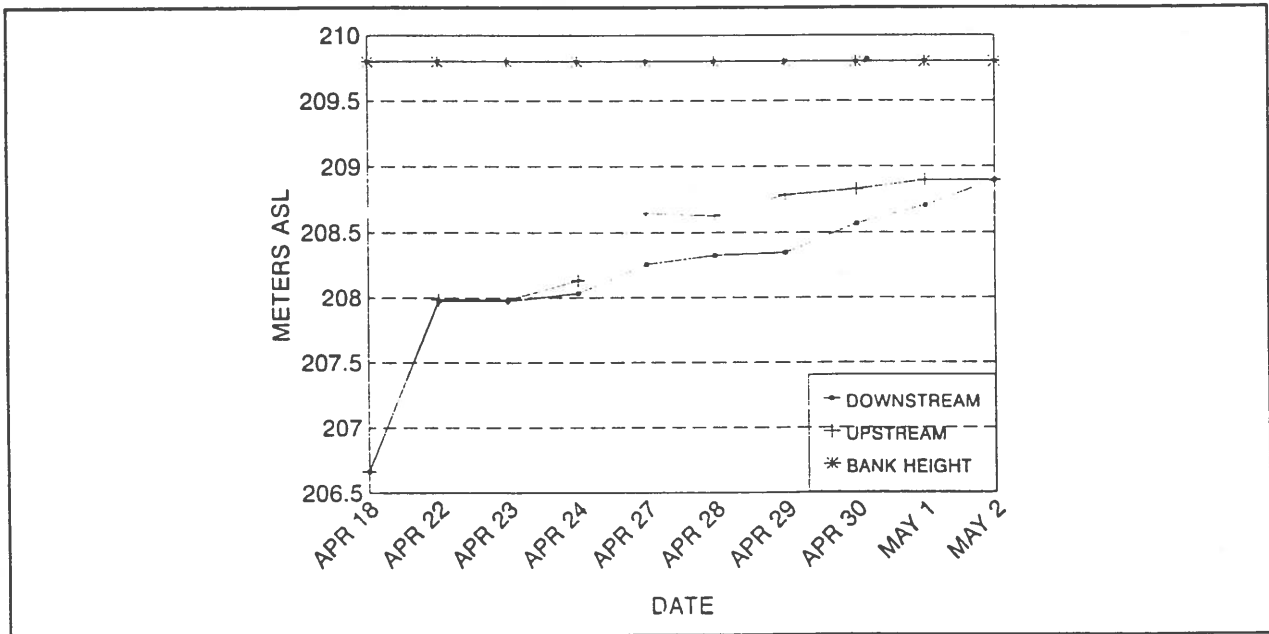
FIGURE 3: 1995 water elevations upstream and downstream of the ice dam compared to bank height.

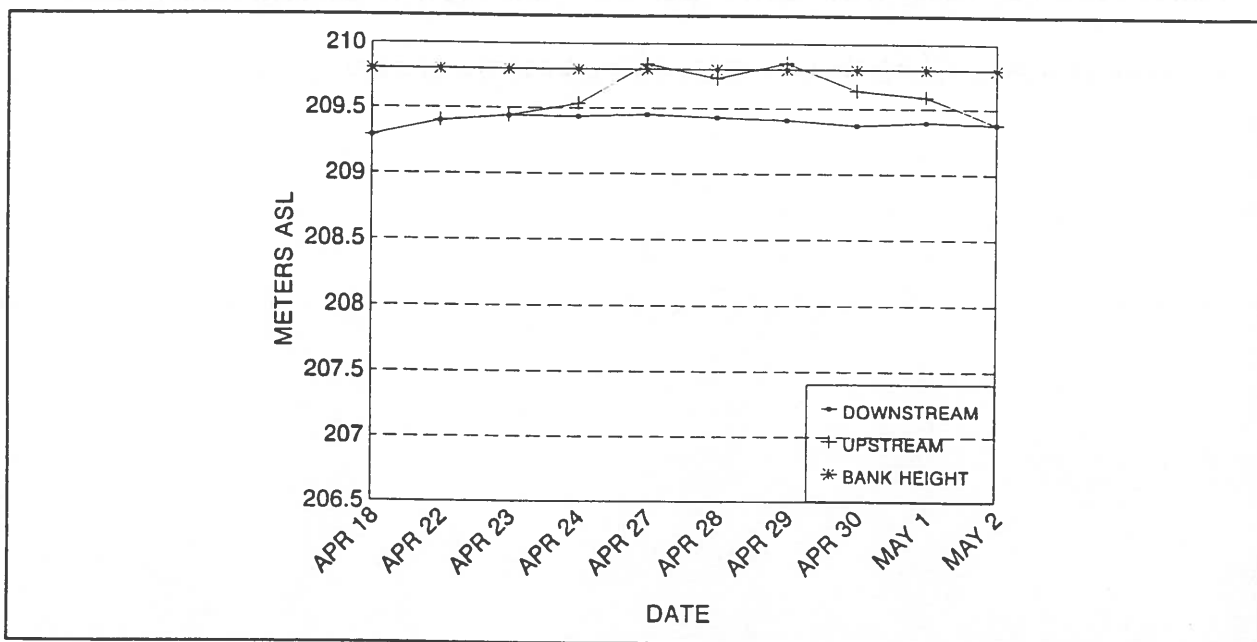
FIGURE 4: Estimated 1995 upstream water elevations using 1994 water elevations at Old Dog Camp for the downstream plot. The upstream plot was produced by applying the difference in 1995 elevations above and below the dam to 1994 elevations.

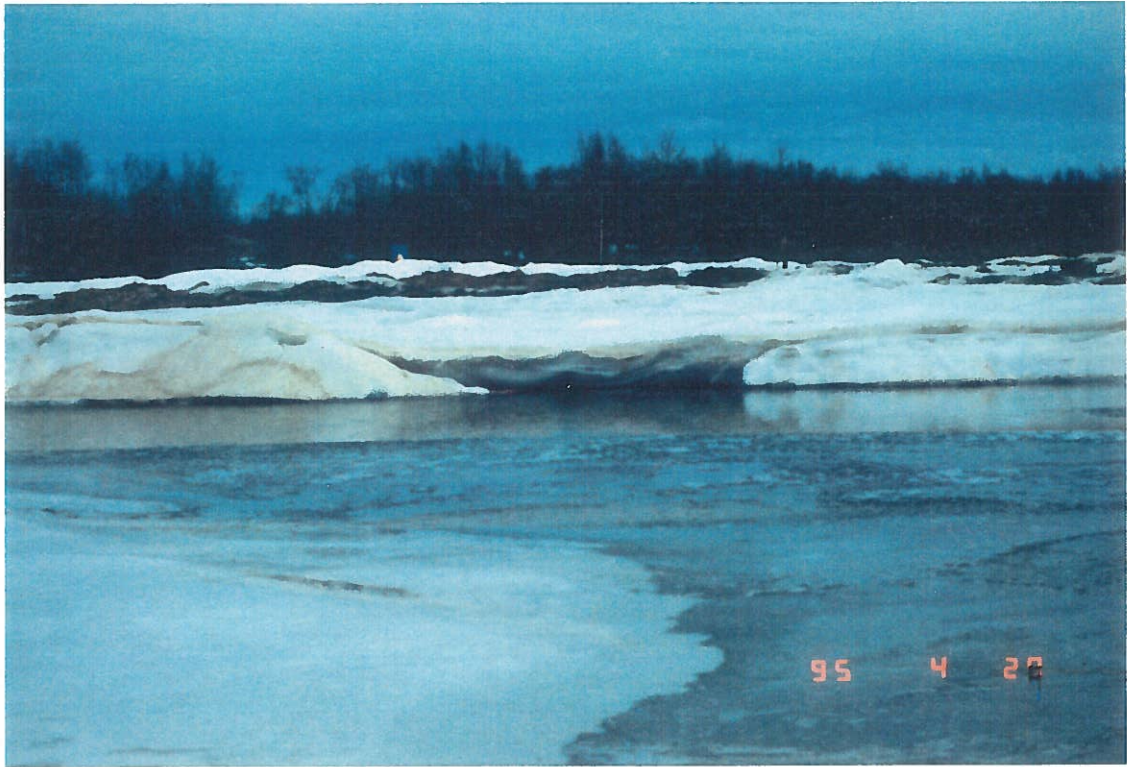
Photo 4: On April 28, 1995 the "wings" on the dam lifted up, apparently also lifting and creating cracks along the dam's bottom. In this photo, a vortex in the cave-like opening was sucking material underneath the dam.

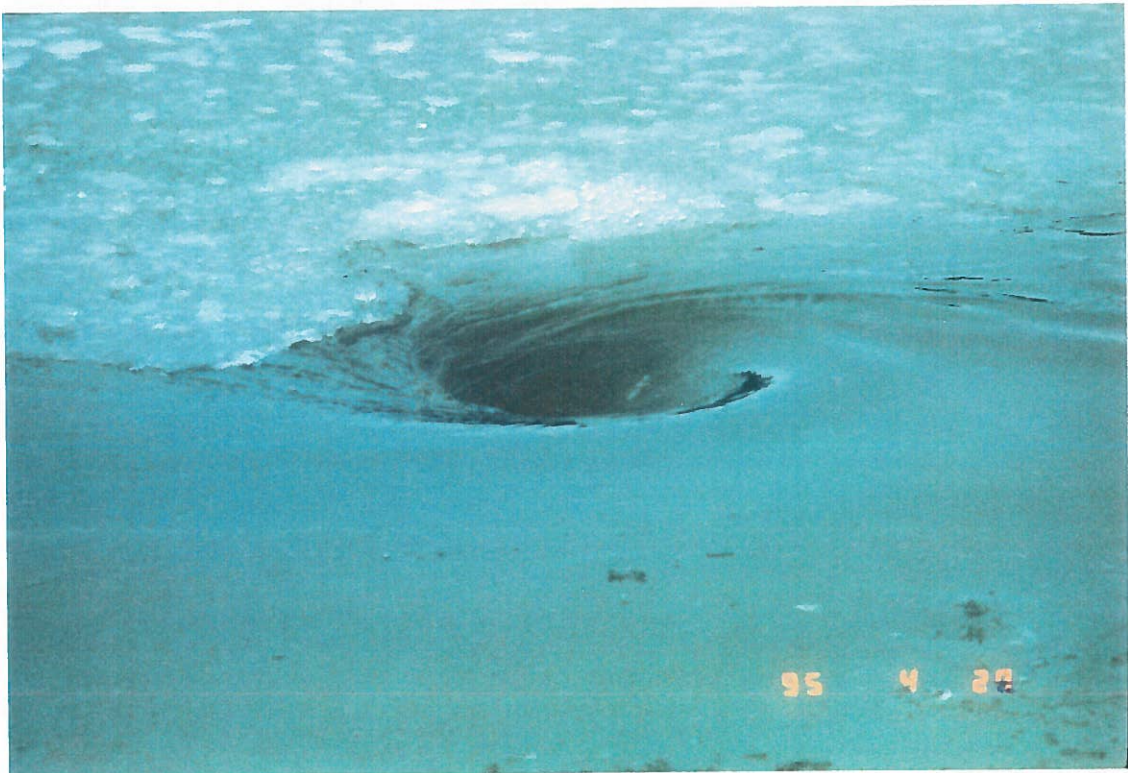
Photo 5: One of the three vortices which formed along the upstream side of the dam.

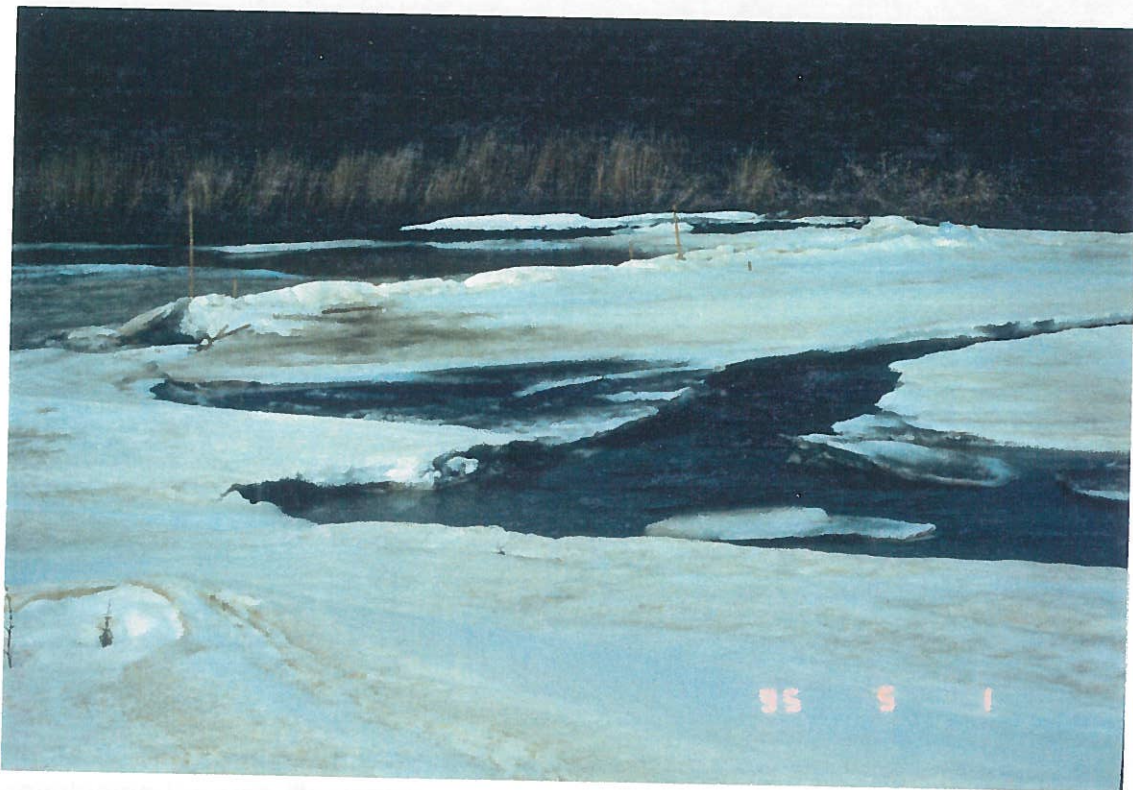
Photo 6: Water flowed through and enlarged the hinge cracks on the north dam.

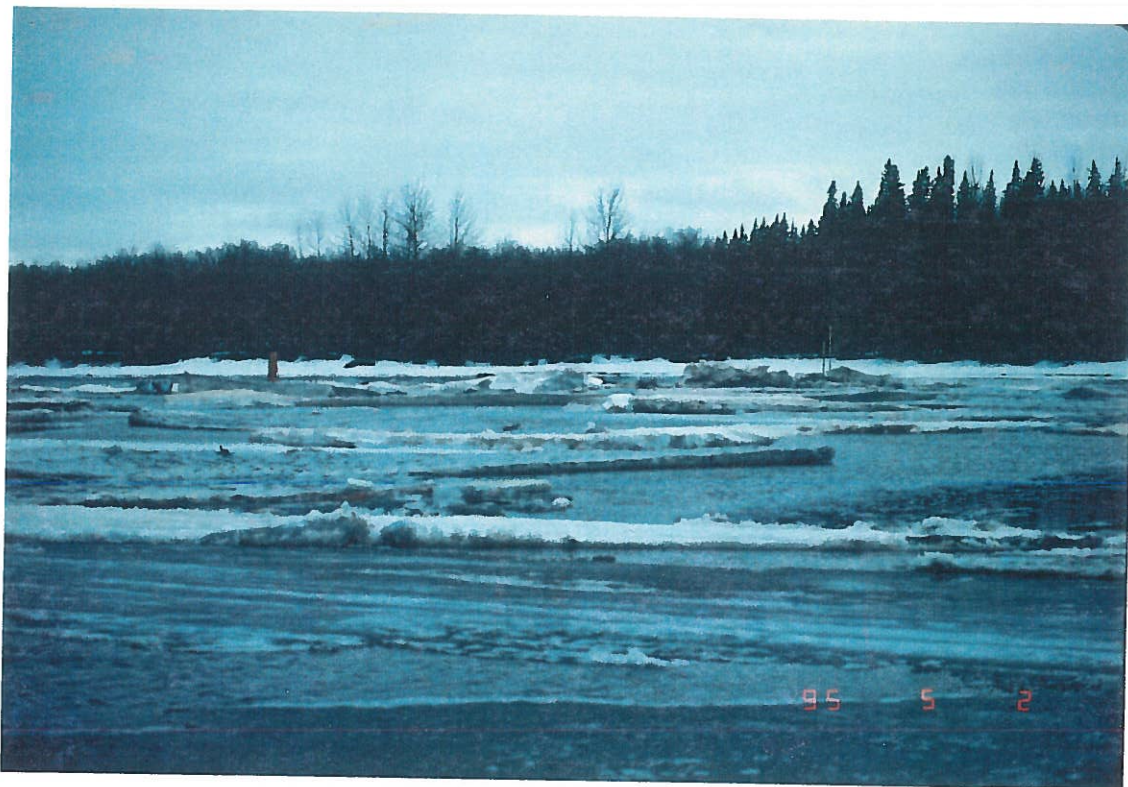
Photo 7: Water flowing through the hinge cracks on the north dam cut the dam free and it floated in its near entirety down the river.

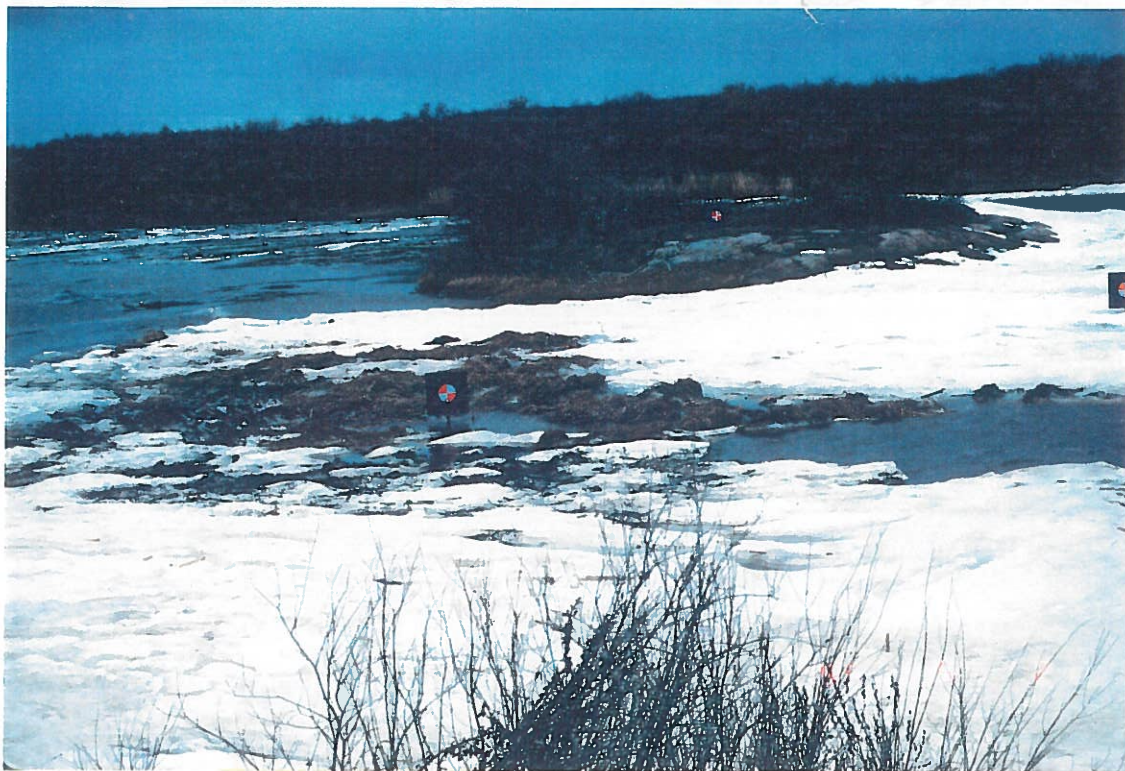
Photo 8: The south dam eroded away from the bottom up, with a channel finally developing through it's centre.
