North Pacific Cannery

Archaeological Resource Inventory

March 2000

**David J.W. Archer
Heritage Consultant
589 5th Avenue East
Prince Rupert, B.C.
V8J 3Y3**

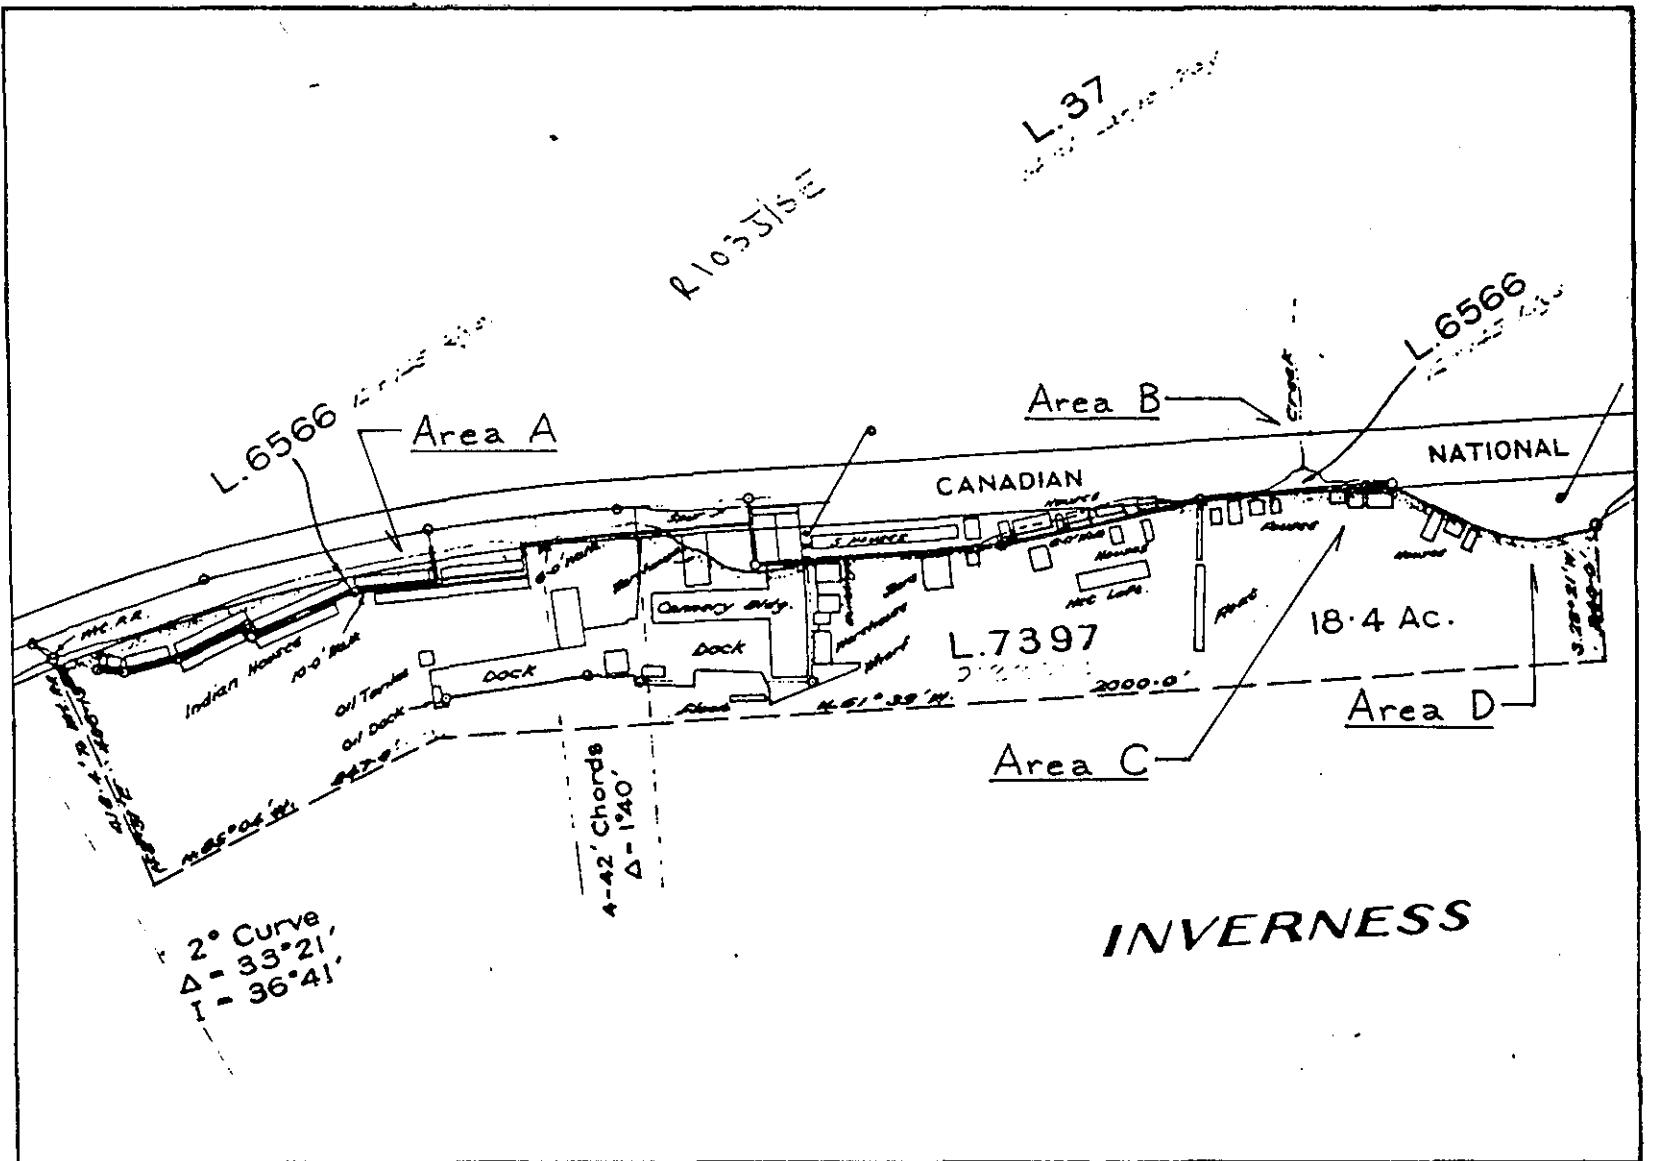
Figure 1. Map of North Pacific Cannery, from Coell & Associates (1985:15).

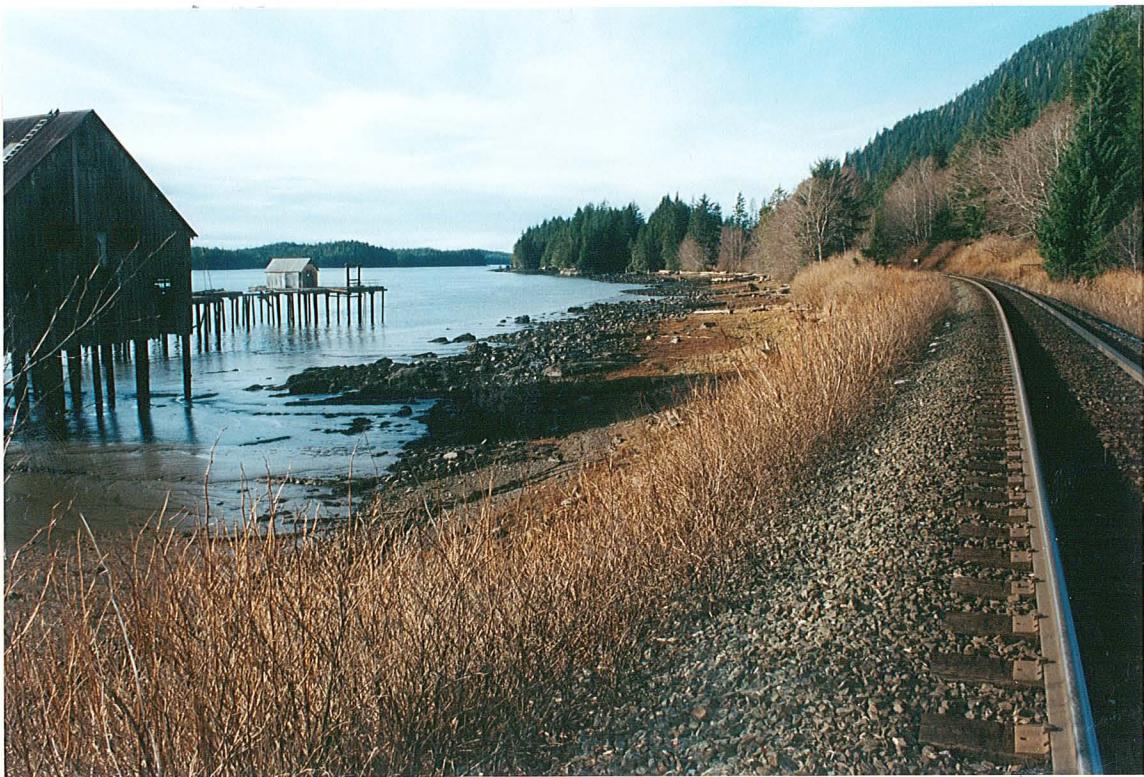
On the beach, directly west of the Machine Shop at North Pacific Cannery are the remains of the living quarters used by First Nations cannery workers and their families (Figures 3 and 4). A map of the cannery drawn in 1923 shows two rows of small, rectangular houses facing each other, with a boardwalk in between (Figure 5). There were 17 huts on the north side of the boardwalk and 15 on the south side, for a total of 32. The entire complex was built over the intertidal zone and supported on pilings. The map shows that a long, straight section of boardwalk linked the First Nations housing area to the shore, just west of the can-making building, with a shorter section branching off to give access to the main wharf. By 1934, the housing for the First Nations workers had apparently been expanded. A map dating to that year shows 42 huts in the section where previously there had been only 32. There were 22 huts on the north side of the boardwalk and 20 on the south side (Figure 6). Moreover, the 1934 map shows a westward extension to the boardwalk, built at a slight angle to the main walkway. The new section had eight additional huts in a single row, thereby increasing the total to 50. Yet another

Figure 3. General view of Area A, looking west from the CN Railway tracks.

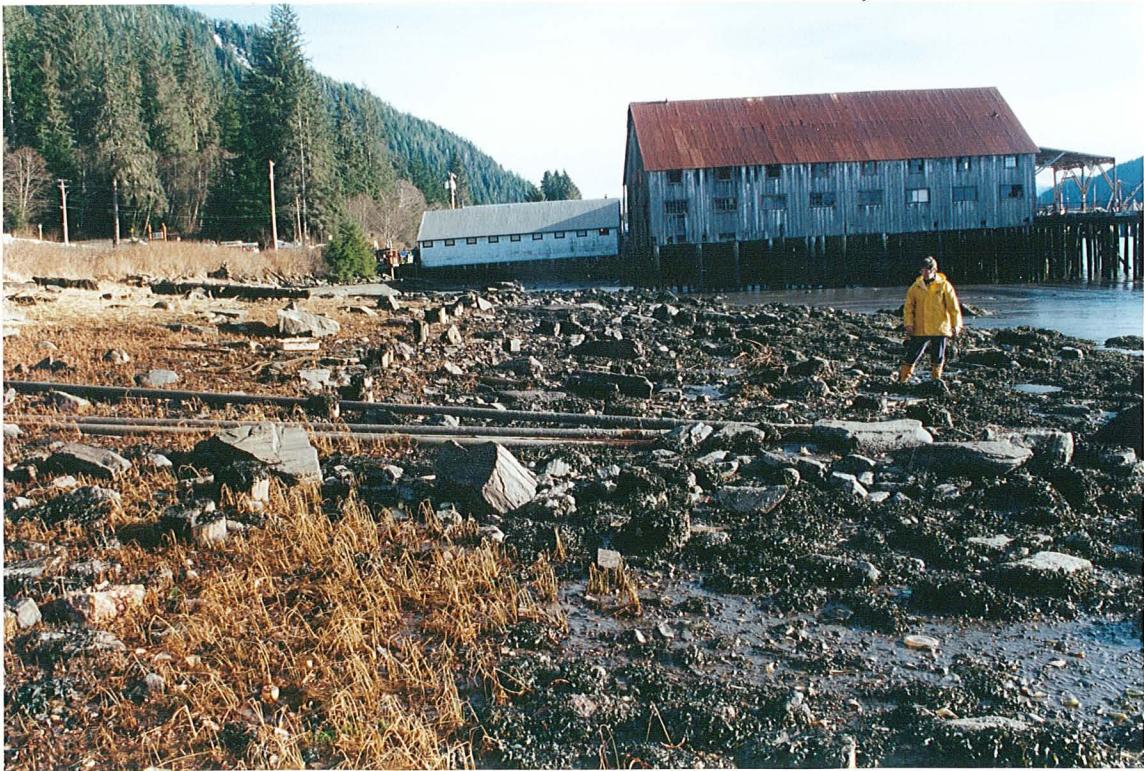
Figure 4. Area A, showing the rows of piling stubs in the intertidal zone.

The remains of the First Nations housing that have survived to the present include a scatter of historical artifacts, as well as the stub ends of the pilings that once supported the huts and boardwalks. There are no intact structures left in the area; the last were demolished some time ago, although photographs of the Native housing were taken as recently as 1974 (eg. Blyth 1991:58). On our survey of the intertidal zone, we located the stubs of 143 pilings (Figure 7). Some are aligned, and almost certainly represent the supports for the main boardwalk through the area, and there are also stubs that may have supported the huts themselves. However, it appears that some (perhaps many) of the pilings that once stood in the area are not included among the surviving remains. What became of the missing stubs is uncertain. Some may have been removed when the houses were taken down; others may have simply rotted away over time. In any case, there does not appear to be sufficient material remaining to allow for a detailed reconstruction of the facilities within this area.

1. Area A. It is my understanding that the archaeological remains in Area A are under threat from two sources: (a) the possible construction of a First Nations housing exhibit in that area; and (b) the looting of historical artifacts from the area by local beachcombers. In view of these dangers, I recommend a small scale archaeological salvage operation in Area A. The objectives would be to compile a more precise record of the pilings in the area using a transit or some other major surveying instrument and to make a systematic collection of the historical items that lie either on or in the beach deposits. The project could be designed with a public aspect. Tourists and local residents could be given an opportunity to help with the salvage excavations and in the process increase their knowledge of the local history and of historical archaeology in general. The project might also lead to the recovery of items that could be used in cannery displays.

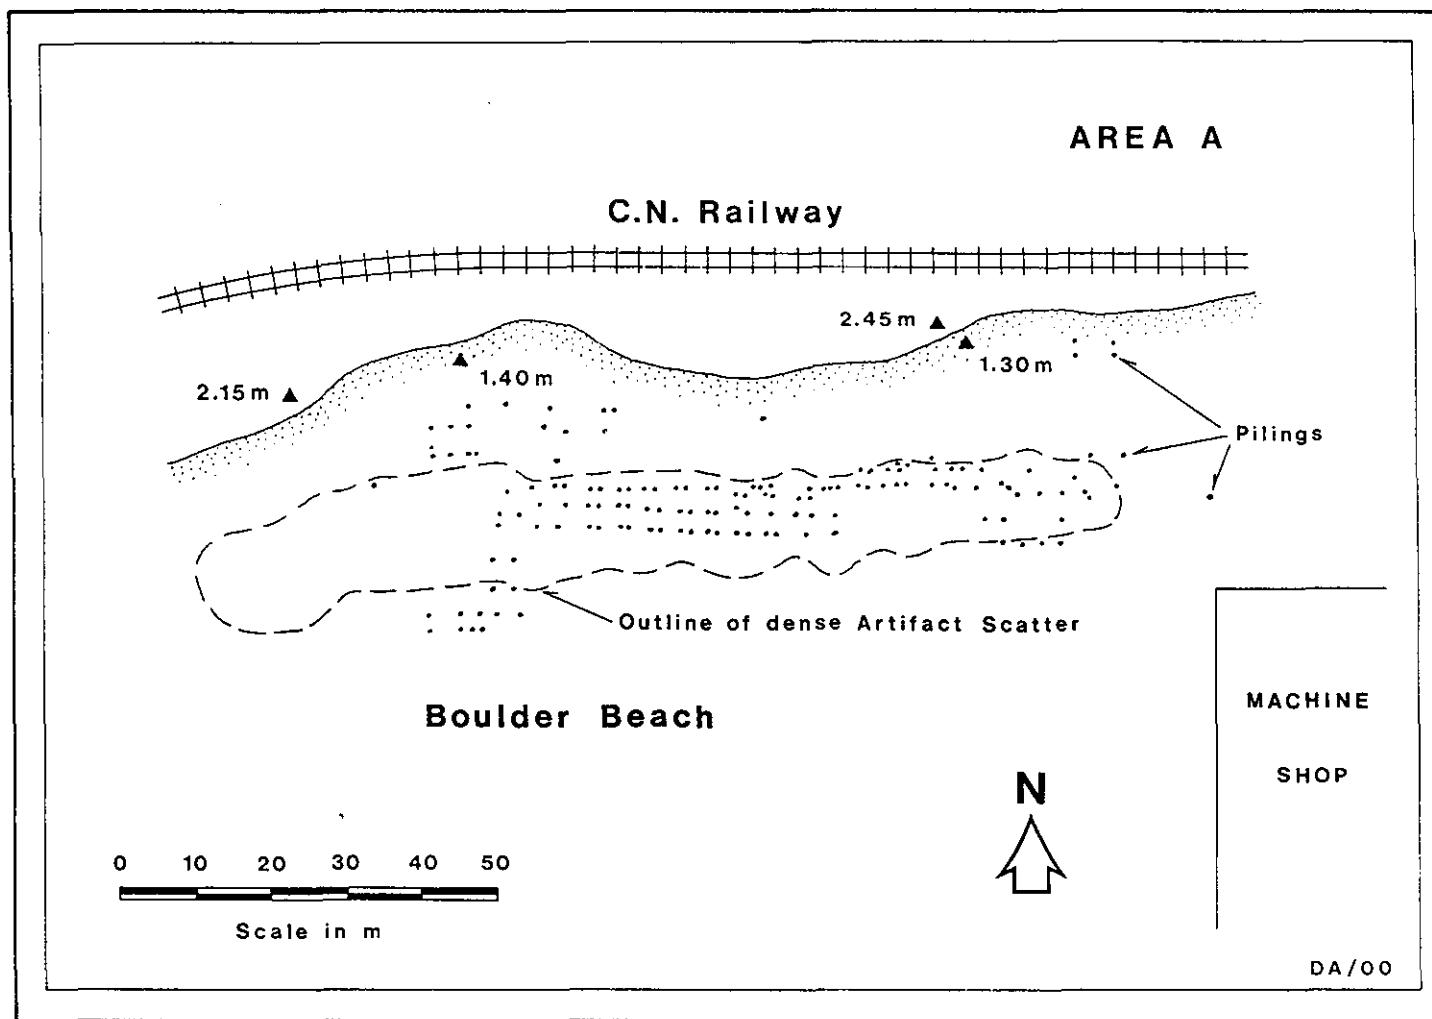
The artifact scatter in Area A is linear in form, which corresponds with the arrangement of huts along the boardwalk. Most items occur within a few metres of pilings, which suggests that the refuse was discarded either from the houses or the boardwalk. Almost all of the artifacts in the area may be classified as domestic refuse. Items include whole and broken pop bottles, liquor bottles, cold cream jars, medicine bottles, broken dishes (including oriental soup bowls), cutlery, and personal items, such as tooth brushes (Figures 8 and 9). A few industrial artifacts were also seen within the intertidal zone, including fragments of metal equipment. The artifacts seem to be of widely varying age. Some may be as much as a century old, while others are close to the modern era. No prehistoric stone artifacts were observed, although the beach was carefully searched with this in mind. Shovel tests dug at intervals across the area indicate that the artifacts are mainly confined

Figure 7. Site map of Area A.

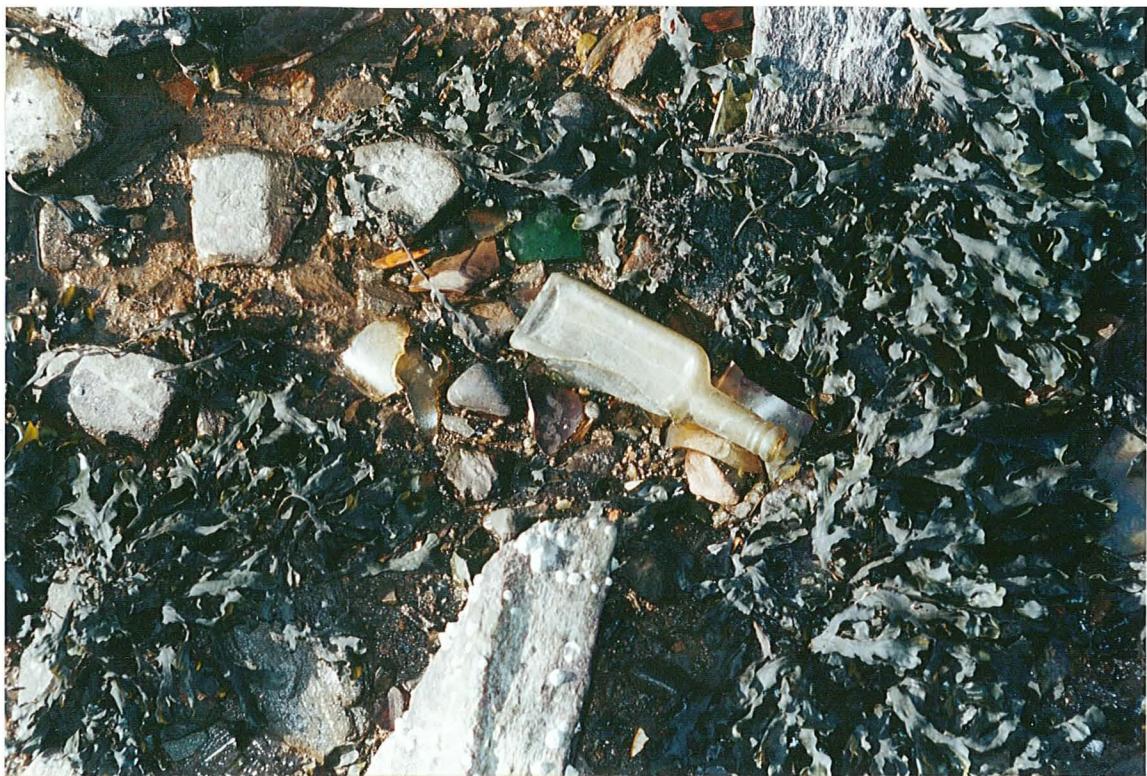
Figure 8. Domestic refuse in Area A, including a whole medicine bottle.

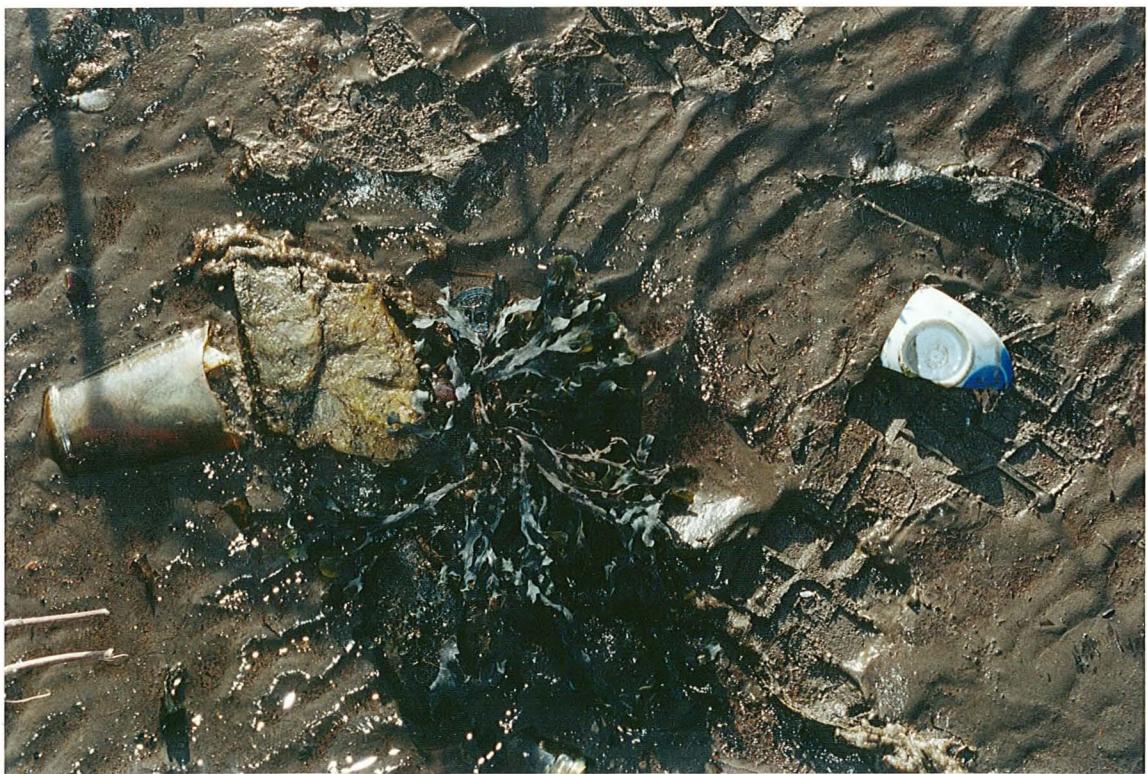
Figure 9. Domestic refuse in Area A, including a fragment of an oriental bowl.

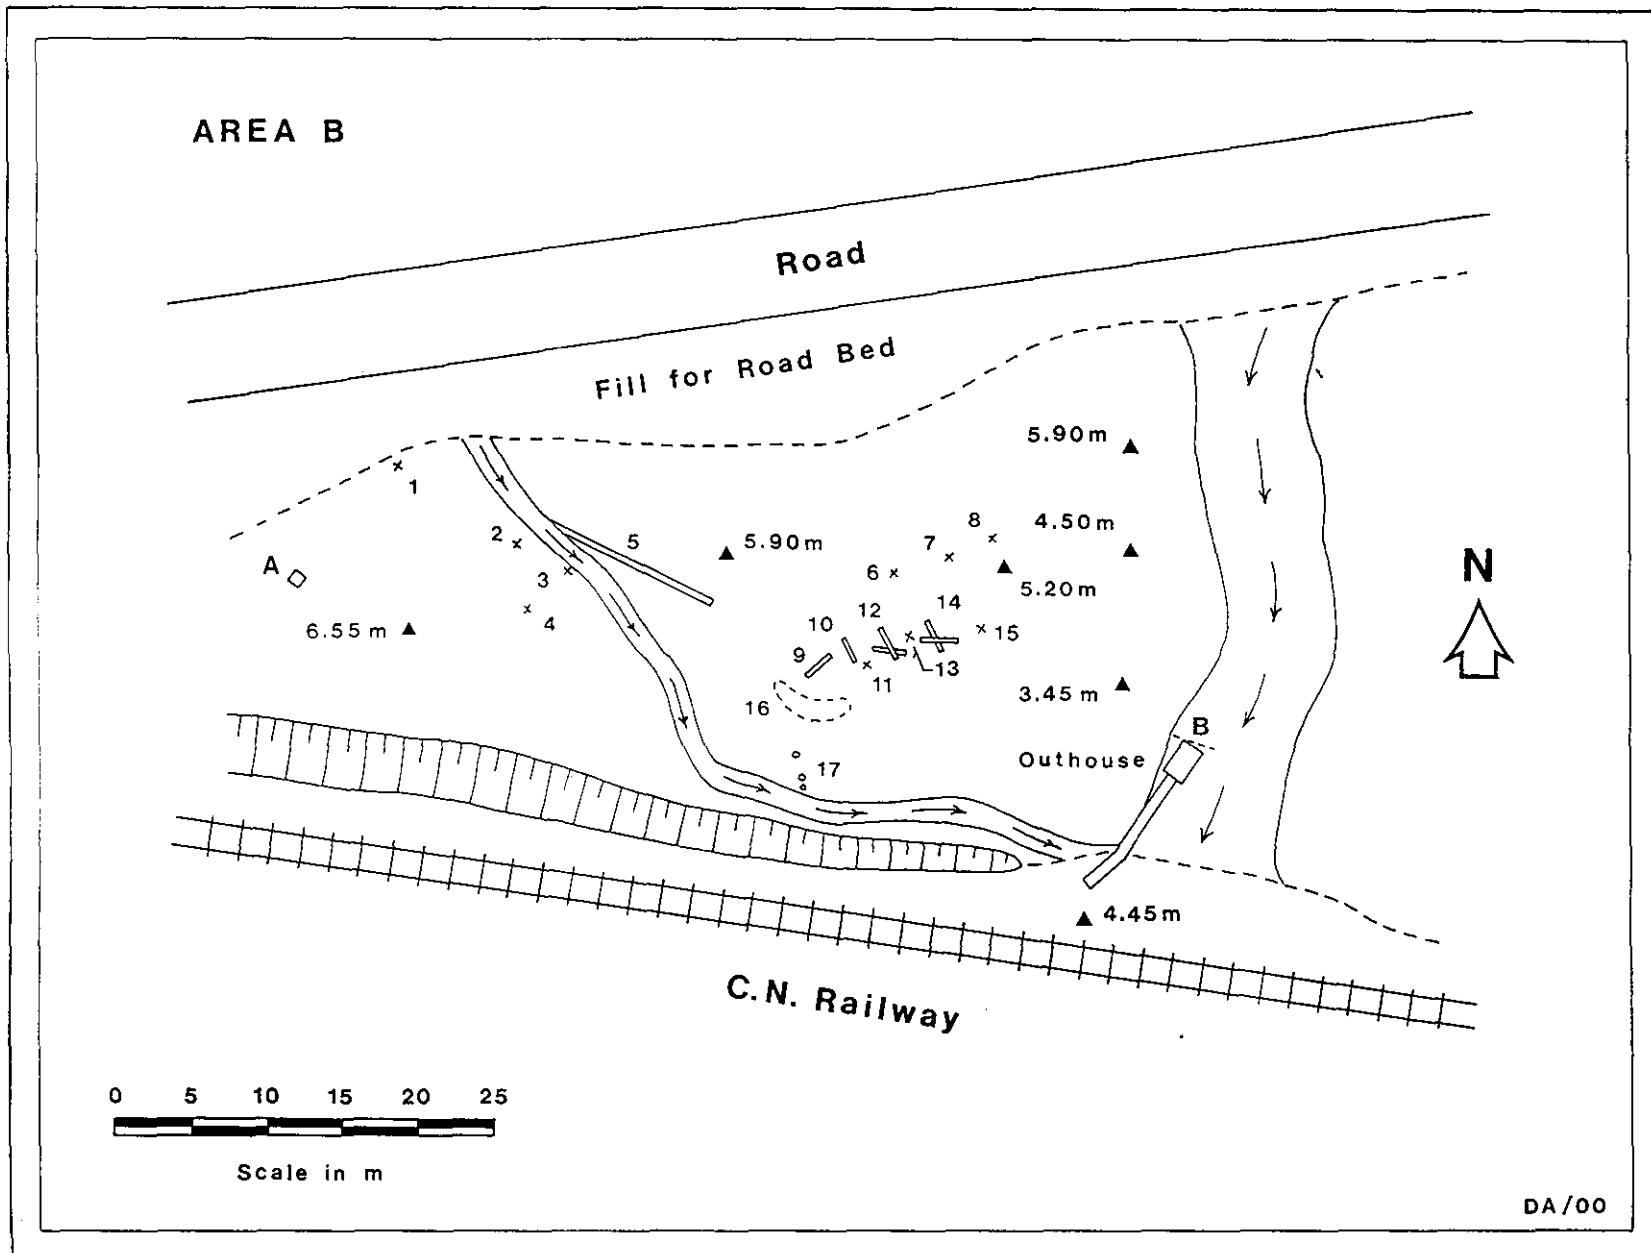
A small creek flows into Inverness Passage about 80 m east of the main group of buildings at North Pacific Cannery, and Area B is on the west bank of the creek (Figure 10). It measures 35 m N-S by 60 m E-W and contains a scatter of historical artifacts, which seem to relate to an occupation by Japanese cannery workers of the early to mid twentieth century. Area B is bounded on the south side by the C.N. railway tracks, on the north side by the secondary road that runs between Port Edward and Cassiar Cannery, and on the east side by the edge of the creek. The western margin is defined only by the distribution of artifacts and other remains across the area.

Figure 10. Site map of Area B.

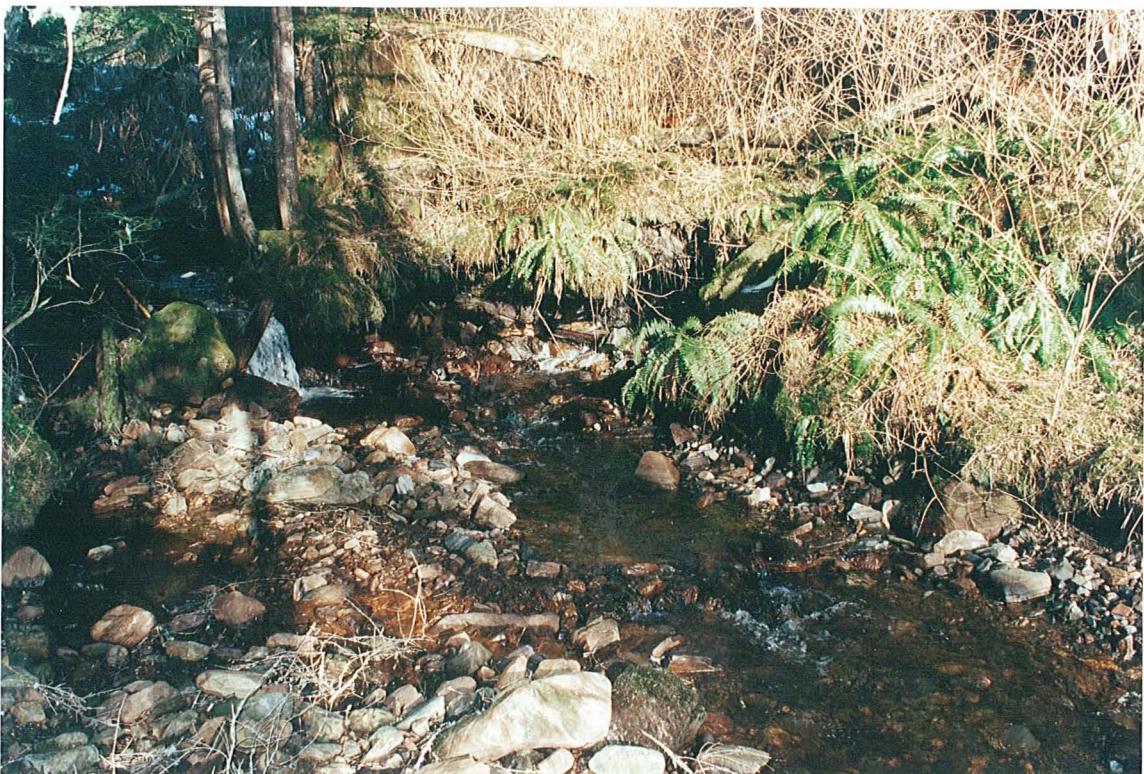
The most prominent physical feature of Area B is the creek itself (Figure 11). Although quite shallow, it has an average width of about 6 m. There is also a small tributary, about 1 m wide, that flows through Area B and joins the main creek at the edge of the C.N. railway bed. The course of the tributary may well have been altered by the construction of the railway, as it now flows along the edge of the railway bed for some considerable distance. Originally, it likely flowed directly into the waters of Inverness Passage about 30 m west of the creek. The local terrain is uneven, due in large part to the irregularities of the underlying bedrock. A few small patches of flat ground occur, but these are generally wet and boggy. The vegetation in Area B is variable, perhaps reflecting the patterns of human activity in the area. Near the creek is a small stand of mature second growth forest, consisting of Sitka spruce, western hemlock and red alder, with an understory of red huckleberry, sword fern and moss. Several large stumps are also present within a few metres of the creek. The size of the living trees suggests that Area B was originally logged off during or soon after the construction of the cannery. About 20 m west of the creek, the forest gives way to a dense thicket of shrubs, consisting mainly of salmonberry bushes. In this area, the second growth trees were probably cleared out when the huts were built for the Japanese workers. The present shrub cover is typical of areas that have been cleared for some purpose and then abandoned.

Figure 11. The creek at the eastern edge of Area B.

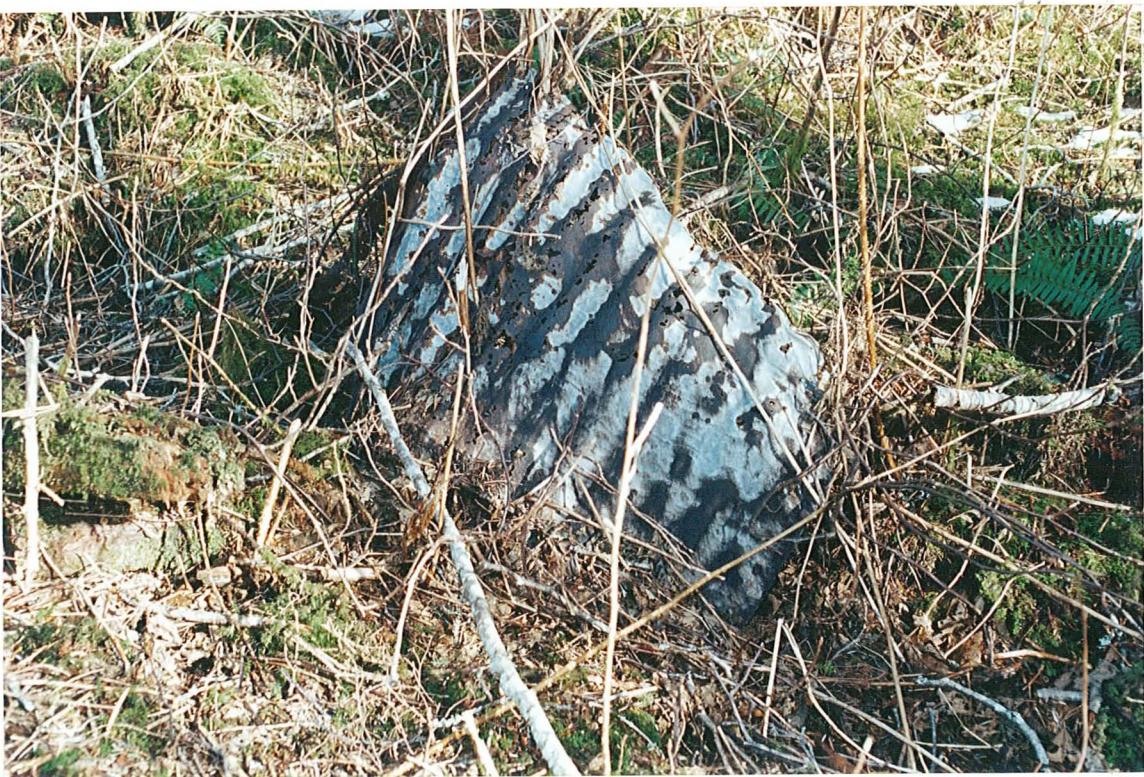
Figure 12. Several sheets of corrugated metal in Area B.

6. A piece of corrugated metal, about 1 m square.
7. Several sheets of corrugated metal, roughly 1 x 2 m (Figure 12).
8. A rusted bucket.
9. A 6 x 6 inch post with a nail in it, at least 2 m long.

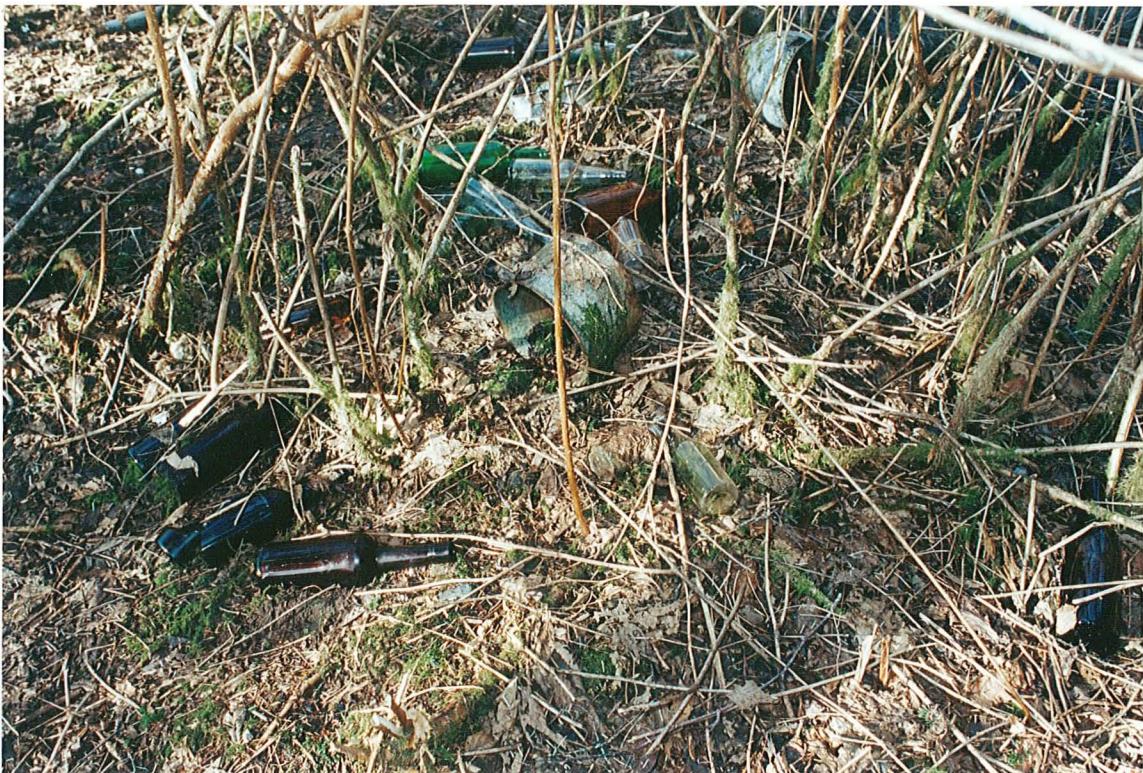
Figure 13. Accumulation of domestic refuse in Area B.

16. An accumulation of domestic refuse, including liquor bottles, medicine bottles, food bottles and jars, and metal pots (Figure 13).
17. A group of three posts: an 8 inch post with a nail in it, 75 cm high; to the south of this, a 6 inch post, cut off just above the ground; and to the south of this, an other 8 inch post, again cut off just above the ground.

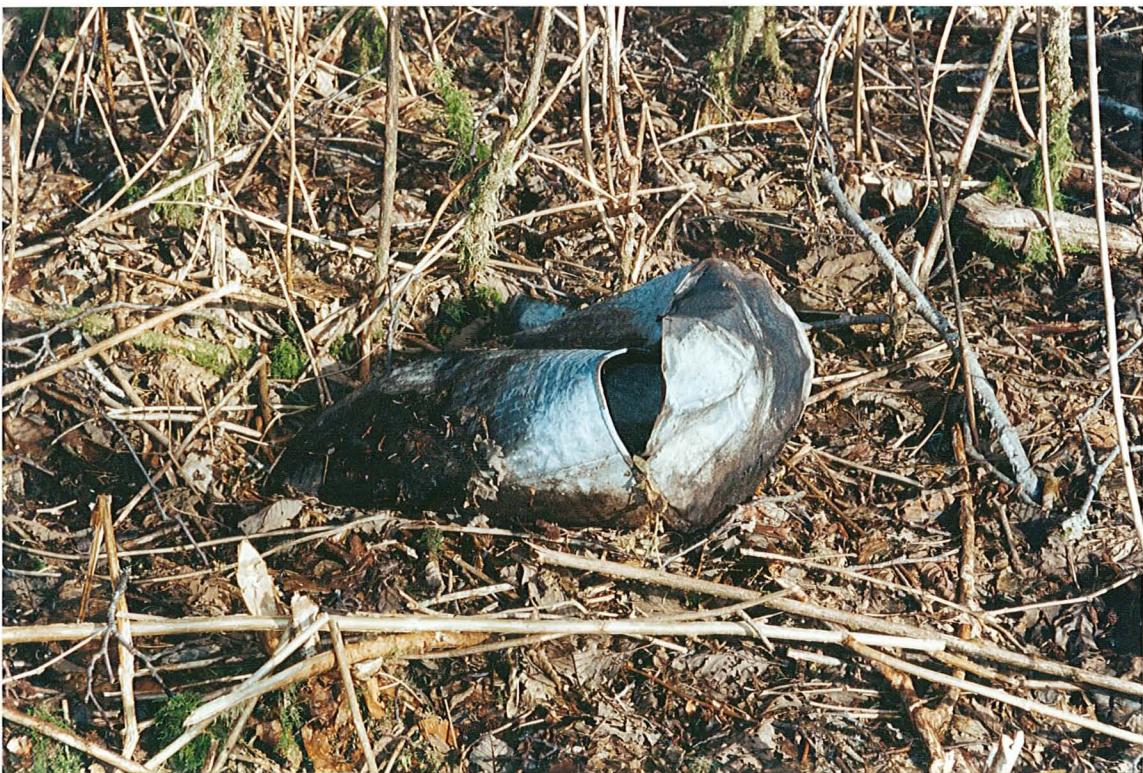
Figure 14. A 5 gallon metal bucket in Area B.

1. A galvanized bucket.
2. A 2.5 gallon gas can.
3. A stove oil container.
4. A 5 gallon metal bucket (Figure 14).
5. A wooden waterline, 8 inches in diameter, wrapped with wire (Figure .

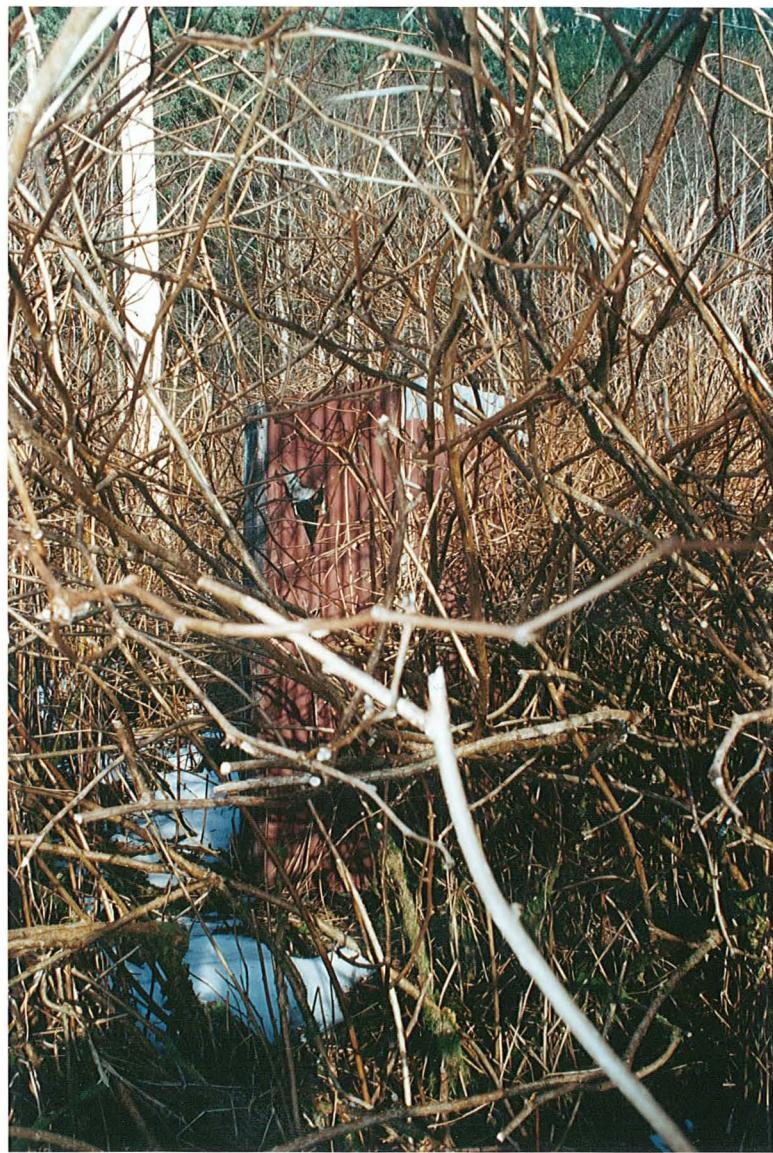
Figure 15. Remains of a small smoke house (Structure A) in Area B.

A small, abandoned building (Structure A) standing at the western edge of Area B measures 1 x 1 m around the base and 2 m in height (Figure 15). Although in poor condition, it appears to be the remains of a smoke house, used for processing salmon and other fish. The walls are made from sheets of corrugated metal, and on the water side a triangular hole has been cut through the metal, probably to allow the smoke to escape. The doorway is on the north side of the building, facing away from the water. On the walls inside the smoke house are two nails that may have been used for hanging the fish over the fire. The structure has a dirt floor and the roof is missing.

may be that they are now buried under the fill for the Port Edward-Cassiar Cannery road. The poor condition of the smoke house at the western edge of Area B suggests that some time has elapsed since it was last used, but even so, it may date to a time after the occupation by the Japanese cannery workers.

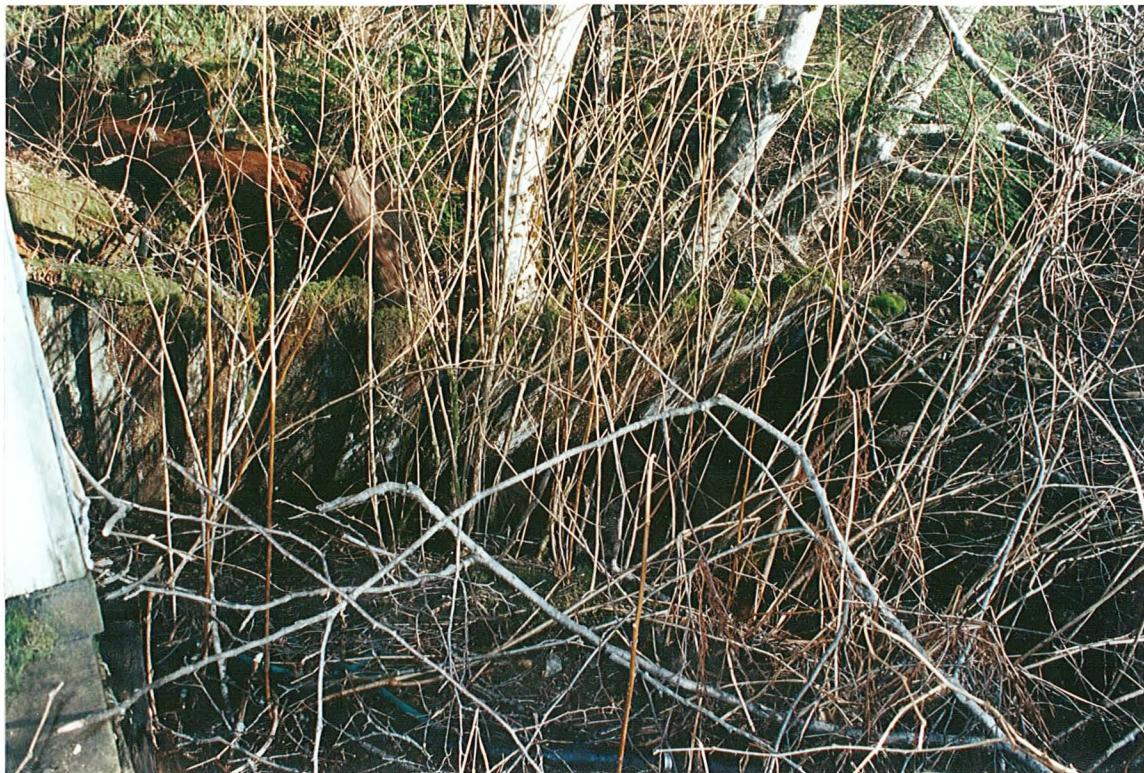
Other facilities observed in or adjacent to Area B include part of a dam on the main creek (Structure B). The remains are about 8 m north of the point where the creek enters a culvert under the railway tracks. The dam was made of vertical planks, a few of which are still intact next to the west bank of the creek (Figure 16). The dam would have created a pool of water, about 1 m deep, providing the inhabitants of Area B with a convenient source of fresh water for drinking, cooking or bathing. At some point, an 8 inch wooden water pipe also was also installed, carrying water from the tributary streamlet to the area where the Japanese hut(s) stood (Figure 17). The significance of the two sources of fresh water is uncertain, but they may have been used at different times or for slightly different purposes.

Figure 16. Remains of wooden dam at the edge of the creek in Area B.

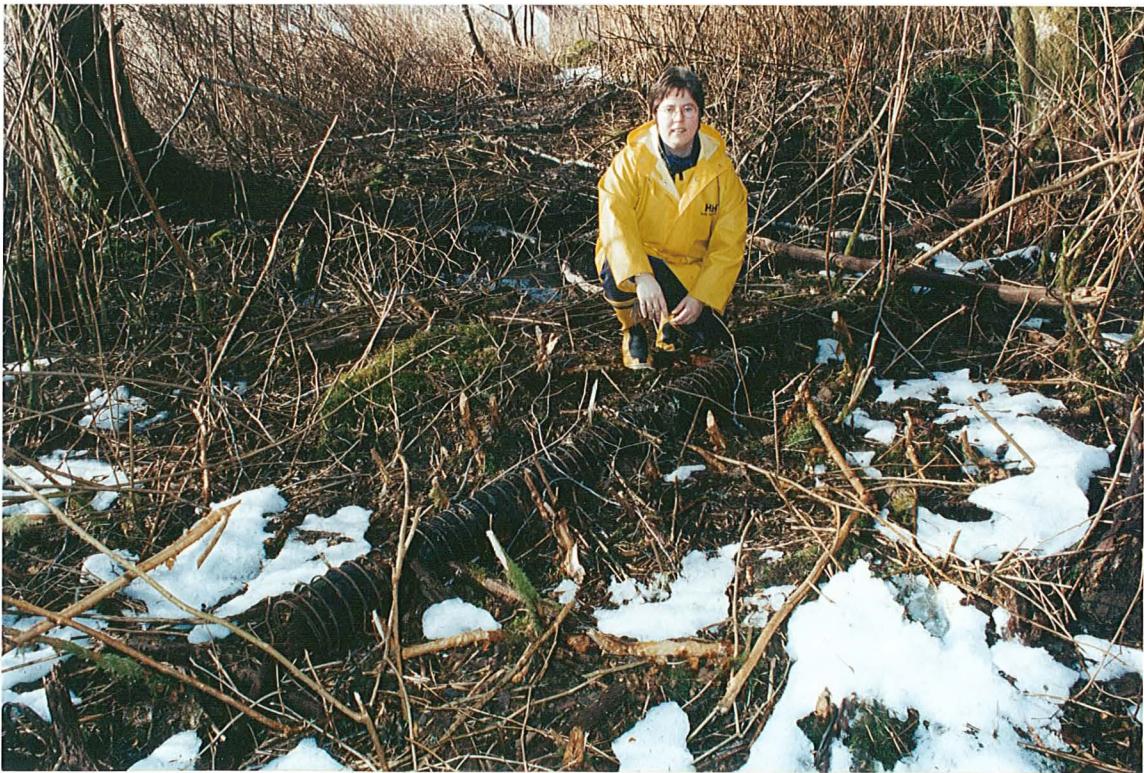
Figure 17. Remains of the wooden water line in Area B.

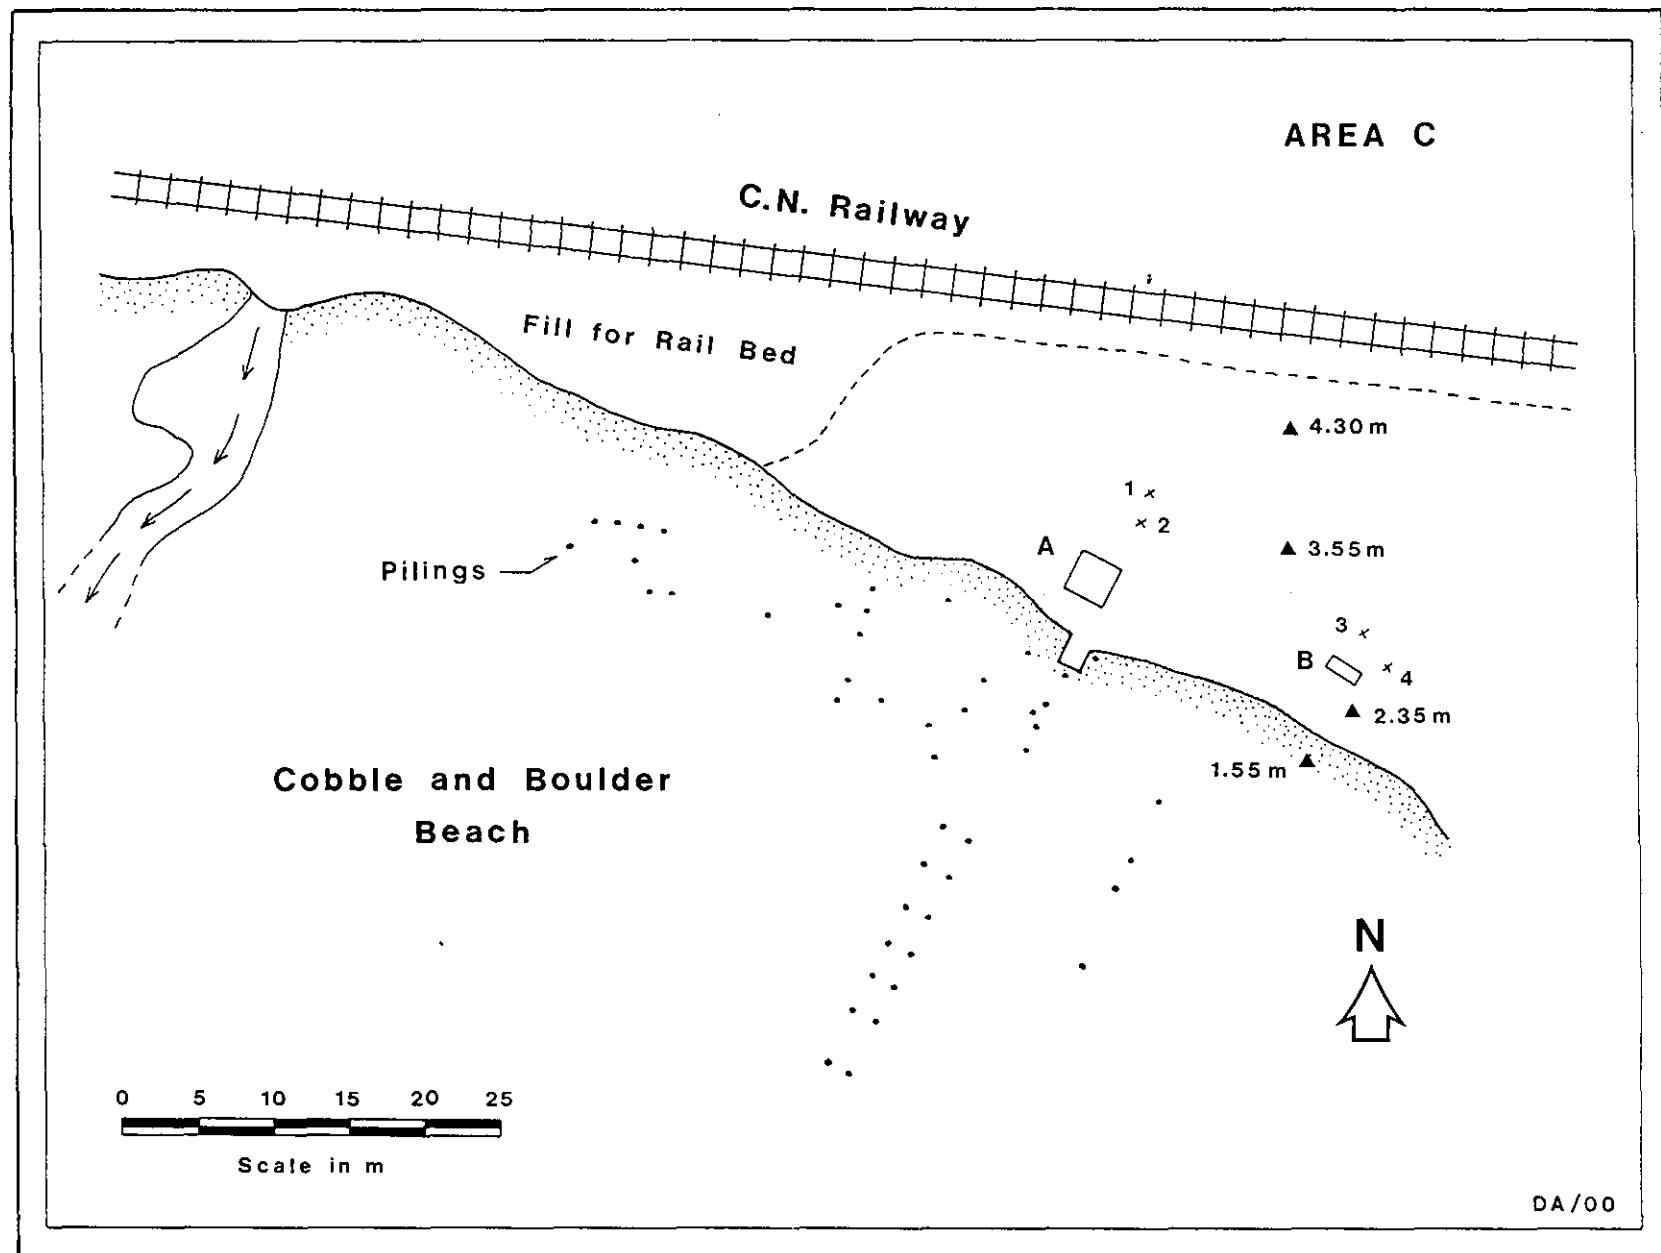
Area C is located just to the east of Area B on the south side of the C.N. railway tracks (Figure 20). It includes a wedge of land measuring about 25 m N-S by 40 m E-W, as well as the adjacent intertidal zone. The wedge of land is bounded on the north side by the railway tracks and on the south side by the rocky shores of Inverness Passage. To the east, it extends to the base of a steep rise, which forms the western limit of Area D. The land is low and flat along the shoreline, but rises gradually towards the railway tracks. The vegetation in Area C is a dense growth of shrubs, with a few scattered red alder trees. The shrubs appear to be salmonberry bushes, although a positive identification is difficult during the winter season when the leaves are down. Below the high tide line is a gently sloping beach of cobbles and boulders, which gives way in the lower intertidal zone to a broad expanse of sand and silt (Figure 21).

Figure 20. Site map of Area C.

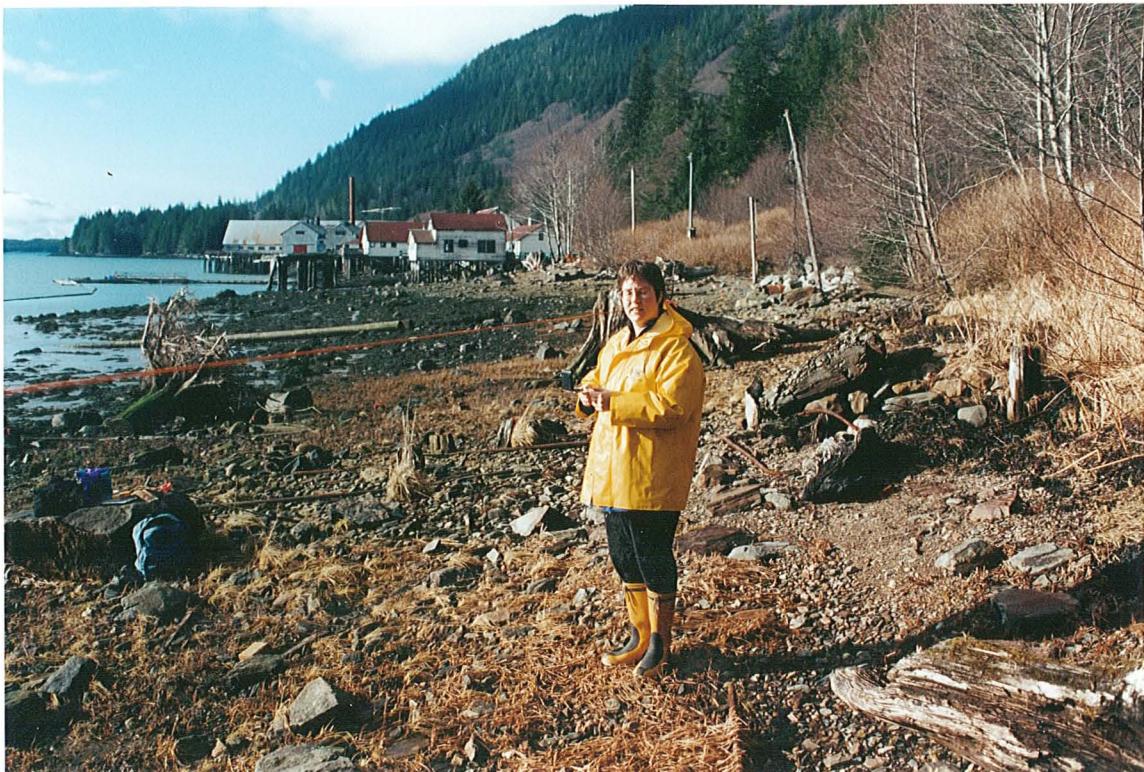
Figure 21. Teresa Weismiller mapping the intertidal zone in Area C.

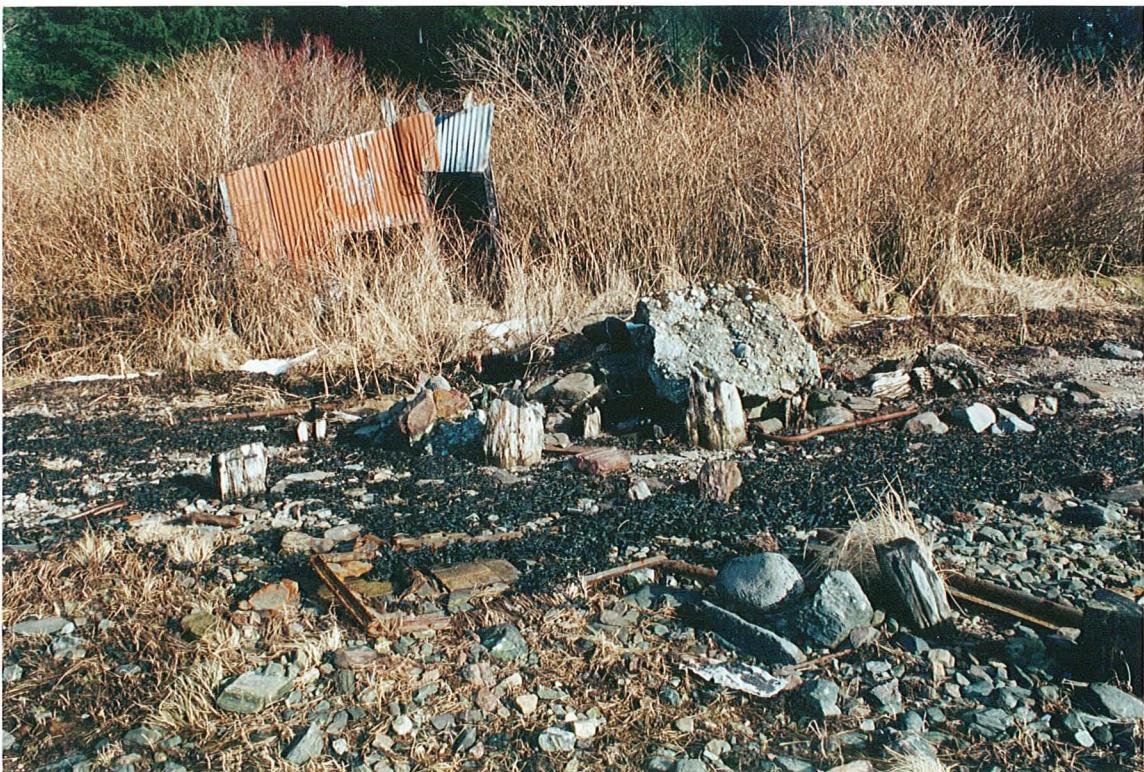
Just above the high tide line in Area C is a small, dilapidated building that was probably used for some industrial or commercial purpose (Figure 22). Structure A is squarish in plan, measuring 3.0 m along the front (facing the beach) and 3.1 m along the side. It has a single-pitched roof which slopes downward slightly towards the west. From the ground up, the roof is 1.7 m high at the southwest corner and 2.4 m high at the southeast corner. Inside the structure, the main corner uprights are 4 x 4 inch posts, while the secondary uprights, cross-pieces and roof supports are 2 x 4 inch studs. Both the sides and roof are covered with sheets of corrugated metal. The entrance to the building is in the southeast corner facing the beach and measures 1.85 m high and 0.70 m wide. Overall, the building is in poor condition. Some of the siding is missing; there is evidence of charring along the upright by the door; and the roof is partly collapsed. Inside the shed is an old motor, mounted on a wooden block, and a pile of discarded fish netting. The building may have been used as a storage facility when no longer serviceable for other purposes. Directly in front of the building, the shoreline has been extended

Figure 22. Remains of a shed (Structure A) in Area C.

3. Area C. At present, there appear to be no urgent threats to this area. I therefore recommend regular monitoring by museum staff to assess the condition of Structure A, the pilings and associated artifact scatter. If any changes are perceived, it may be necessary to plan a detailed recording of the building and pilings, and a systematic recovery of the portable artifacts.
