North Pacific Cannery

Archaeological Resource Inventory

March 2000

**David J.W. Archer
Heritage Consultant
589 5th Avenue East
Prince Rupert, B.C.
V8J 3Y3**

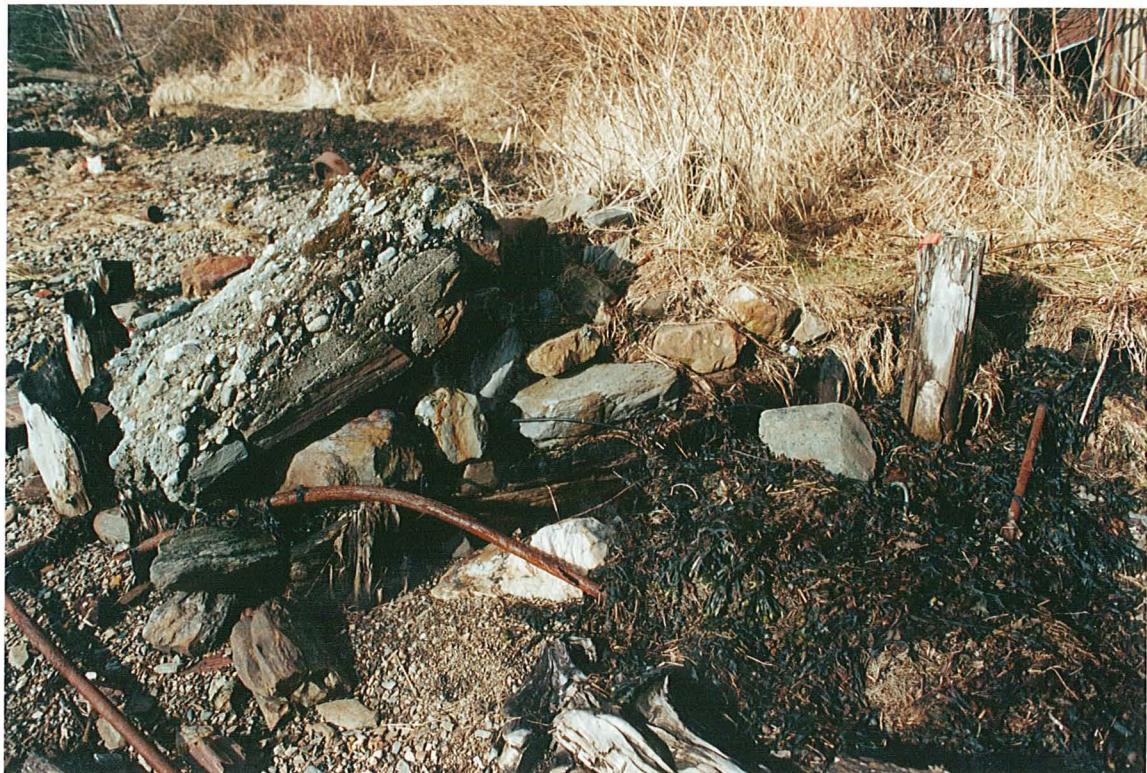
outward slightly through the construction of a small rectangular pad (Figure 23). The sides of the pad are made of thick, rough planks, held in place by posts driven into the beach gravels. The space inside the pad has then been filled with boulders from the beach. The purpose of the extension is unknown.

Figure 23. Extension at the edge of the shoreline in front of Structure A in Area C.

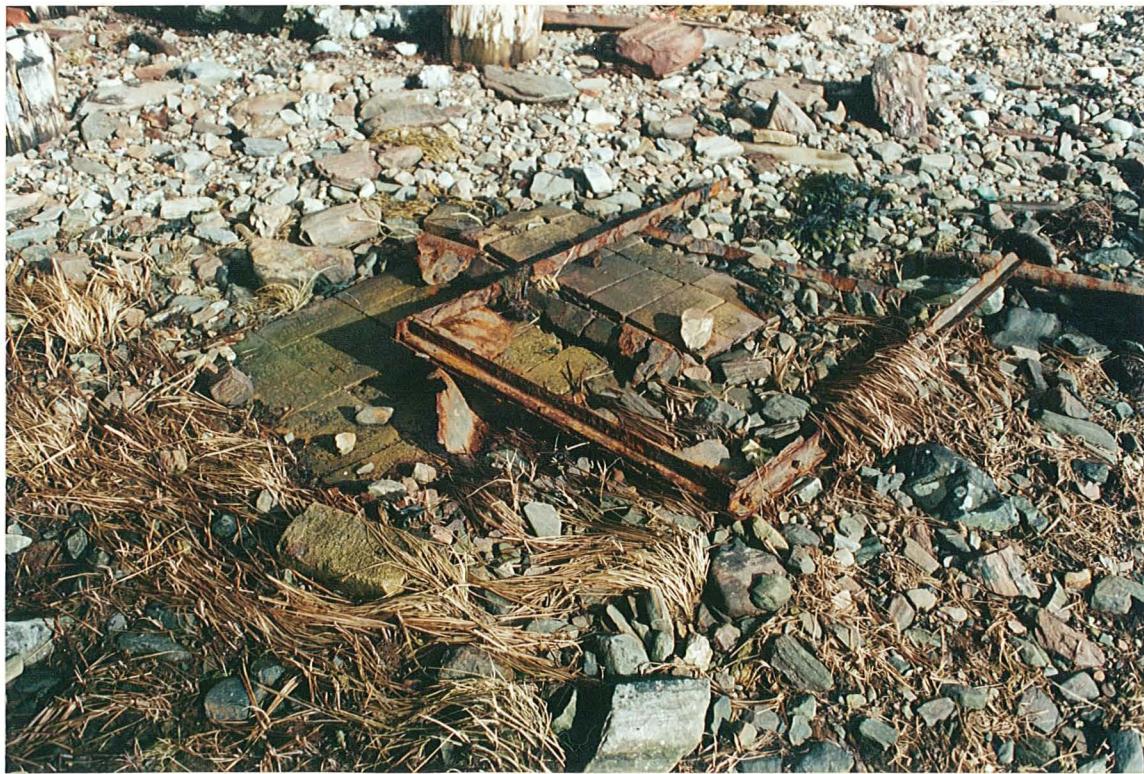
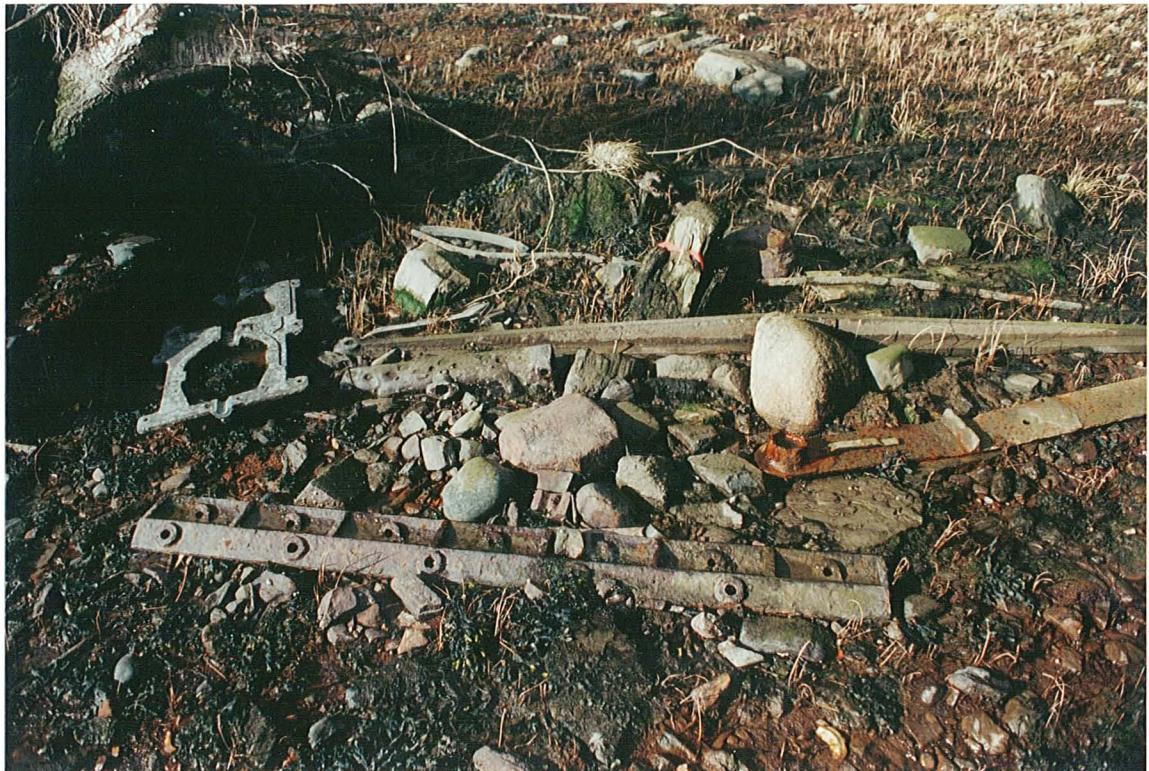
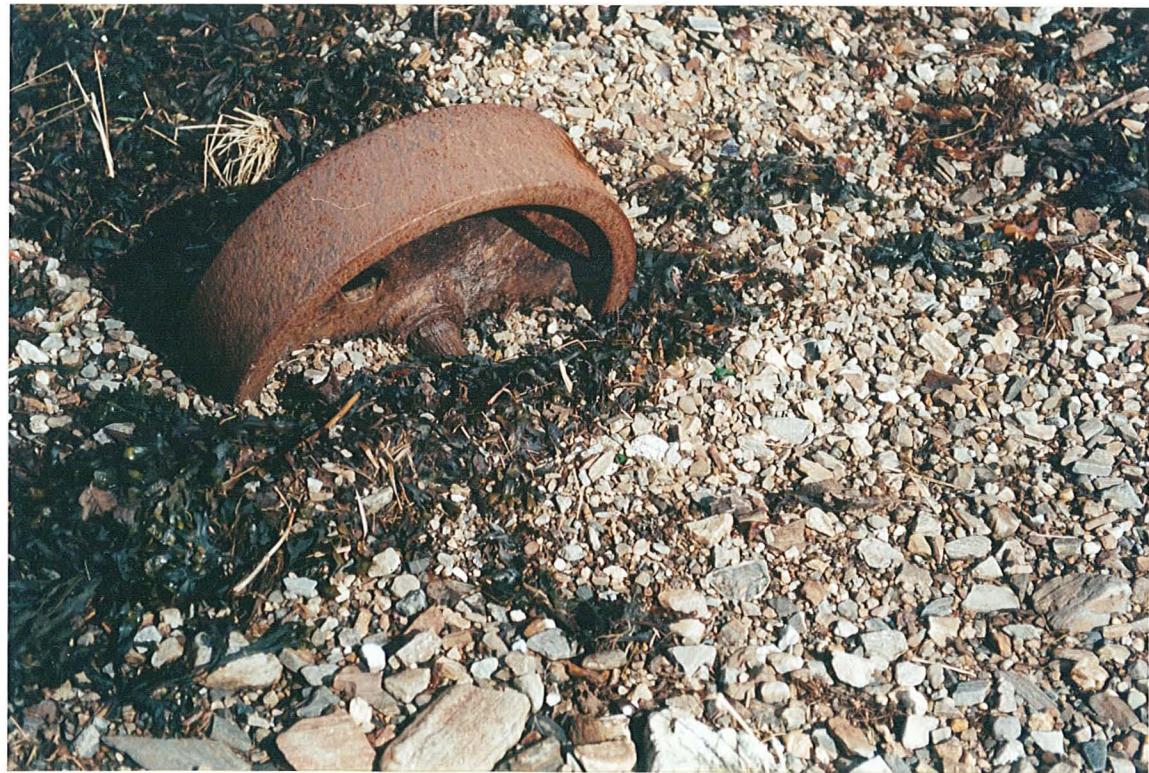
In the intertidal portion of Area C are the remains of 48 pilings, all cut off at a height of about 30 cm above the beach. The pilings probably supported a variety of structures, including workshops, boardwalks, and dock facilities. Some of the stub ends are aligned and were likely parts of the same structure. For example, directly in front of Structure A, there are two parallel rows of pilings, extending southward into the intertidal zone, at right angles to the shoreline, about 2 m apart. The arrangement suggests a small wharf or perhaps a dry dock facility used to haul up fish boats in need of servicing. The beach in Area C, is littered with historical items, most of which are industrial in nature. They include bricks, metal frames and brackets, metal pipes, lengths of wire cable, and a large flywheel, as well as the ubiquitous fragments of broken glass (Figures 24, 25 and 26).

Figure 24. Bricks and metal frame on the beach in Area C.

Figure 25. Metal brackets and other debris on the beach in Area C.

Figure 26. Large metal flywheel on the beach in Area C.

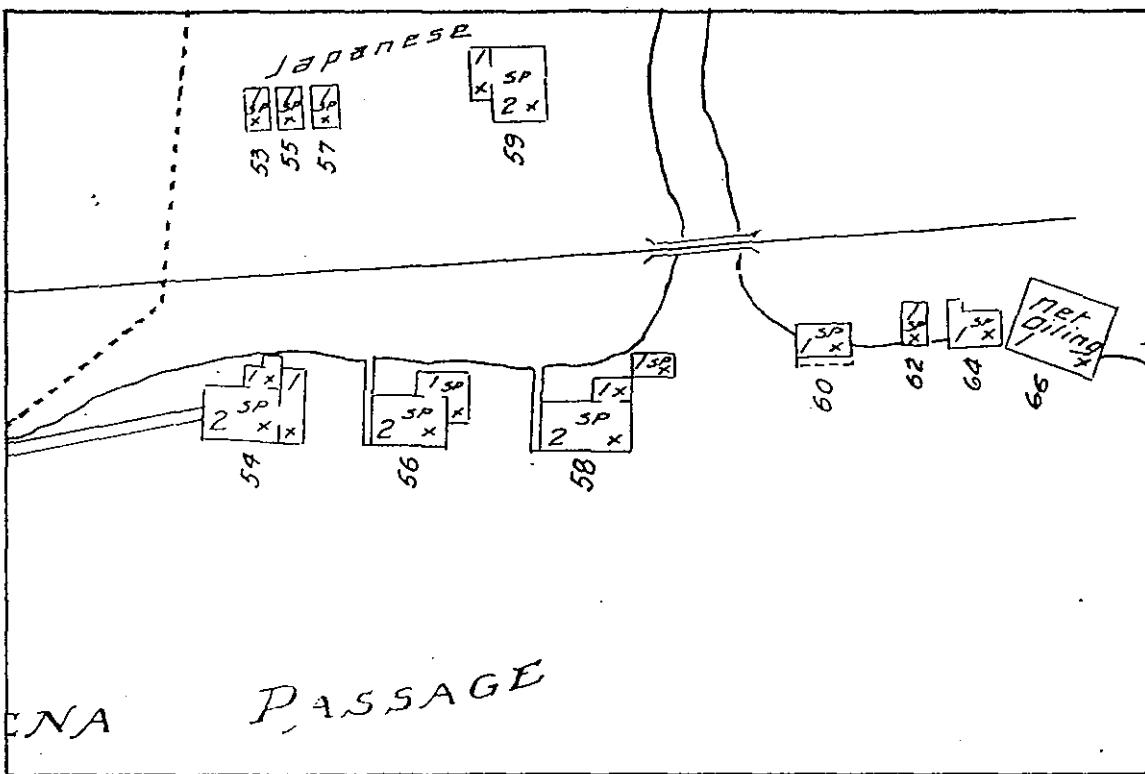
and must have been supported at least partially on pilings (Figure 27). The largest structure is identified as a net oiling shed; the others are of unknown function. A later map, dating to 1934, also shows four buildings in this area, but they do not appear to be the same set of structures (Figure 28). At this time, all four extended into the intertidal zone and would have required pilings for support. The nature of the buildings is not indicated, although it is stated that they were used by Japanese workers. Given the changes that evidently occurred in the use of Area C, it may be difficult to associate the existing pilings with particular historical structures.

Figure 27. Detail of 1923 map of North Pacific Cannery, showing Area C.

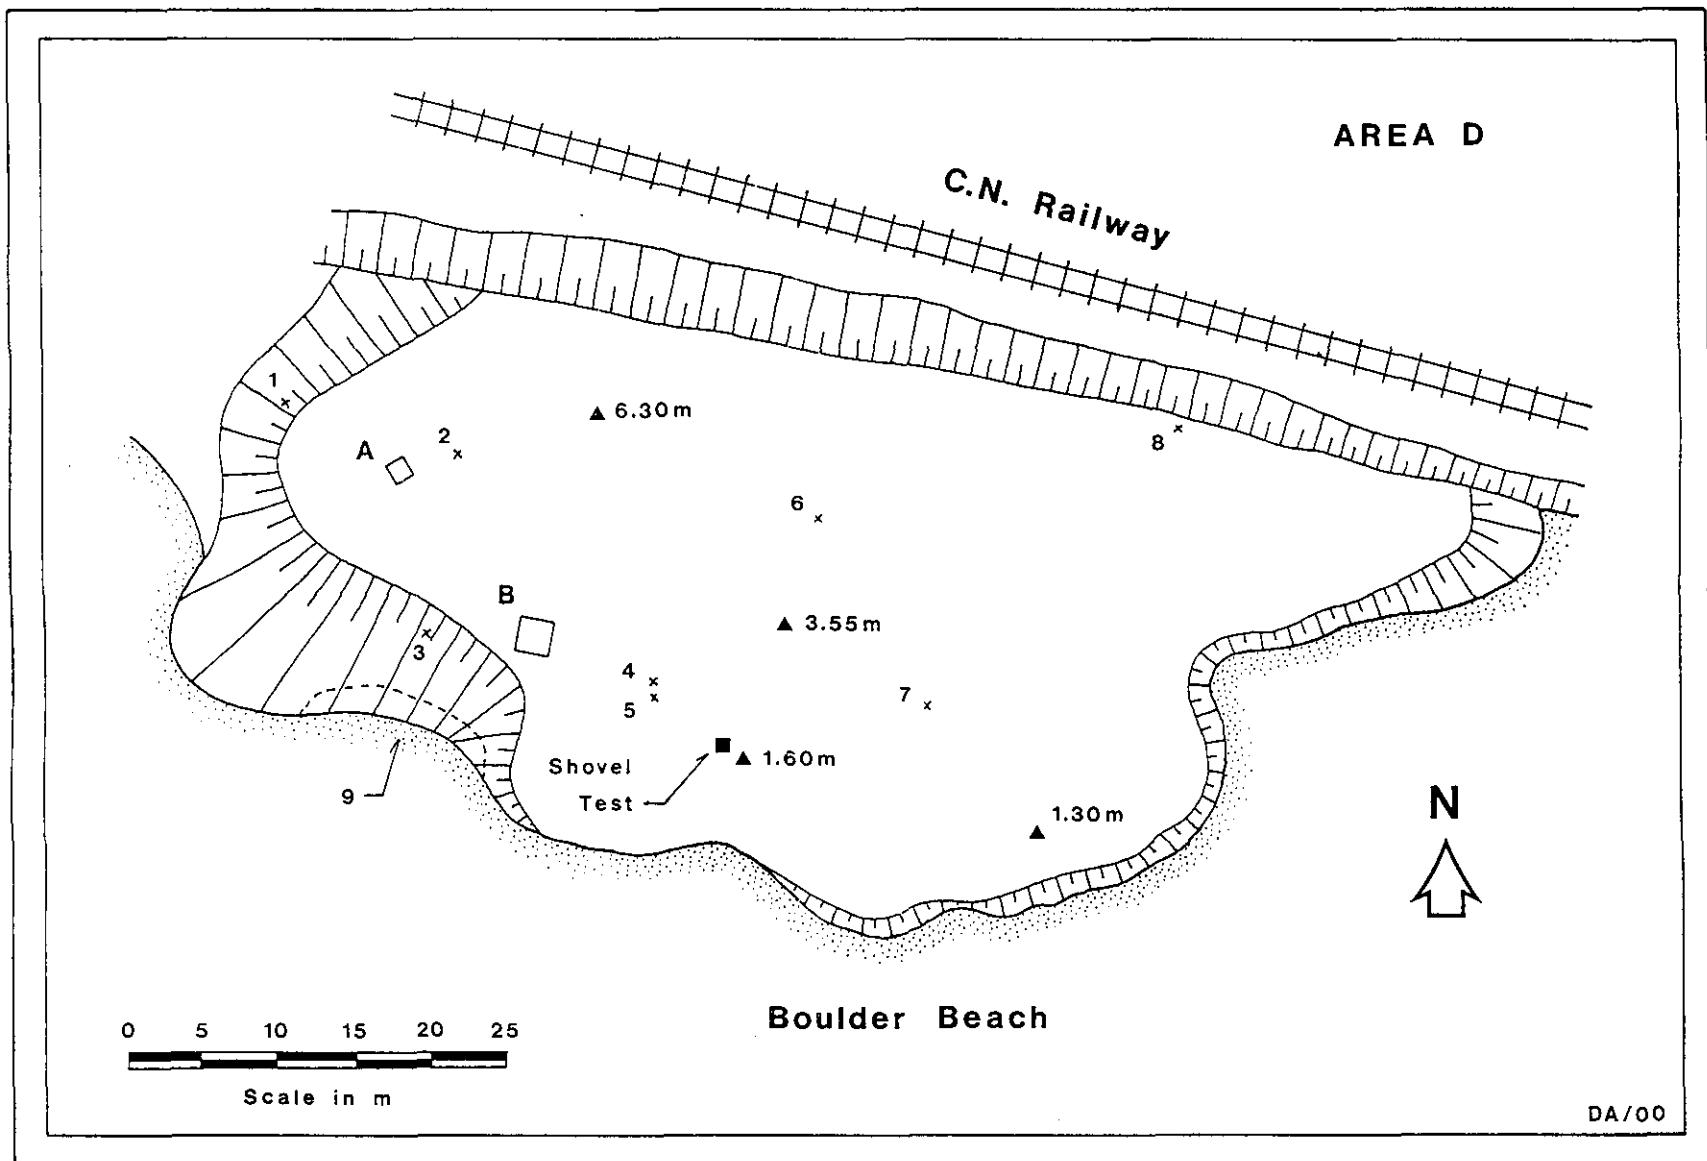
The forested point of land at the eastern edge of the cannery property is Area D (Figure 29). It measures 42 m N-S by 88 m E-W and has an irregular topography underlain with bedrock. Along the south side of the point, facing Inverness Passage, is a rocky beach of boulders, cobbles and bedrock outcrops. The northern boundary is defined by the C.N. Railway tracks. The railway here runs through an artificial cut with the original bedrock surface standing 1-2 m above it on either side. Some blasting was evidently needed to level the rail bed in this area. From south to north across the point, elevations increase gradually. Measurements taken show an overall rise of about 5 m across the area, which seems to reflect a general rise in the underlying bedrock. In most places that we cored, bedrock was no more than 10-20 cm below the surface. The vegetation on the point is dominated by a second growth forest of western hemlock, Sitka spruce and western red cedar, with an understory of red huckleberry bushes, sword ferns and moss (Figure 30). Several large stumps are present, and judging from the size of the living trees, the area was probably logged off about a century ago, during or soon after the construction of North Pacific Cannery.

Figure 29. Site map of Area D.

A systematic search of the point led to the discovery of 13 historical artifacts, all lying on the surface of the ground (Figure 29):

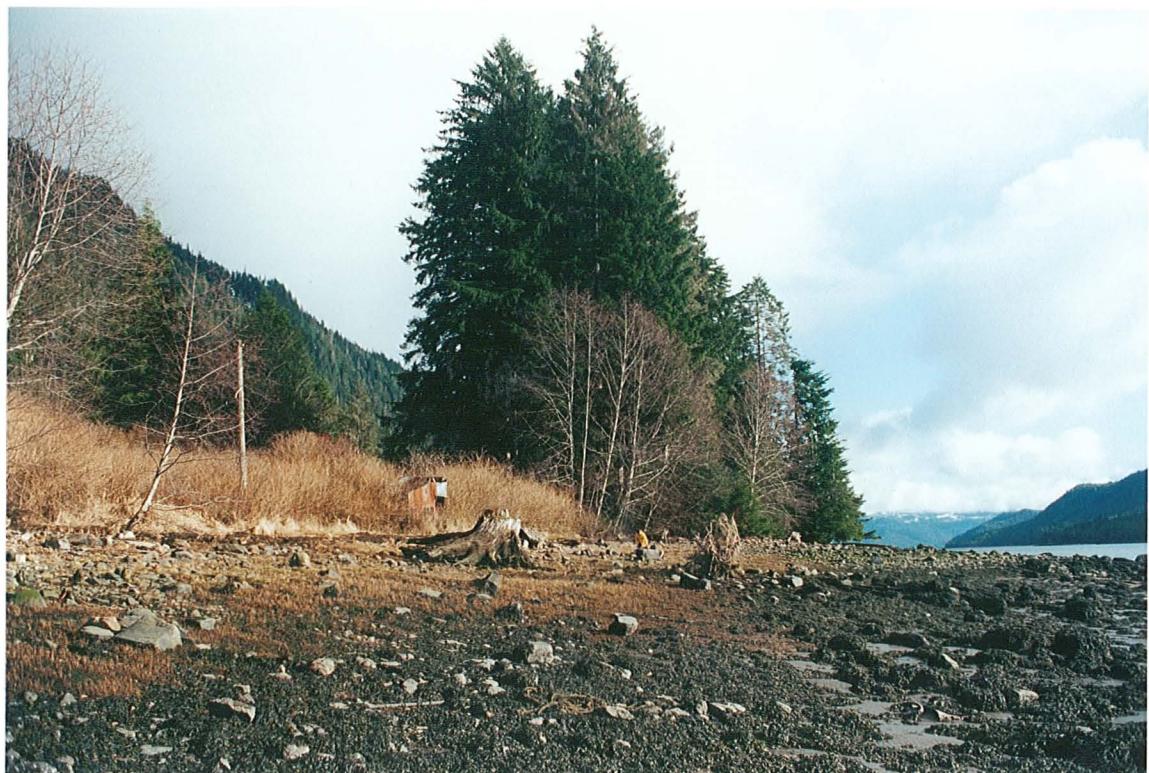
Figure 30. General view of Area D looking east.

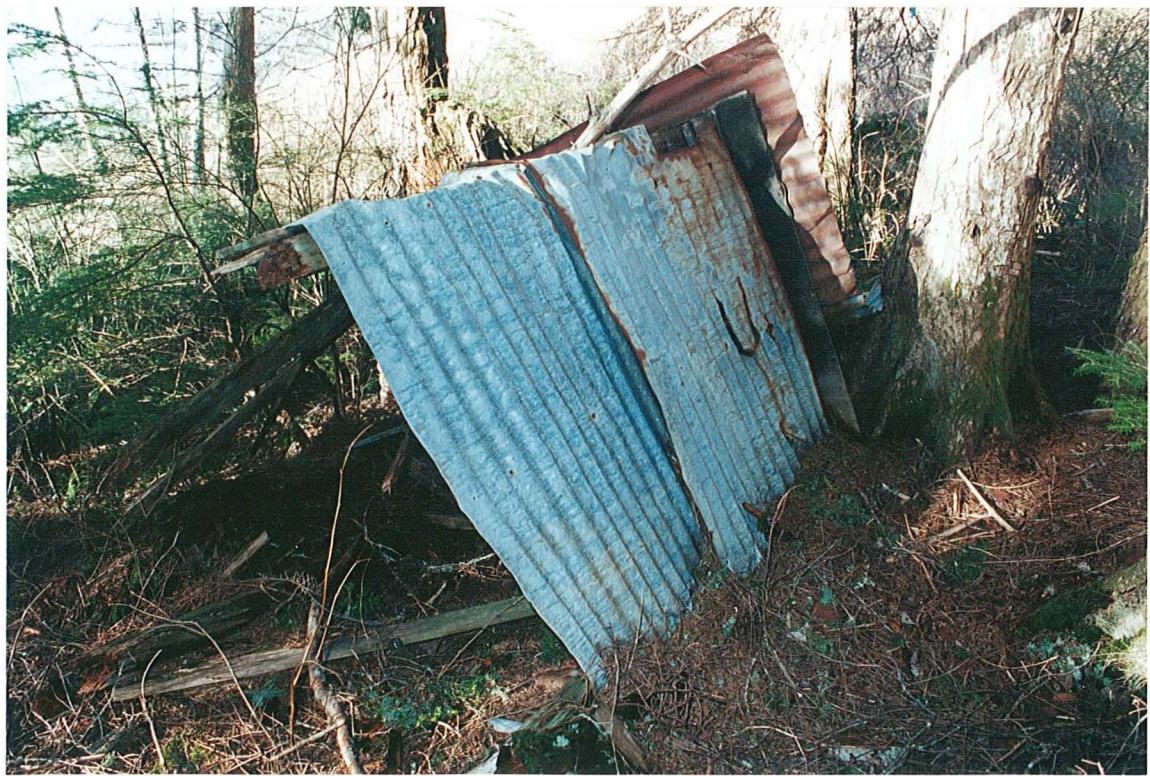
On the west side of the point overlooking the beach are two partially intact structures. They both appear to have been used as smoke houses, for processing salmon and other fish. Structure A, the smaller of the two, has been overturned and is lying on its side (Figure 31). Its basal dimensions are 1.30 x 1.25 m. The height for the building could not be determined with any precision due to its poor condition, although it was probably a little over 1.80 m high. The uprights used in

Figure 31. Smoke house (Structure A) lying on its side in Area D.

its construction are 4 x 4 inch milled lumber, and the cross pieces in the side walls are 2 x 4 inch studs and 1 x 6 inch planks. The walls were enclosed with sheets of corrugated metal. The roof was flat, made of plywood, and it too was covered with corrugated metal. The dimensions of the roof are 1.75 x 1.5 m, which makes it slightly larger than the base of the building, leaving a projection out to the front and a smaller overhang on the other three sides. The door of the structure is missing, and nothing can be said about its construction. Inside, horizontal slats have been nailed onto the side walls--at least three on each side. Presumably, the fish to be smoked were hung from rods, and the ends of the rods were supported on the horizontal slats. The structure does not appear to have had a floor. The present alignment of the building suggests that it faced in a southwest direction, towards the beach.

4. Area D. The museum is considering a low-impact development of this area to provide a small camp ground for visitors to the cannery. If this plan is put into effect, Structures A and B should be recorded in more detail prior to any development. The few surface artifacts in the area should also be collected prior to any development. In the meantime, the area should be monitored on a regular basis by museum staff.
5. There is also need for some additional archaeological assessment within the cannery property. The stub ends of some pilings were noted in the intertidal zone south of Area B, on the west side of the creek mouth. However, time constraints made it impossible to investigate further. Other areas yet to be examined include the east side of the creek north of the railway tracks, and the area north of the road. These areas should be surveyed and assessed as soon as possible.

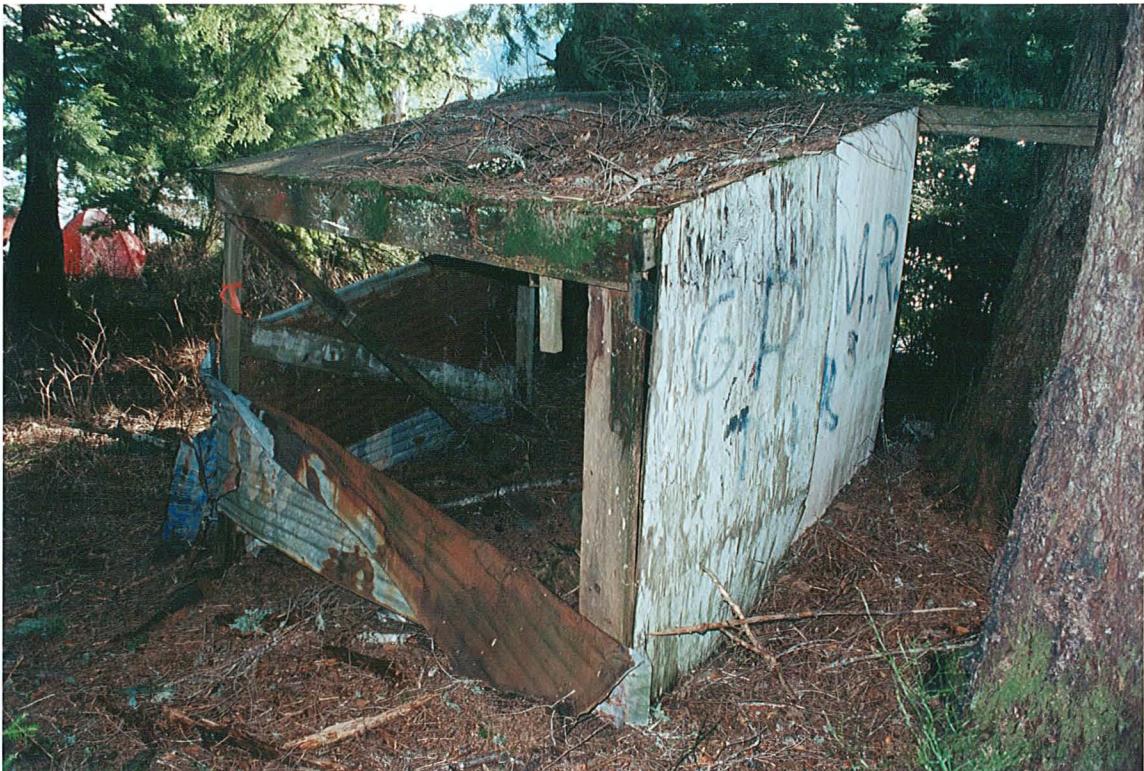
The second smoke house, Structure B, is larger than the first, measuring 2.5 x 2.3 m (Figure 32). It has a single pitched roof, with a gentle slope running east to west. On the east side, the roof is 2.1 m high; on the west side, it measures 1.7 m high. In framing the walls, the builders used an assortment of lumber: 2 x 4 inch studs, as well as 2 x 6 inch and 2 x 8 inch planks. On two sides (south and west), the walls are enclosed with sheets of plywood; on the other two, sheets of corrugated metal have been used for the same purpose. The roof is of plywood and has no overhang. Originally, it may have been covered with sheets of corrugated metal, as in Structure A, but if so, none remains in place. The building has a dirt floor and a doorway on the south side (east corner), facing the shoreline. The opening is 1.8 m high by 0.8 m wide. Structure B is in fairly poor condition. Some of the corrugated metal sheets on the walls have been torn off; the door is missing; and the plywood roof is sagging. There appear to be no brackets on the inside of the shed to support the rods from which the fish were hung. However, they have been removed when the structure was abandoned.

Figure 32. Smoke house (Structure B) in Area C.

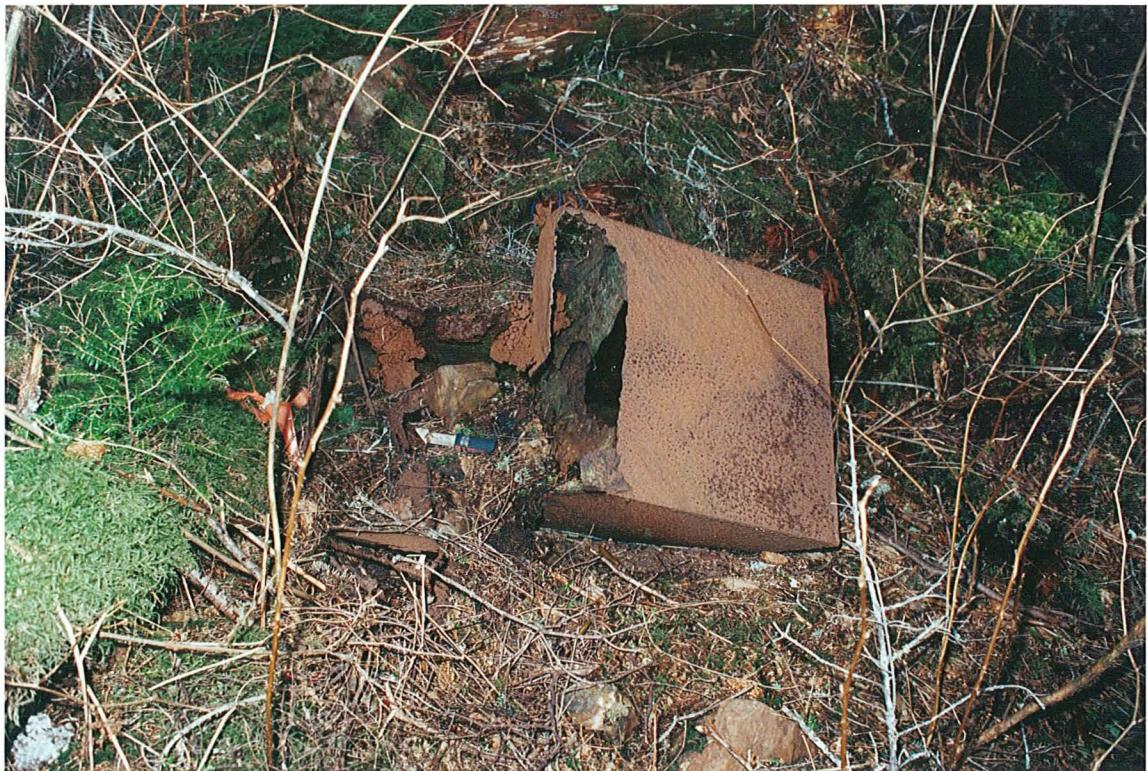
Figure 33. Rusted metal tank, possibly part of a stove, in Area D.

4. A sheet of corrugated metal, 2.0 x 0.5 m.
5. A rusted metal bed frame.
6. Part of a rusted metal bucket.
7. A rusted metal tank, 0.9 x 0.5 x 0.5 m, possibly part of a stove (Figure 33).
8. A rusted metal bed frame.
9. A cluster of items, including a TV antenna, a metal bed frame, a bucket, a wooden box and a rusted metal container.
