Canadian Heritage River Monitoring Report

Kicking Horse River: 1999-2010

March 2011

Parks
Canada

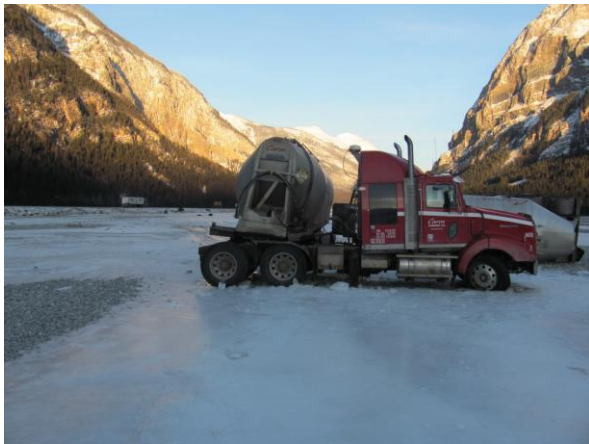
Truck slid on the frozen Kicking Horse River in 2010
Photo: Parks Canada, K.Schroeder

There are several accidents annually along the Kicking Horse River that result in spills of fuel, oil and other engine fluids onto the ground and occasionally into water. Parks Canada employees and the Field Fire Department respond to these incidents and do initial work to contain the spills. Beyond first response, containment and removal of contaminated materials is contracted out.

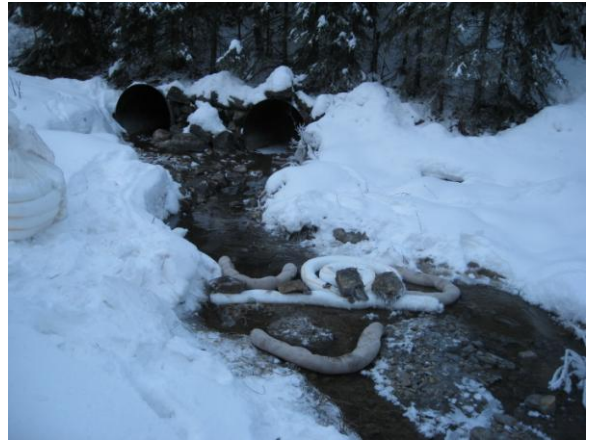
Spill containment on creek by the Field backroad caused by a motor vehicle accident Photo: Parks Canada, K.Schroeder
