Cap-des-Rosiers Natural Dynamics Restoration and Coastal Ecosystem Enhancement

Final Report

Prepared by: Daniel Sigouin

April 2022

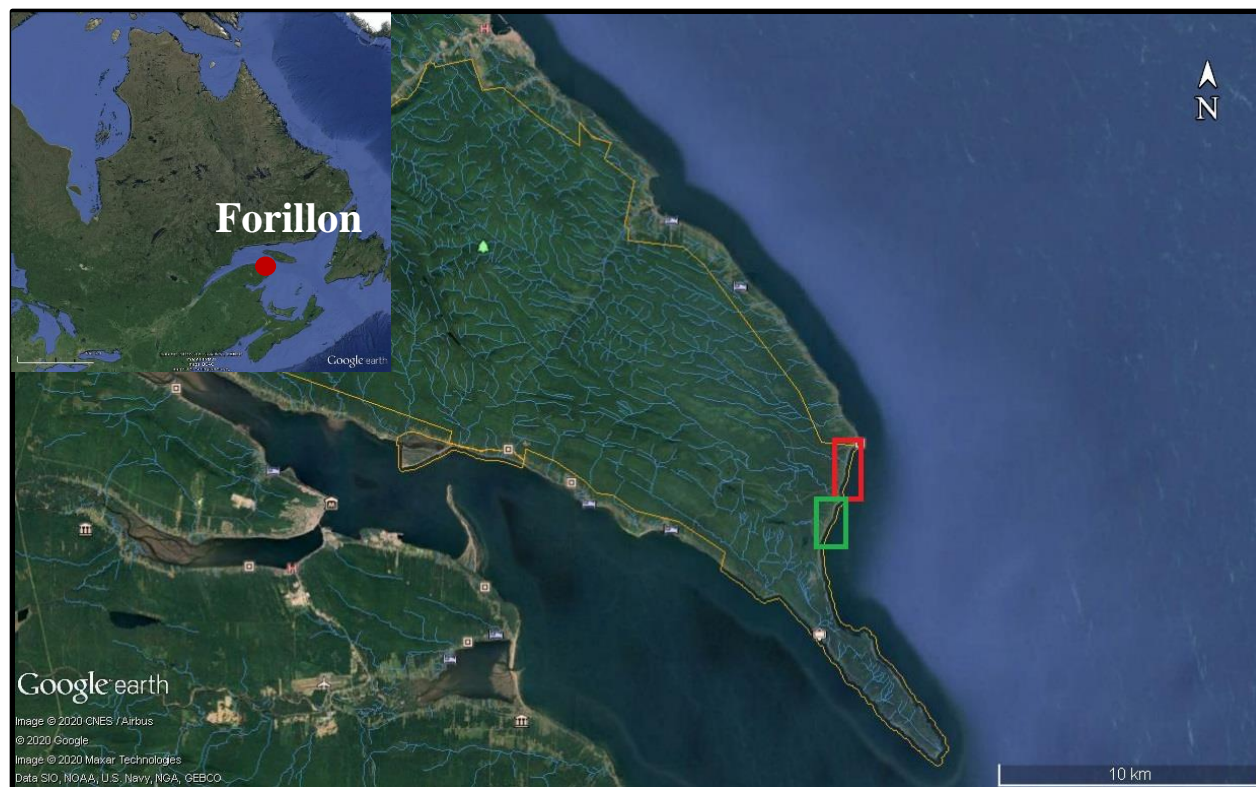
Figure 1. Location of Forillon National Park, located at the eastern tip of the Gaspé Peninsula (red dot in the smaller map) as well as the intervention area (red box) and control area (green box) for the project to restore the natural dynamics and enhance the coastal ecosystem of Cap-des-Rosiers.

The Cap-des-Rosiers area is located on the east coast of Forillon National Park and faces the Gulf of St. Lawrence (Figure 1). The entire area between Cap-des-Rosiers and the tip of Cap-Gaspé is made up of a combination of soft-substrate beaches and coastal cliffs measuring up to 200 metres high. Several species of seabirds can be found in this area of the park depending on the time of year. Between March and August several species nest there, including the double-crested cormorant (*Phalacrocorax auritus*), razorbill (*Alca torda*), the common murre (*Uria aalge*), black guillemot (*Cepphus grylle*) as well as the great black-backed gull (*Larus marinus*) and herring gull (*Larus argentatus*). The area also boasts the largest colony of black-legged kittiwakes (*Rissa tridactyla*) in eastern Canada (Pronovost et Sigouin 2018) and provides an opportunity to observe the magnificent harlequin duck (*Histrionicus histrionicus*), a species of concern (COSEPAC 2013) that regularly uses the park's shores for foraging. Other species of seabirds tend to winter in this area, such as the great cormorant (*Phalacrocorax carbo*), Barrow's goldeneye (*Bucephala islandica*), a species of concern (COSEPAC 2000), common goldeneye (*Bucephala clangula*), long-tailed duck (*Clangula hyemalis*), red-breasted merganser (*Mergus serrator*) as well as the Iceland gull (*Larus glaucooides*) and glaucous gull (*L. hyperboreus*) in addition to the herring gull and great black-backed gull. A freshwater marsh located directly on the seashore is another special feature of this area. This marsh is an important migratory stopover for several species of birds as well as a nesting area for many others. Bats also frequent the marsh area, including the hoary bat (*Lasiurus cinereus*), big brown bat (*Eptesicus fuscus*) and some species of the *Myotis* genus (Sigouin 2017a). These species are protected under the *Species at Risk Act* (SARA). In terms of the marine ecosystem, the area is frequented by amphipods, crustaceans (American lobster [*Homarus americanus*], Atlantic rock crab [*Cancer irroratus*]), mollusks (blue mussel [*Mytilus edulis*], deep sea scallop [*Placopecten magellanicus*]) and pelagic fish such as Atlantic herring (*Clupea harengus*), Atlantic mackerel (*Scomber scombrus*) and capelin (*Mallotus villosus*) (Comeau et al. 2006). Brook trout (*Salvelinus fontinalis*) are also present in the Cap-des-Rosiers stream, (Brodeur et Sigouin 2018) and striped bass, a coastal fish species of concern, (COSEPAC 2004) has also recently appeared in the park's waters.

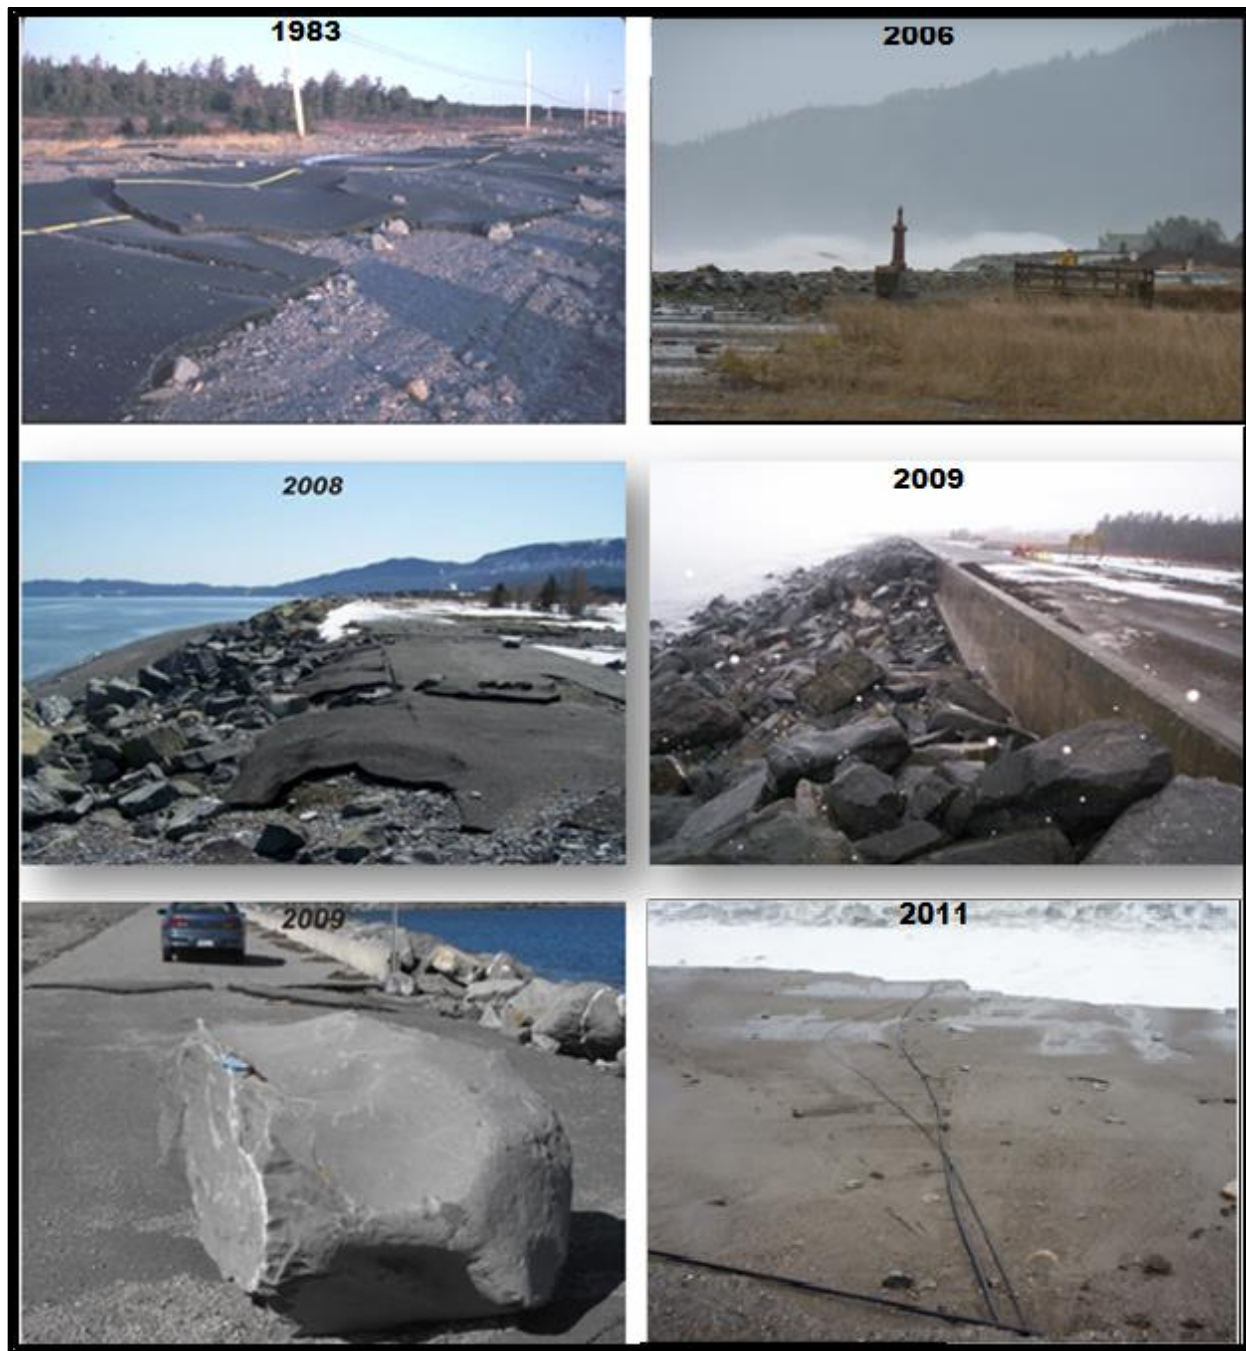
Figure 2. Typical damage observed over the years on Route du Banc and related infrastructure – Source: Parks Canada.

Damage to the road and associated infrastructure (buried power cables, protective structures, Irish Memorial) had been particularly severe since the mid-1990s, and the protective structures were no longer adequate. In 2011, a portion of the road had to be abandoned and relocated because a significant breach in the riprap had appeared and a 15,000-V electrical cable had been damaged. Figure 2 shows the damage over time.

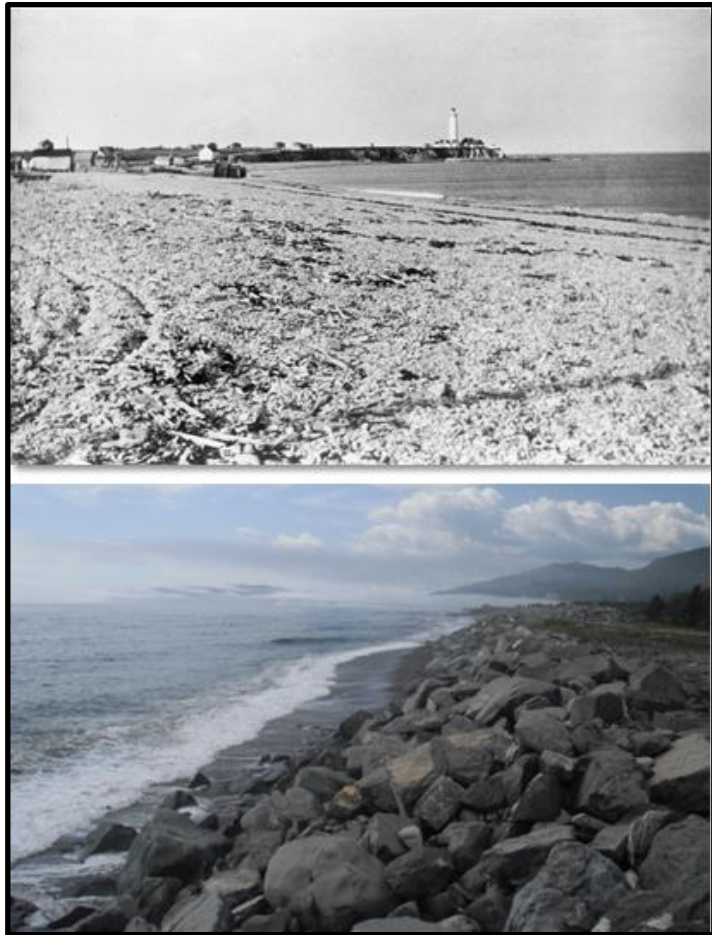
Figure 3. Modification of the profile of the Cap-des-Rosiers beach showing the difference between the width of the beach in the 1920s (top – Source: unknown) compared to what was observed in the 2000s (bottom – Source: Parks Canada).

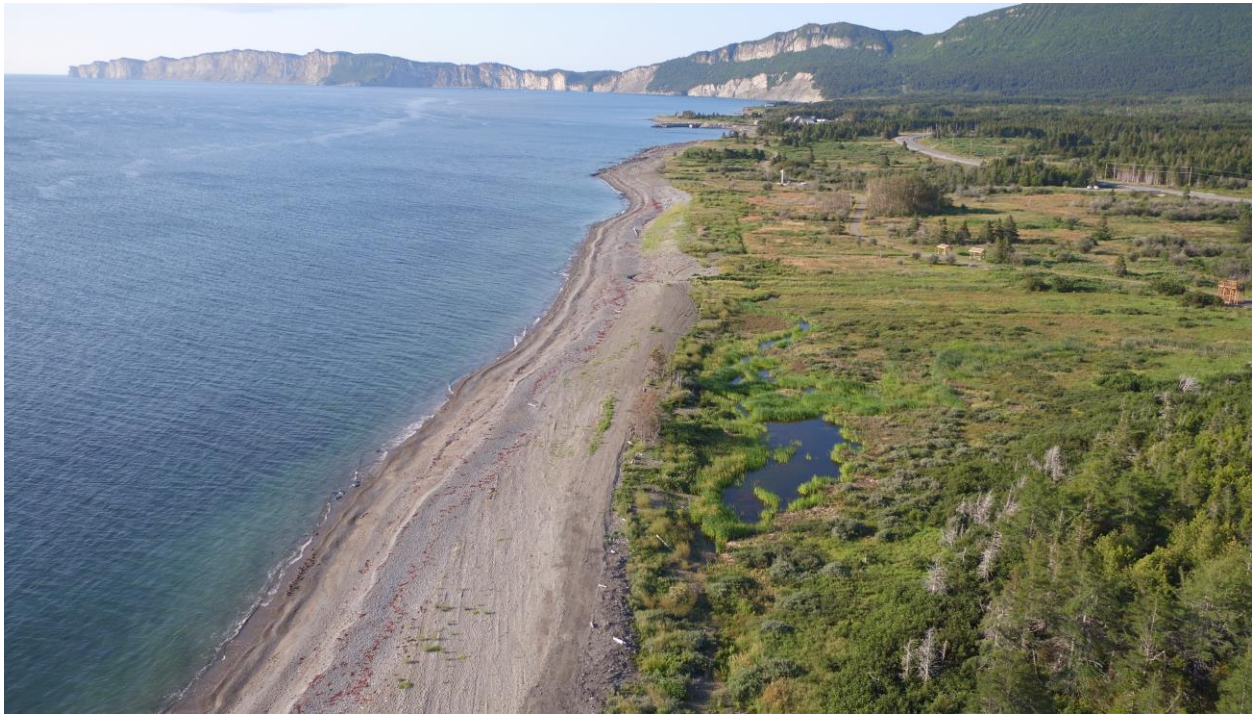
Figure 4. Aerial view of the restored beach without the infrastructures interacting with coastal dynamics. Upper beach vegetation can also be observed that contributes to the stability of the coastal system (Jean-David Dupuis, Parks Canada, 2018).

Detailed results for this component are presented in Sigouin et Dupuis (2021b) and can be seen in Figure 4. In summary, Route Du Banc, located directly in the active coastal zone, has been completely removed. As for the associated riprap, the protection structures had to be maintained or even slightly extended at the ends to maintain active protection for Highway 132 and the Cap-des-Rosiers harbour. A total of 400 metres of riprap had to be kept in place. Despite this, an 80% reduction was observed in the number of metres of coastline directly interacting with human infrastructure. This reduction corresponds with the removal of 1,600 linear metres of infrastructure, which exceeds the initial 1,200-metre target.

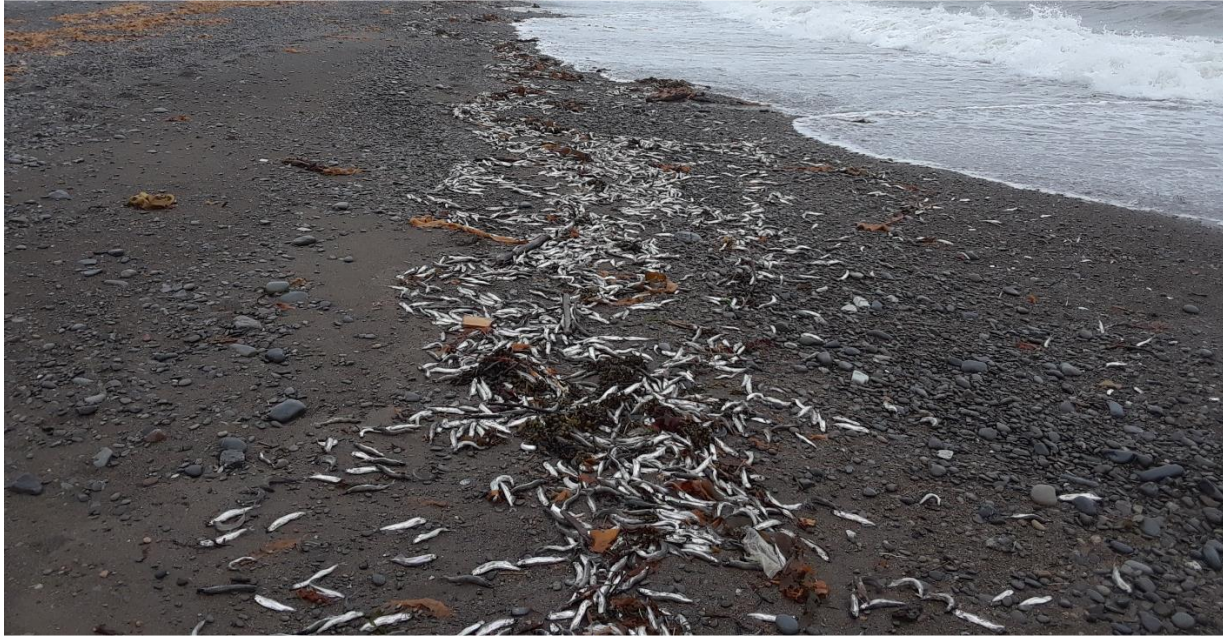
Figure 5. Presence of capelin on the beach following a spawning event (Pierre Paradis, Parks Canada, 2019)

Restoring and increasing the habitat available for capelin spawning is one of the objectives of the beach restoration project. As presented by Sigouin et Dupuis (2021c), capelin is an ecologically important species in the Gulf of St. Lawrence ecosystem. Three different methodological approaches were used to assess the breeding habitat area available to capelin. Regardless of the methodology used to estimate the habitat gain for capelin reproduction, the objective was largely exceeded (11,765 m²). The estimates obtained made it possible to determine that the available habitat area was between 17,809 m² and 50,202 m² in the intervention area. We determined that the second approach, using the elevation of egg sites, was most representative of reality and allowed us to estimate that the available habitat is probably around 23,000 m². Figure 5 provides an overview of the presence of capelin on the beach following a spawning event.

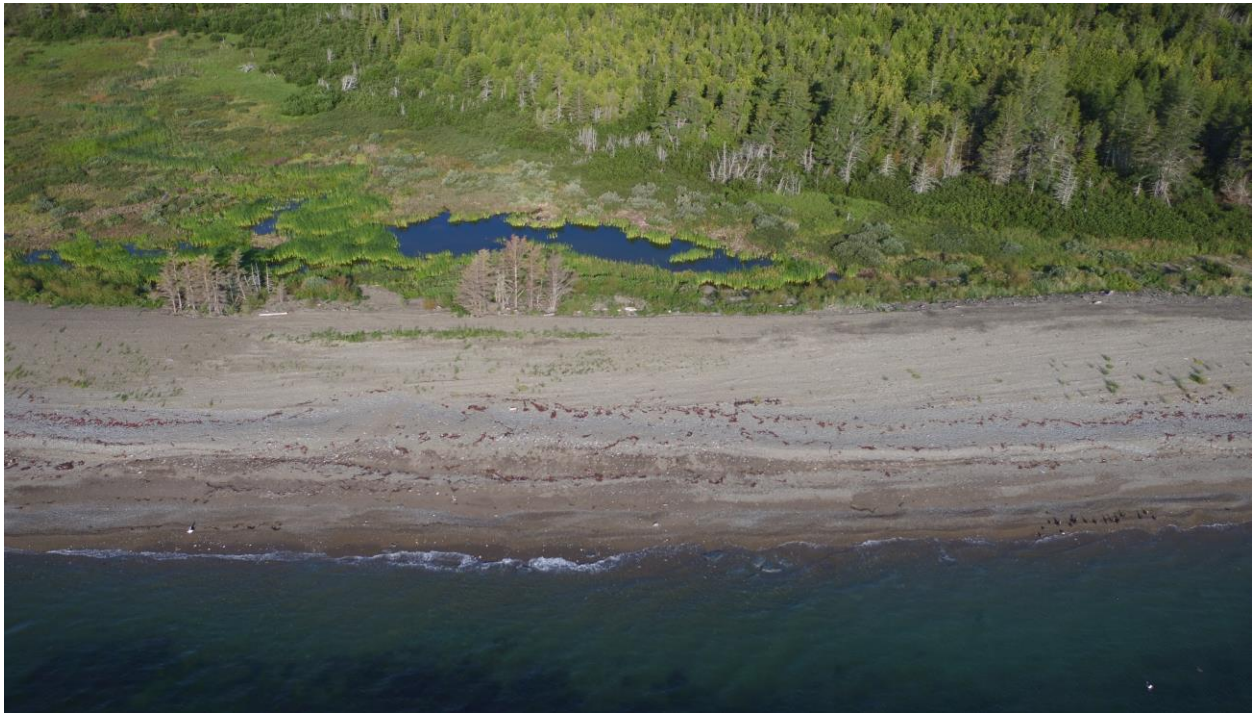
Figure 6. The Cap-des-Rosiers marsh as seen after the restoration work was completed (Jean-David Dupuis, Parks Canada, 2018).

According to property maps dating back to the mid-19th century, the Cap-des-Rosiers marsh (Figure 6) was already present in the area well before the construction of Route Du Banc (in 1926) and the associated protective structures (Carter et Ouellet 1977, Ouzilleau 1977, Synnott et Chouinard 1986).

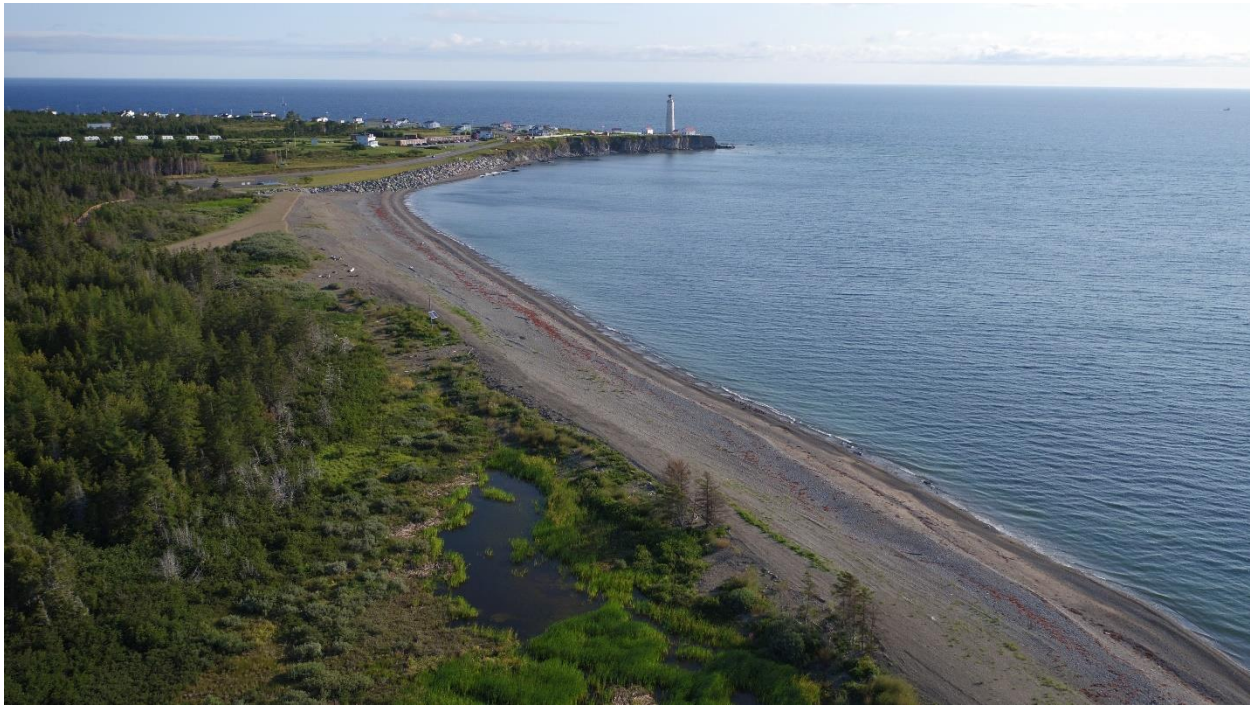
Figure 7. Overview of the physical characteristics observed on the intervention area (beach) after the restoration work was completed (Jean-David Dupuis, Parks Canada, 2018)

Indeed, following the interventions, the maximum elevation and the beach width and slope were more consistent with what was observed in the control area (Figure 7). The beach area has almost tripled due to the restoration of the area, which is more in line with a natural beach area. The monitoring of the erosion markers revealed that the system had not yet regained the same stability in the intervention area as in the control area, which is not unexpected considering the short time that has elapsed since the interventions were completed. This is nonetheless significant and emphasizes the importance of continuing long-term monitoring to follow the evolution of this restored ecosystem and to adequately evaluate the effectiveness of our current and future interventions.

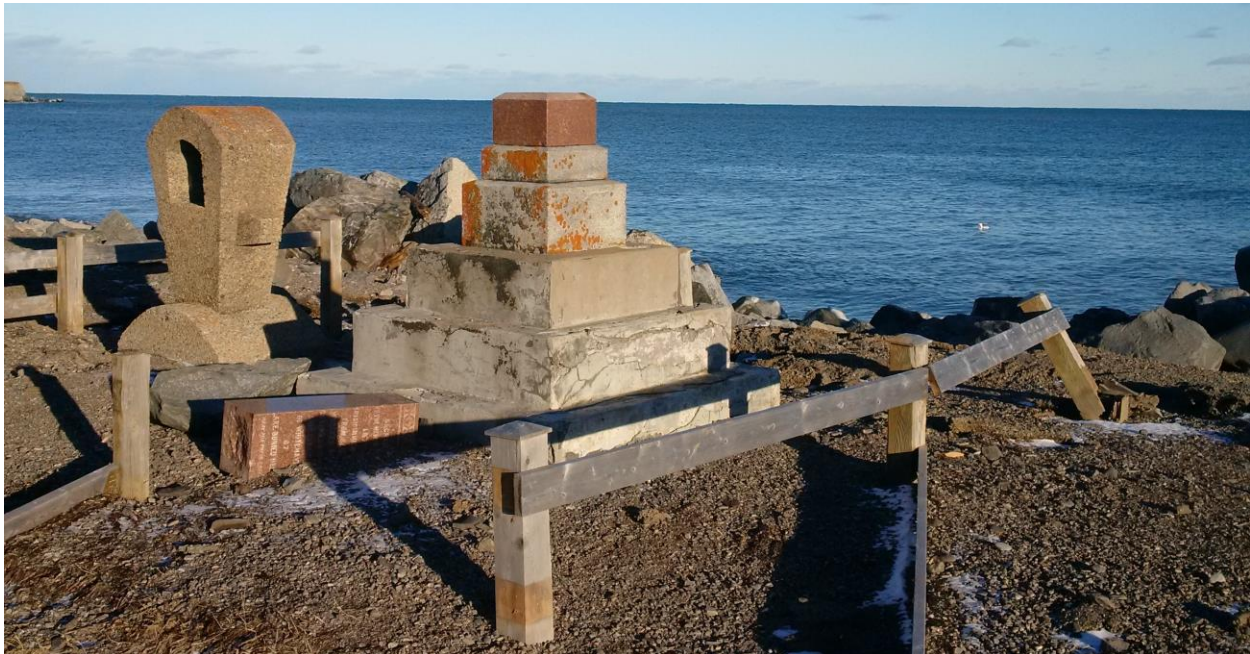
Figure 8. Example of the impacts observed prior to work on the Irish Memorial (Parks Canada, 2016).

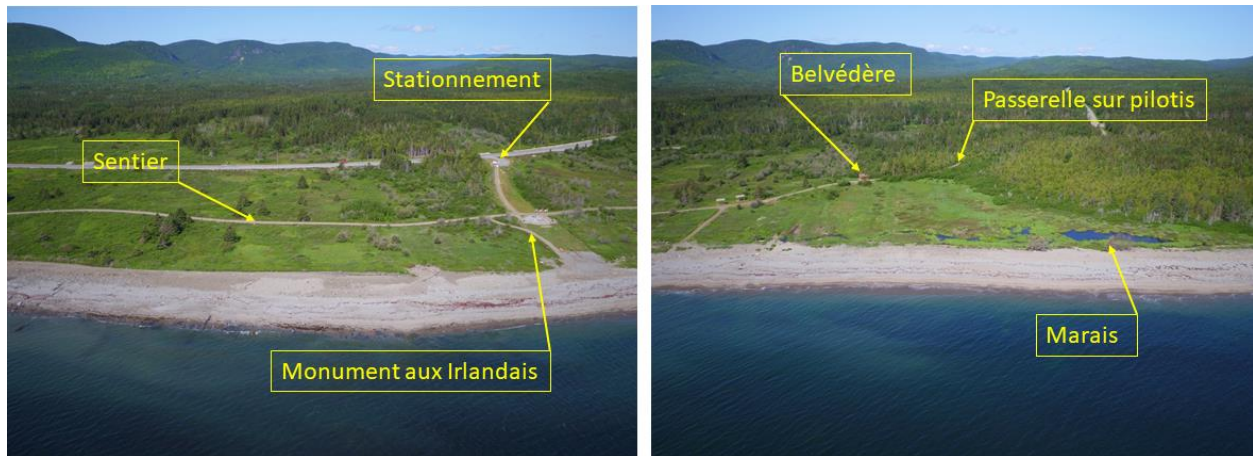
Figure 10. Aerial view of the new Du Banc trail with the Irish Memorial, one of the trail's parking lots, its lookout, its interpretive panels and the raised walkway in the wet woodland portion (Jean-David Dupuis, Parks Canada, 2019).

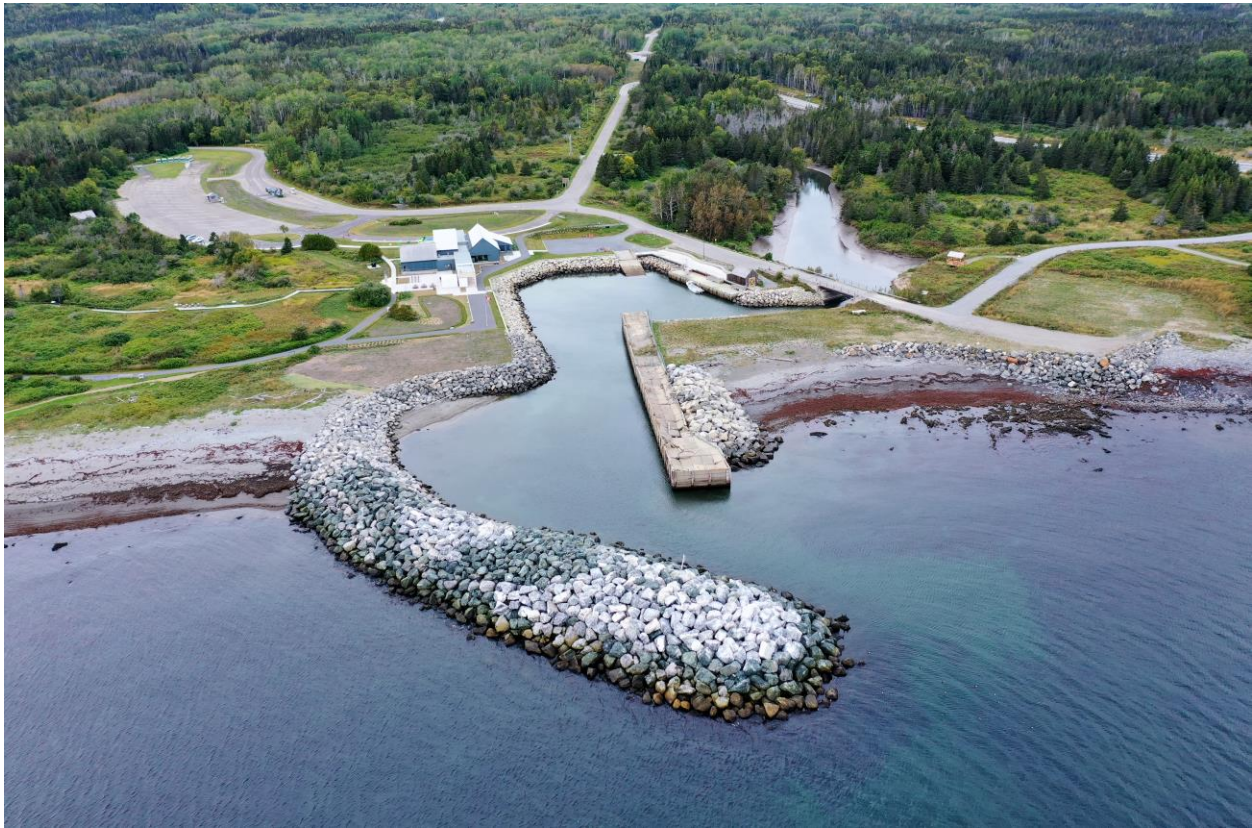
Figure 11. The Cap-des-Rosiers harbour with its restored south pier and the new Visitor Information and Discovery Centre (Jean-David Dupuis, Parks Canada).
