**KOOTENAY NATIONAL PARK
WILDERNESS RECREATION PROGRAM
1986 REVIEW**

**Prepared by: George Sranko
Wilderness Recreation Specialist
Visitor Services
Kootenay National Park**

October, 1986

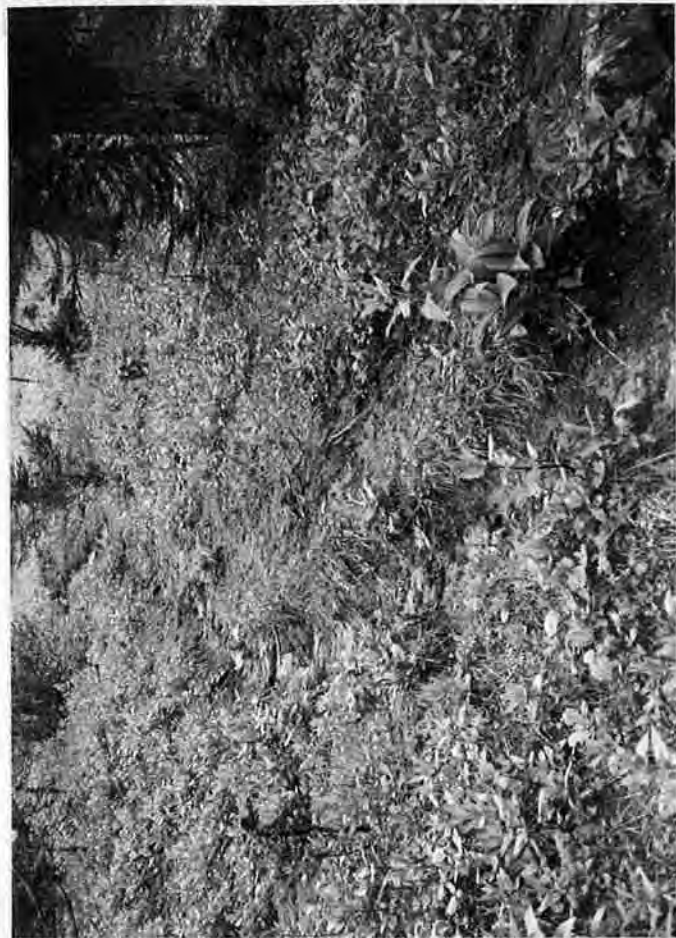
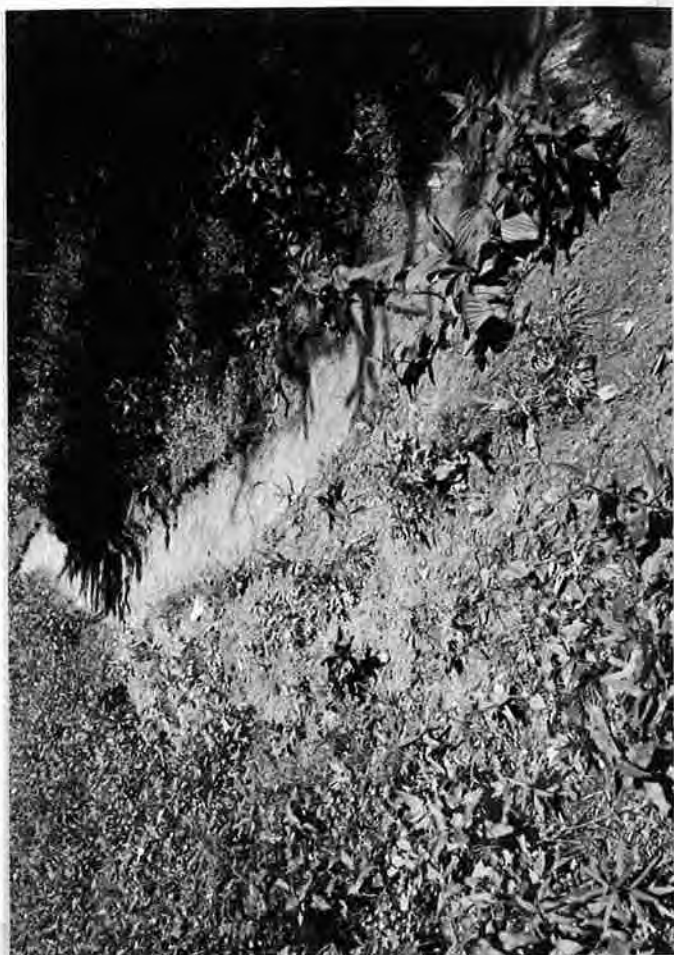
Subject: Rockwall Pass Project-Limestone Section 47
Date: August 10/86
Photographer: T. Van Egmond
Location: Rockwall Trail, kilometre 9.20
Remarks: **BEFORE.** Lower end of wet meadow, notice the muddy multiple trails on the 10-15% slope. This area remains muddy and wet throughout the hiking season. The trail was rerouted around this problem section. See accompanying photo below.

Subject: Rockwall Pass Project-Limestone Section 48
Date: August 28/86
Photographer: T. Van Egmond
Location: Rockwall Trail, kilometre 9.20
Remarks: **AFTER.** This photo was taken after the work on this section was completed, the trail braids and main trail have been revegetated and masked to stop further use. The reroute (from the Helmet side) begins here, the freshly prepared tread surface leads off to the right and continues on a gentle grade with one switchback to join up with the trail over a kilometre away.

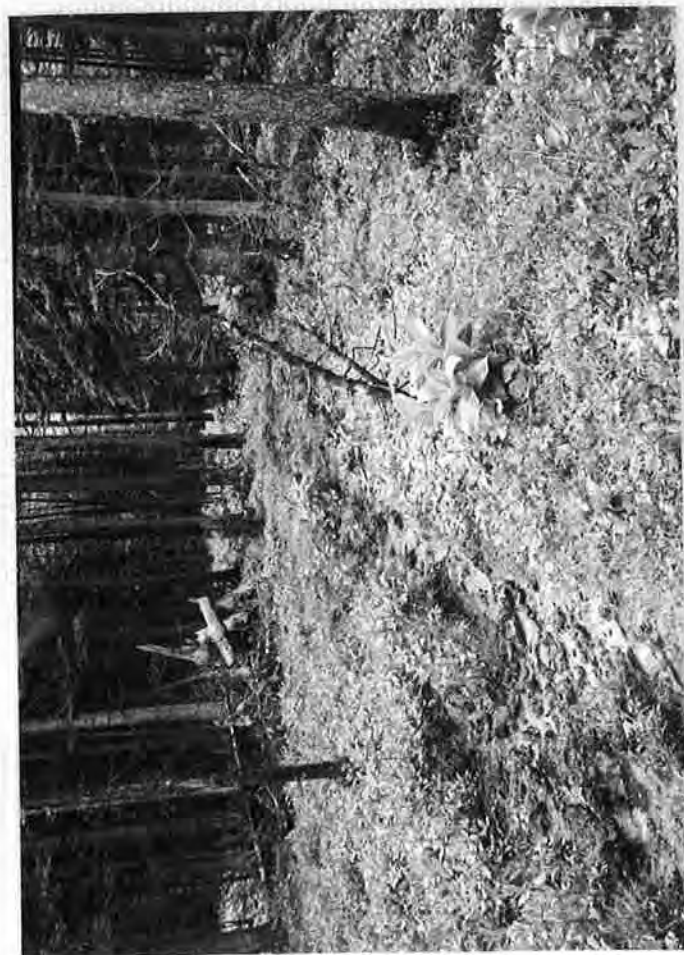
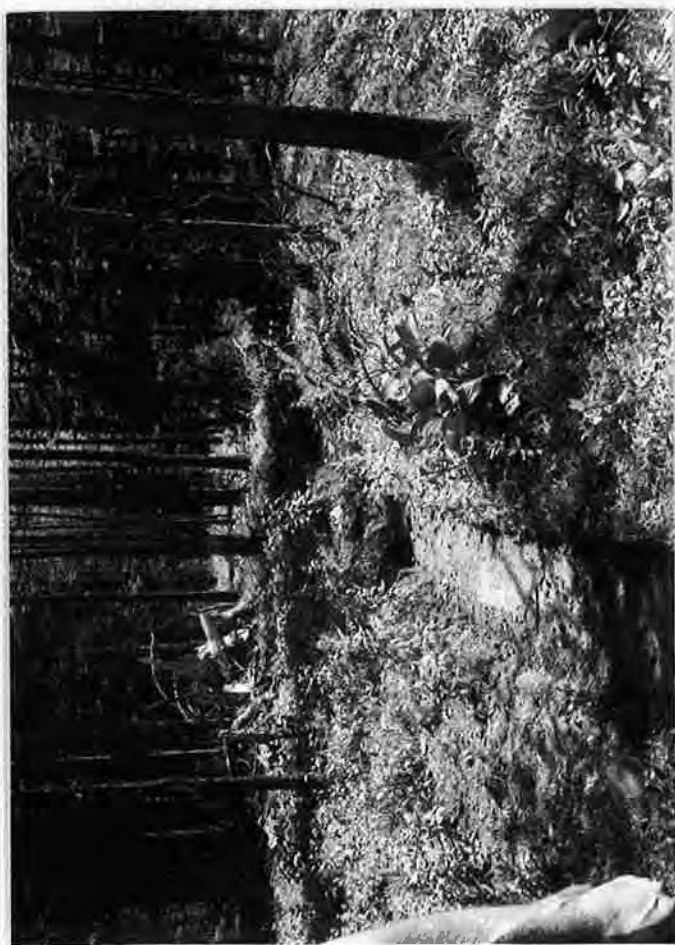
Subject: Rockwall Pass Project-Limestone Section 38
Date: July 28/86
Photographer: T. Van Egmond
Location: Rockwall Trail, kilometre 7.62
Remarks: **BEFORE.** Taken from Photostation #2 before contract work began. The trail leaves a larch meadow and enters a subalpine forest canopy. This is an extremely muddy trail section and is frequently a runoff path in early season. See accompanying photo below.

Subject: Rockwall Pass Project-Limestone Section 41
Date: August 20/86
Photographer: T. Van Egmond
Remarks: **AFTER.** This photo was taken from Photostation #2 after completion of this section of trail. The trail was drained above to run the water off to the right where a slope drained to the creek. The new gravel tread surface was established and the impacted trail-side was revegetated.

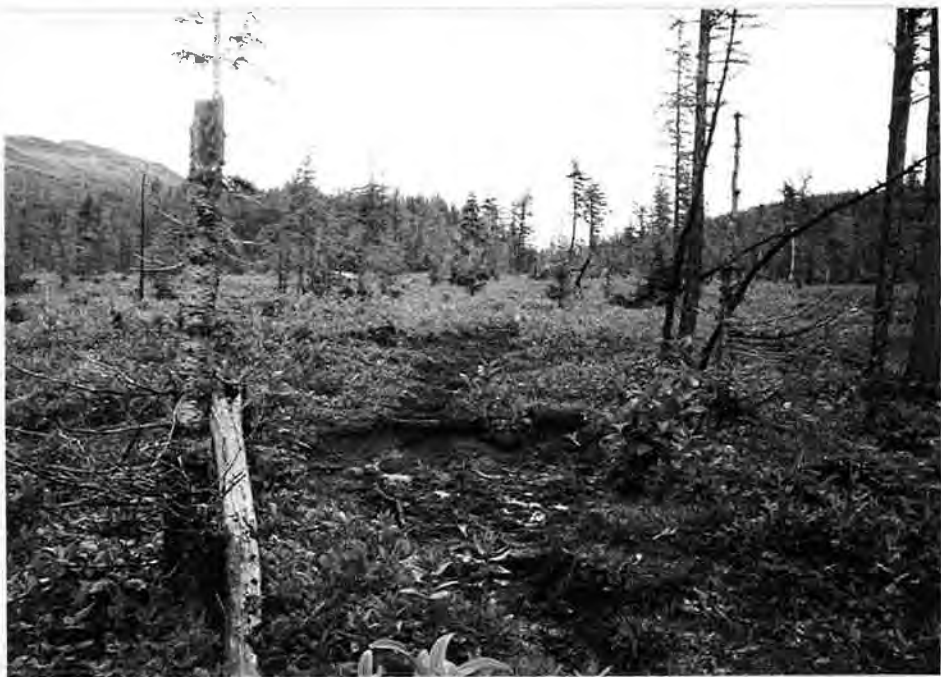
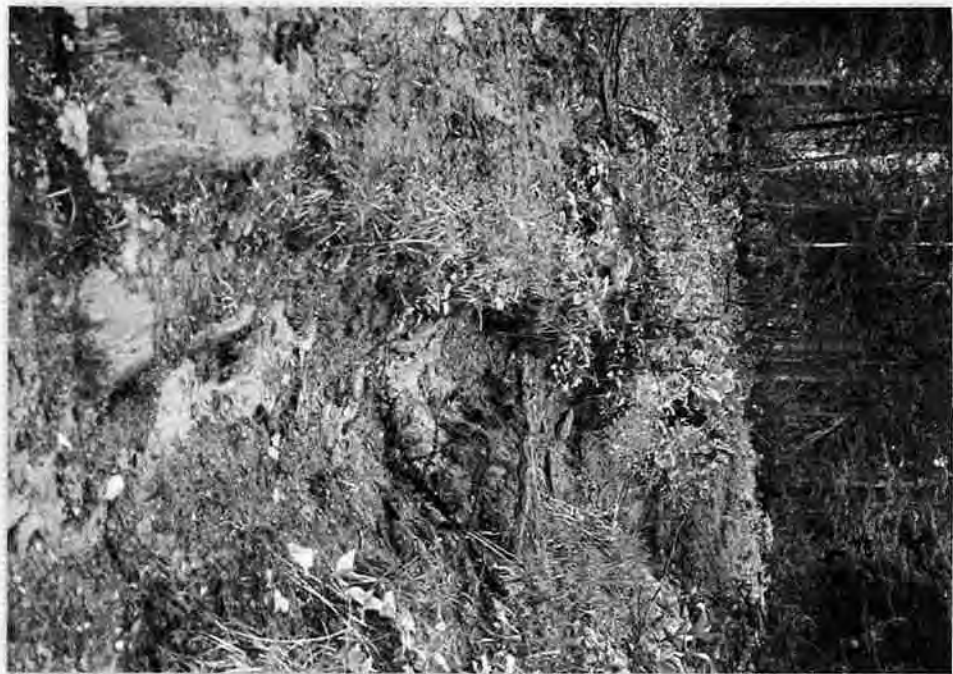
Subject: Rockwall Pass Project-Wolverine Section 30
Date: August 5/86
Photographer: T. Van Egmond
Location: Rockwall Trail, kilometre 3.70
Remarks: **BEFORE.** Taken from Photostation #1 before work began. This hummocky meadow is where the new reroute will cross to the base of the scree slope. Note pegs in the photo. See accompanying photo below.

Subject: Rockwall Pass Project-Wolverine Section 33
Date: August 27/86
Photographer: T. Van Egmond
Location: Rockwall Trail, kilometre 3.70
Remarks: **AFTER.** Taken from Photostation #1 after completion of contract work. As this is a moist meadow the trail is finished with gravel. Note the revegetated in the left foreground of the photo.

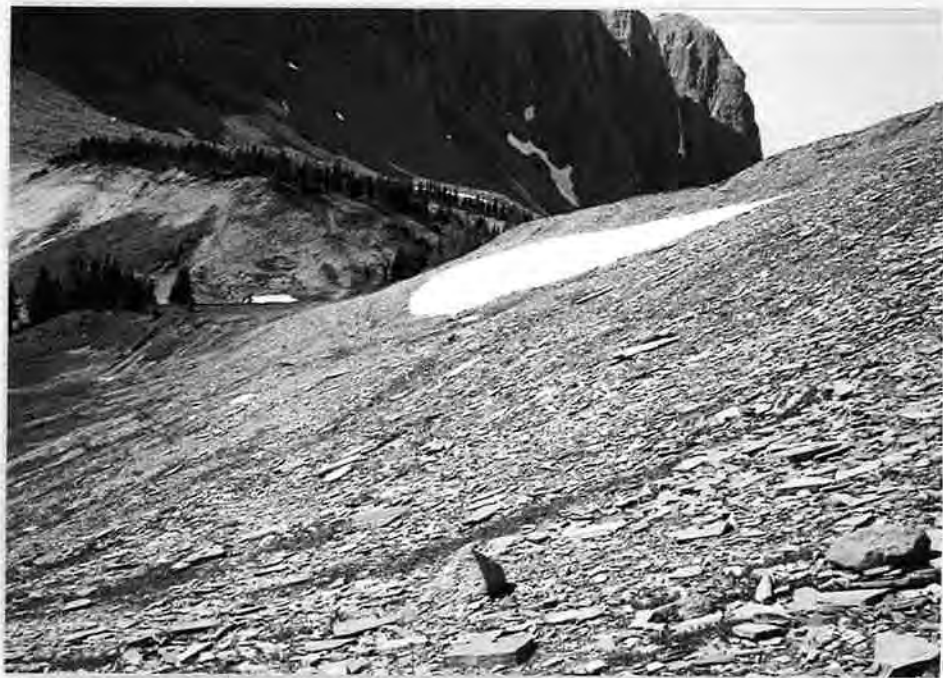
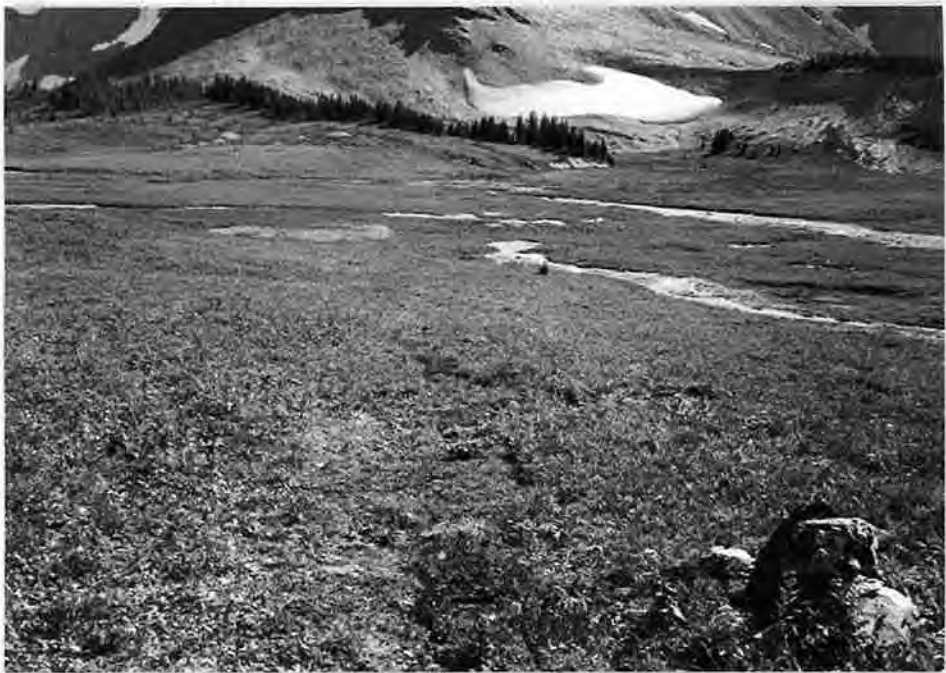
Subject: Rockwall Pass Project-Wolverine Section 31
Date: August/86
Photographer: K. Baines
Location: Proposed trail route in Wolverine section, approximately kilometre 3.50, Wolverine Pass in background of photo.
Remarks: **BEFORE.** This is the base of the scree slope which the trail will cross in the reroute around the meadow. As there is a complete lack of vegetation this will be a minimal impact trail. See accompanying photo below.

Subject: Rockwall Pass Project-Wolverine Section 32
Date: August/86
Photographer: K. Baines
Location: **AFTER.** New trail across scree slope pictured above, approximate location is 3.40 kilometres.
Remarks: Completed trail, note the use of ditching and drainage to allow the continually melting snowpack to drain while keeping the trail dry.

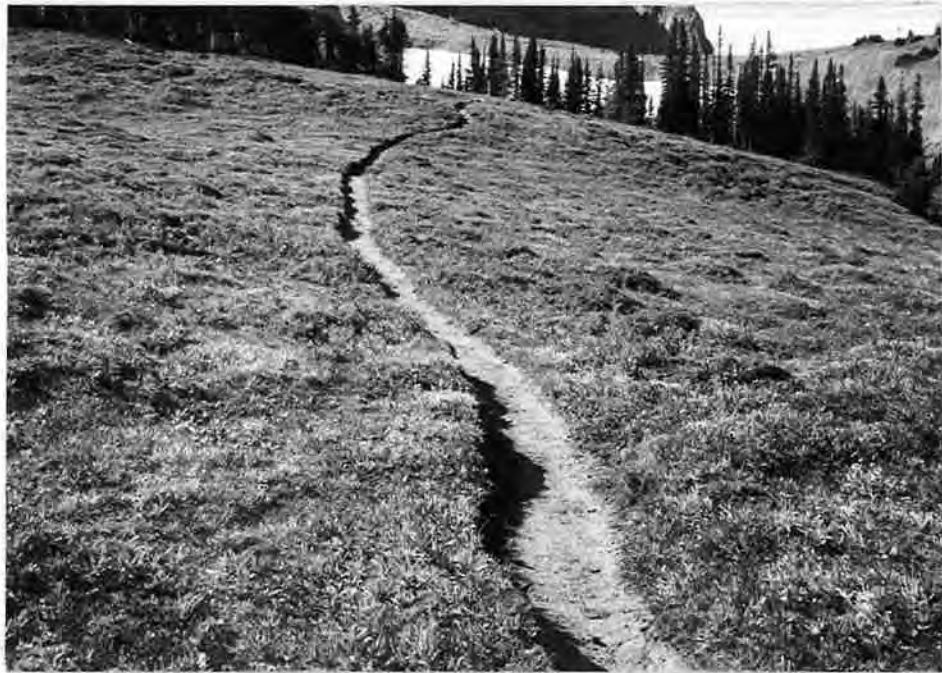
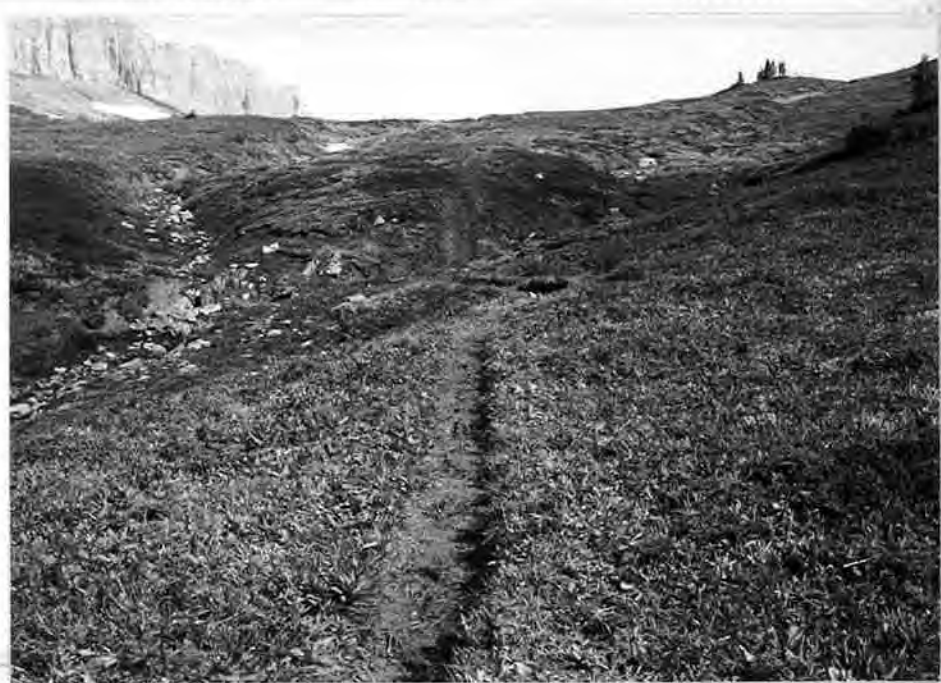
Subject: Rockwall Pass Project-Wolverine Section 22
Date: August 5/86
Photographer: T. Van Egmond
Location: BEFORE. Rockwall Trail, kilometre 3.20
Remarks: Photo taken at photostation #4. Trail leaves meadow and winds up a 10-15% grade to an alpine fir patch. This section of trail is roughly 100 metres in length and is severely compacted. The meadow to the upper, left side of the trail is often 10-20 centimetres above the tread surface. See accompanying photo below.

Subject: Rockwall Pass Project-Wolverine Section 25
Date: August 19/86
Photographer: T. Van Egmond
Location: Rockwall Trail, kilometre 3.20
Remarks: AFTER. Photo taken from Photostation #4 after revegetation was finished on this section of trail. An excellent example of revegetation work. Take note of the sod transplants which match closely to the contour of the original slope, each transplant is wedged tightly into the original prepared trail surface. Complete sodding of trails such as these effectively eliminates erosion and usage by people who are curious as to where the original trail went. Already invisible from a short distance away this trail will be hidden to trained eye in the next growing season.

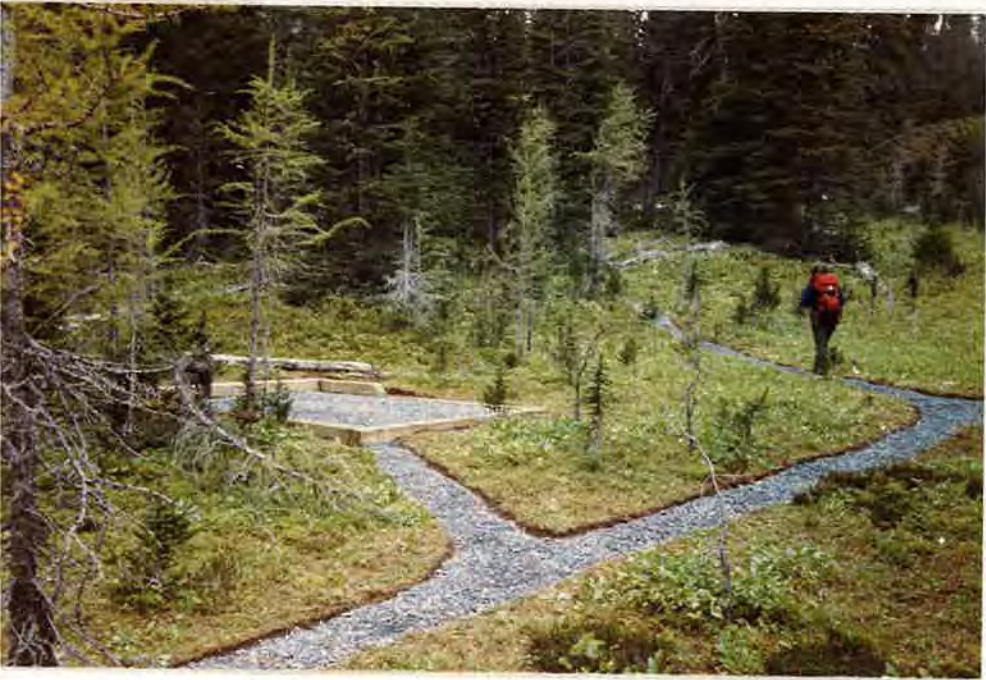
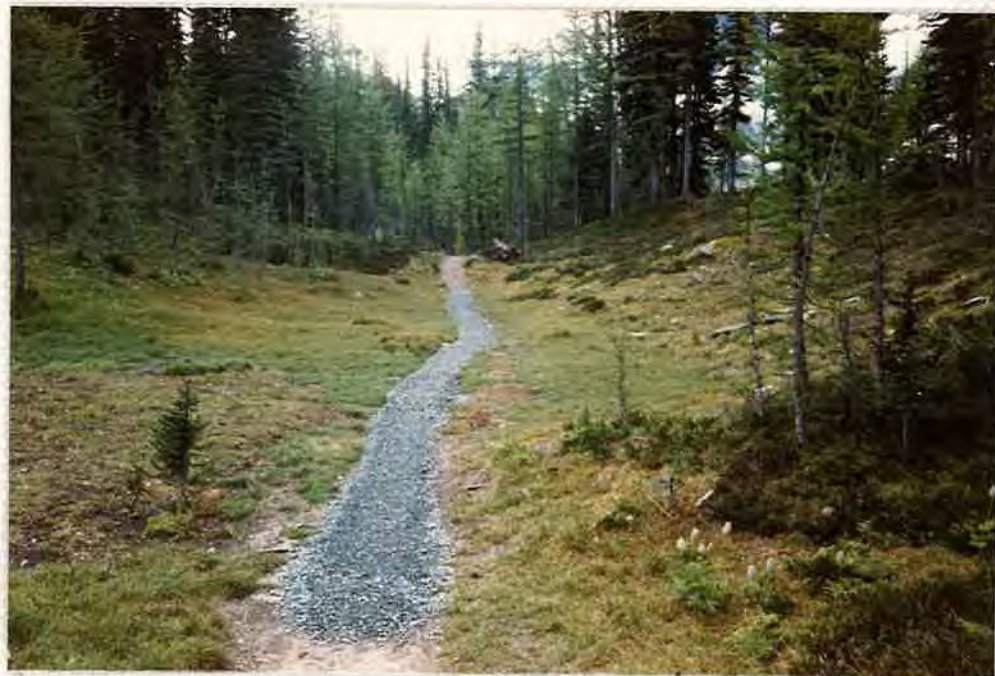
Subject: Floe Lake Project 23
Date: Sept 5/86
Photographer: K. Baines
Location: Main trail through campsite, revegetated area at left is old campsite 12d.
Remarks: Sections of trail which cannot be properly drained are gravelled. This is one such section of trail, located in a "valley" water from the slopes on each side has no where to go, often resulting in a muddy trail. Gravelled trails provide a firm base for walking and keep travellers off the vegetation.

Subject: Floe Lake Project 24
Date: Sept. 5/86
Photographer: K. Baines
Location: Campsite 12c
Remarks: Tables of eating area are arranged in a pleasing manner following the contour of the natural landscape. Structures like this should be located where they fit in to the natural landscape, orderly symmetrical patterns should be avoided as they look out of place in nature.

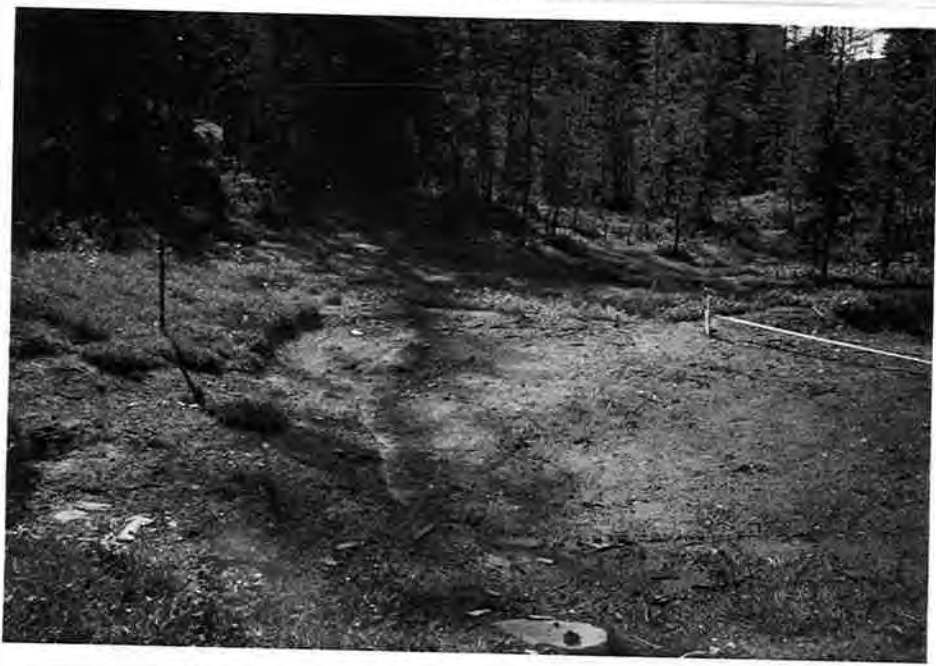
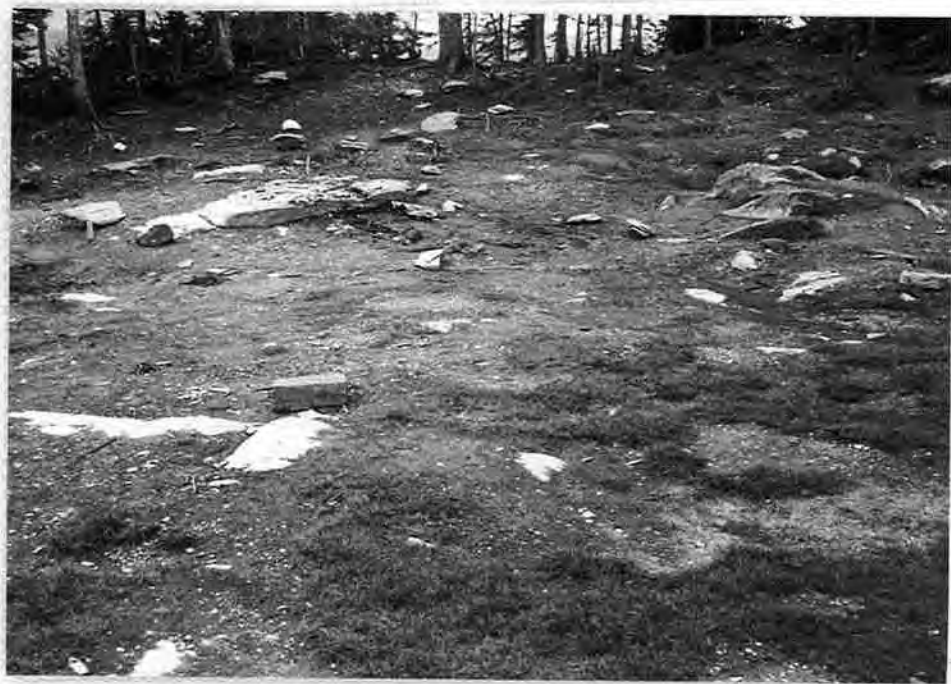
Subject: Floe Lake Project 9
Date: July 29/86
Photographer: T. Van Egmond
Location: Campsite 12c
Remarks: **BEFORE.** Taken from photostation #3 prior to construction work. A portion of campsite is shown, it is undeveloped with large compacted areas. Bare soil is evident in a large segment of the photo. Another compacted area appears in the left background and three communal trails in the right backdrop of the picture. Soil compaction is evidenced by the sharp line of vegetation in the left of the photograph. See accompanying photo below.

Subject: Floe Lake Project 10
Date: Sept 13/86
Photographer: T. Van Egmond
Location: Campsite 12c
Remarks: **AFTER.** Photo taken at photostation #3 one week after all work was completed. This area was upgrade into an eating area. The original contour was restored and the disturbed matrix was revegetated with native plant ecotypes, the transplanted vegetation in the foreground is primarily composed of Carex sedges. Note in the background the upgrading of one of the access trails, the other two communal/access trails were revegetated and masked.

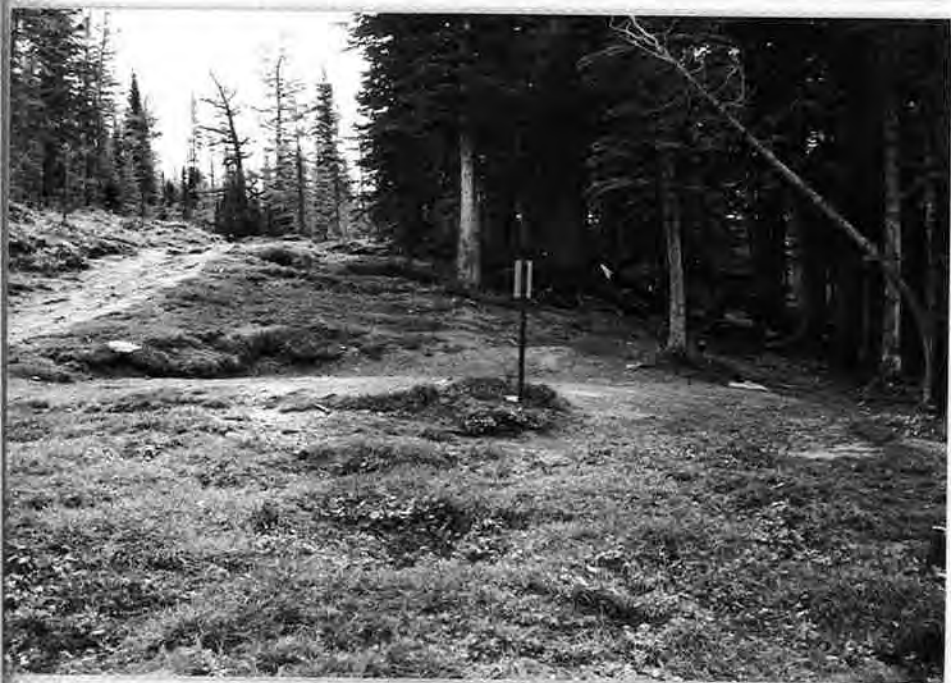
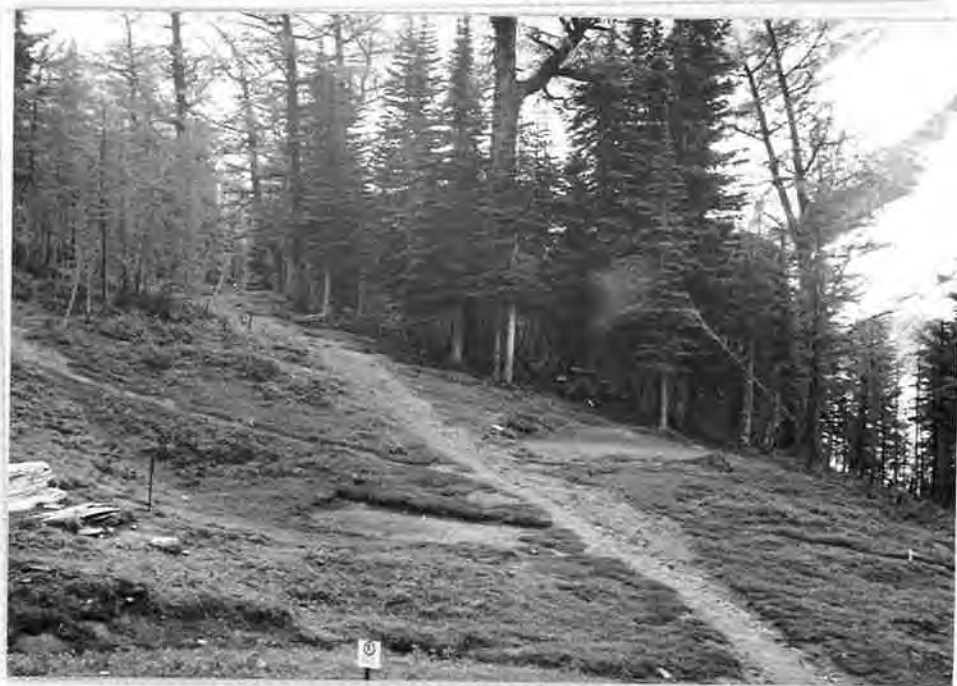
Subject: Floe Lake Project 7
Date: July 29/86
Photographer: T. Van Egmond
Location: Campsite 12a and 12b
Remarks: **BEFORE.** Photo taken at Photostation #1 prior to start of work. Note the deeply cut tentpads on each site and the damaged vegetation surrounding the barren core. The main trail, which is very wide due to peripheral trampling, cuts through each campsite very close to the barren tentsites. This is an open scenic meadow and therefore both campsites were closed for rehabilitation. See accompanying photo below.

Subject: Floe Lake Project 8
Date: Sept 13/86
Photographer: T. Van Egmond
Location: Campsite 12a and 12b
Remarks: **AFTER.** Taken from photostation #1. These campsites were located in a scenic meadow offering views to the lakeshore, they were moderately to heavily impacted and were very close to the main trail. Both campsites were rehabilitated. The contour was restored, the main trail slimmed down and both sites planted with natural vegetation. The "tent sites" sign at the trail junction is a temporary measure which will be removed when permanent signs are installed at the campsite.

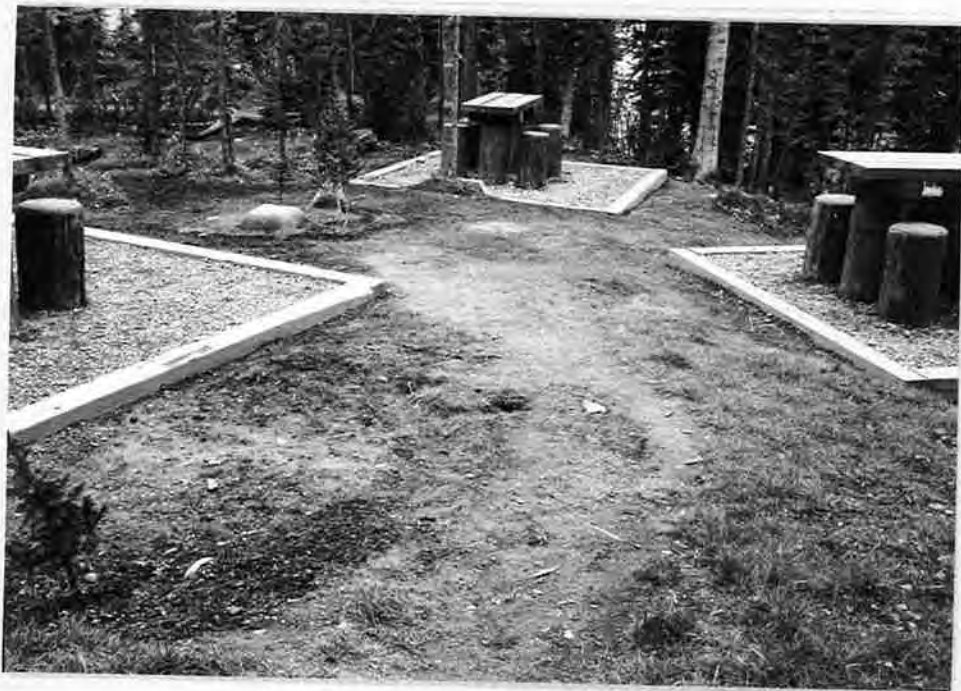
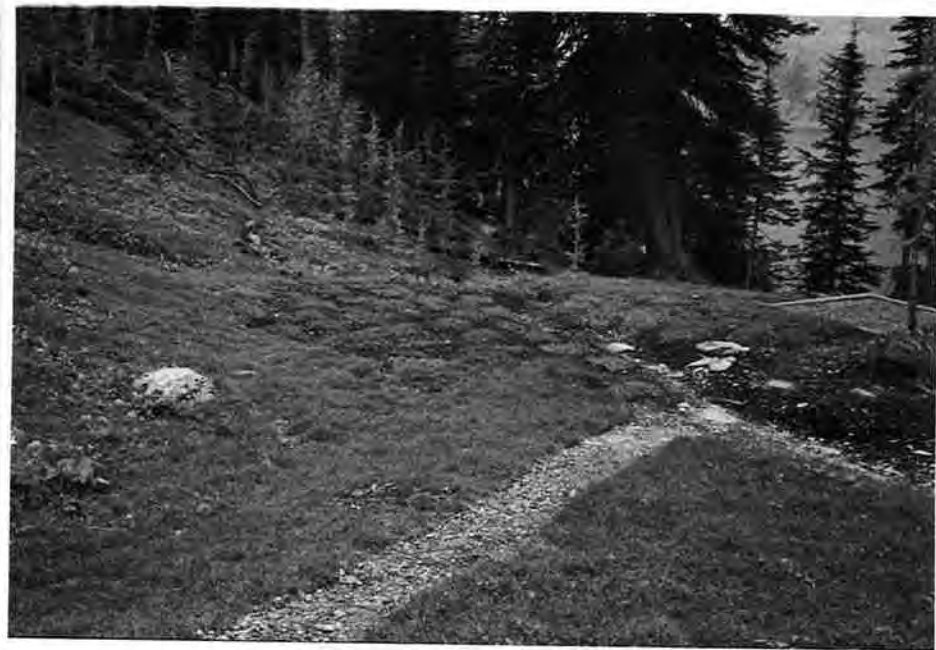
Subject: Floe Lake Project 1
Date: July 29/86
Photographer: T. Van Egmond
Location: Campsite 12g
Remarks: **BEFORE.** Photo taken at photostation #8 before contract work began. An undeveloped campsite with room for up to 4 tents. There are three trails leading to this campsite (only one is visible). There is a barren core in the tentsite area which has a runoff washout eroding through the center of it. This tentsite is in plain view of the main trail. See accompanying photo below.

Subject: Floe Lake Project 2
Date: Sept 13/86
Photographer: T. Van Egmond
Location: Campsite 12g
Remarks: **AFTER.** Photo taken at photostation #8 one week after all work was completed. Campsite was upgraded to 2 tent pads (portion of one seen in right of photo). The previously disturbed barren core was revegetated with "meadow sod" and the tent pads placed away from the runoff zone and the main trail. Two access trails were upgraded and one, with two communal trails, was closed and rehabilitated
