THE EXCAVATION OF A SIXTEENTH CENTURY SPANISH BASQUE
WHALING GALLEON IN RED BAY, LABRADOR: A SUMMARY OF
THE 1981 FIELD SEASON

Marine Excavation Unit

Parks Canada, Ottawa

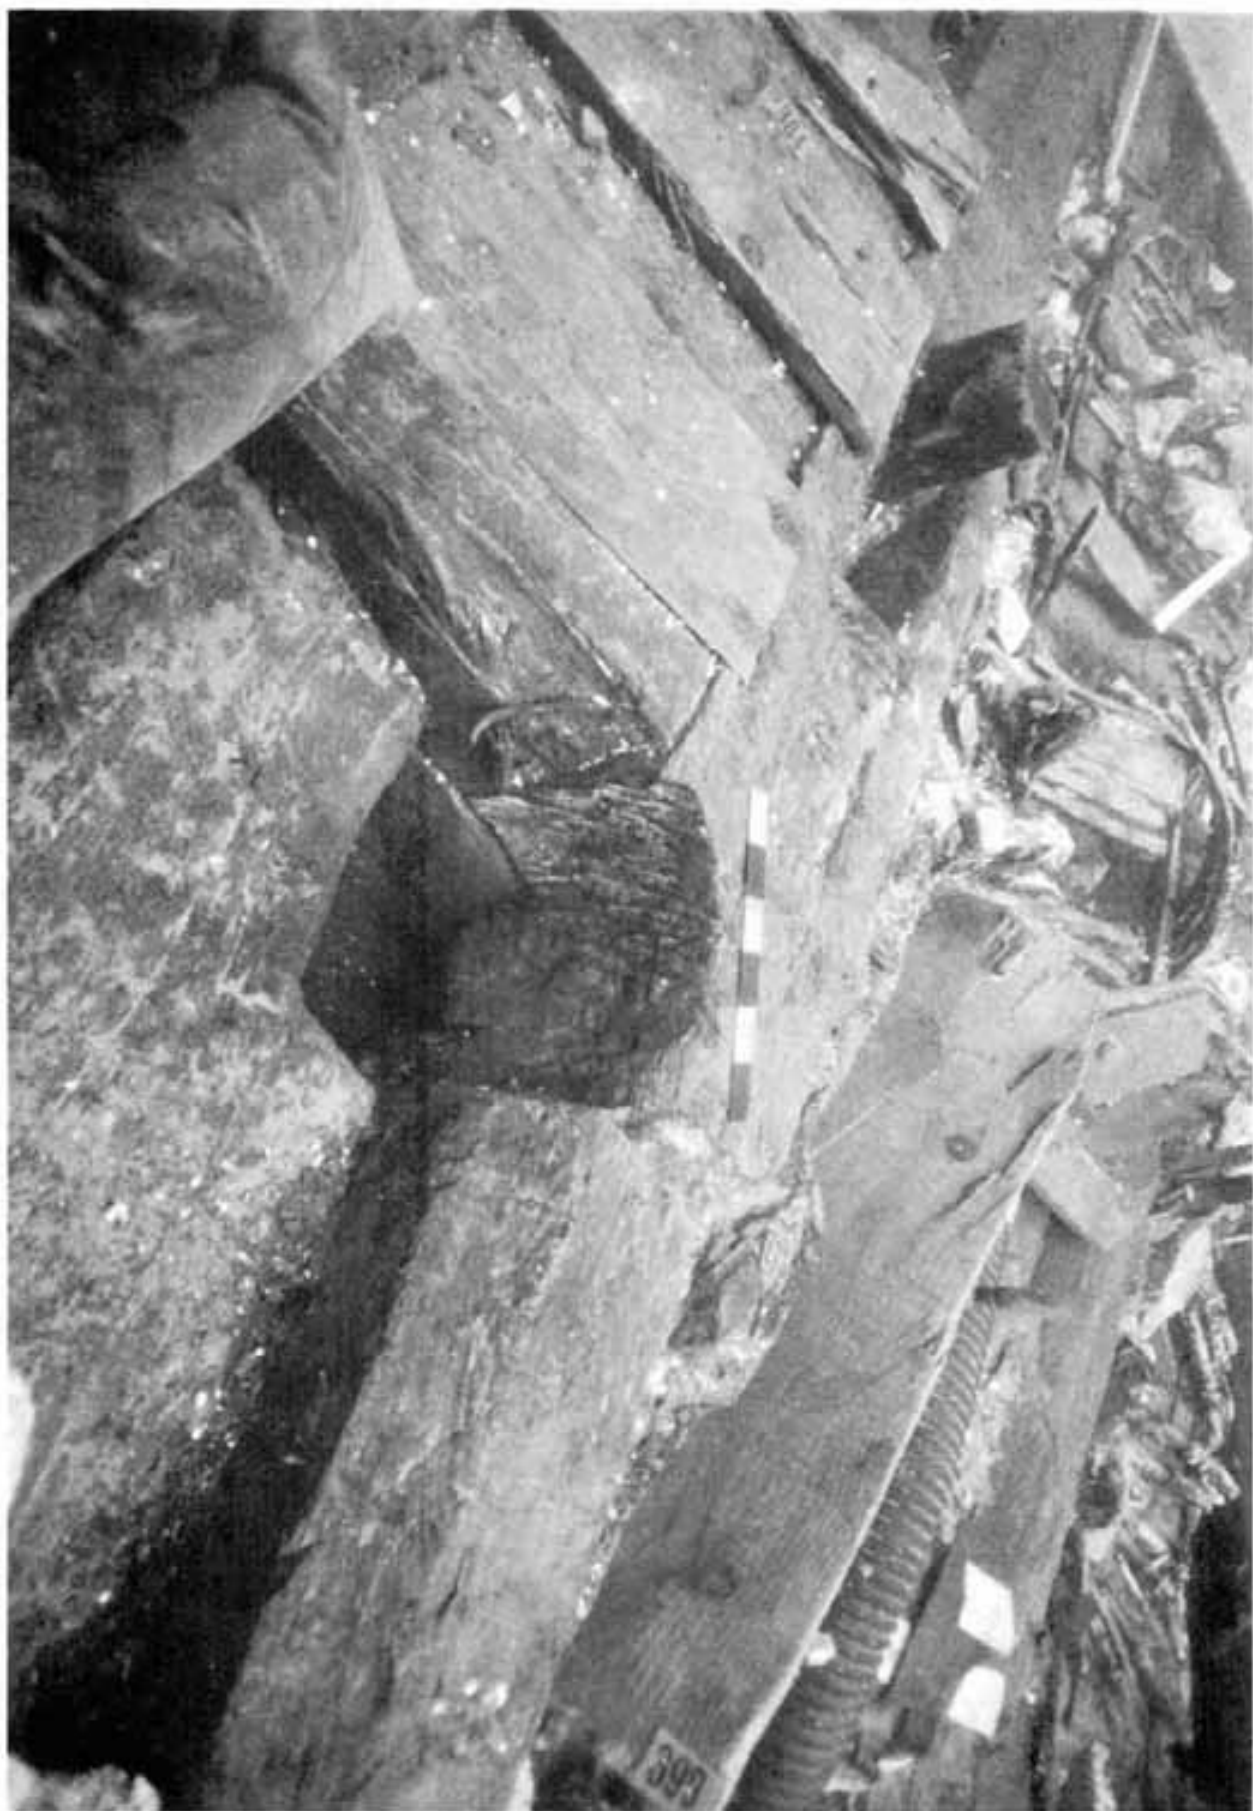
FIGURE 6

The mast step area of the vessel showing the well sump cut into the keelson. (Photo by P. Waddell, Parks Canada).

One of the major artifacts recovered in 1981 was a section of the pump tube (Figures 4 and 5). It consisted of a squared tube with an outer diameter of 26 cm and an inner bore diameter of 12 cm. The tube and its plunger were excellently preserved within the cargo of casks beneath the existing seabed. The base of the tube was located next to the pump well sump, a circular hole cut into the port side of the keelson at the mast step (Figure 6). Artifacts found within the well sump consisted of a foot valve and associated leather flapper. The well sump and tube were enclosed by a pump well or box which also extended over a portion of the mast step. The mast step was incorporated into the keelson as an expansion of the keelson. It served as the base for a rectangular recess cut into the top of the keelson which acted as a type of mortice for the heel of the mast. The recess was large enough to allow for mast adjustment fore and aft.

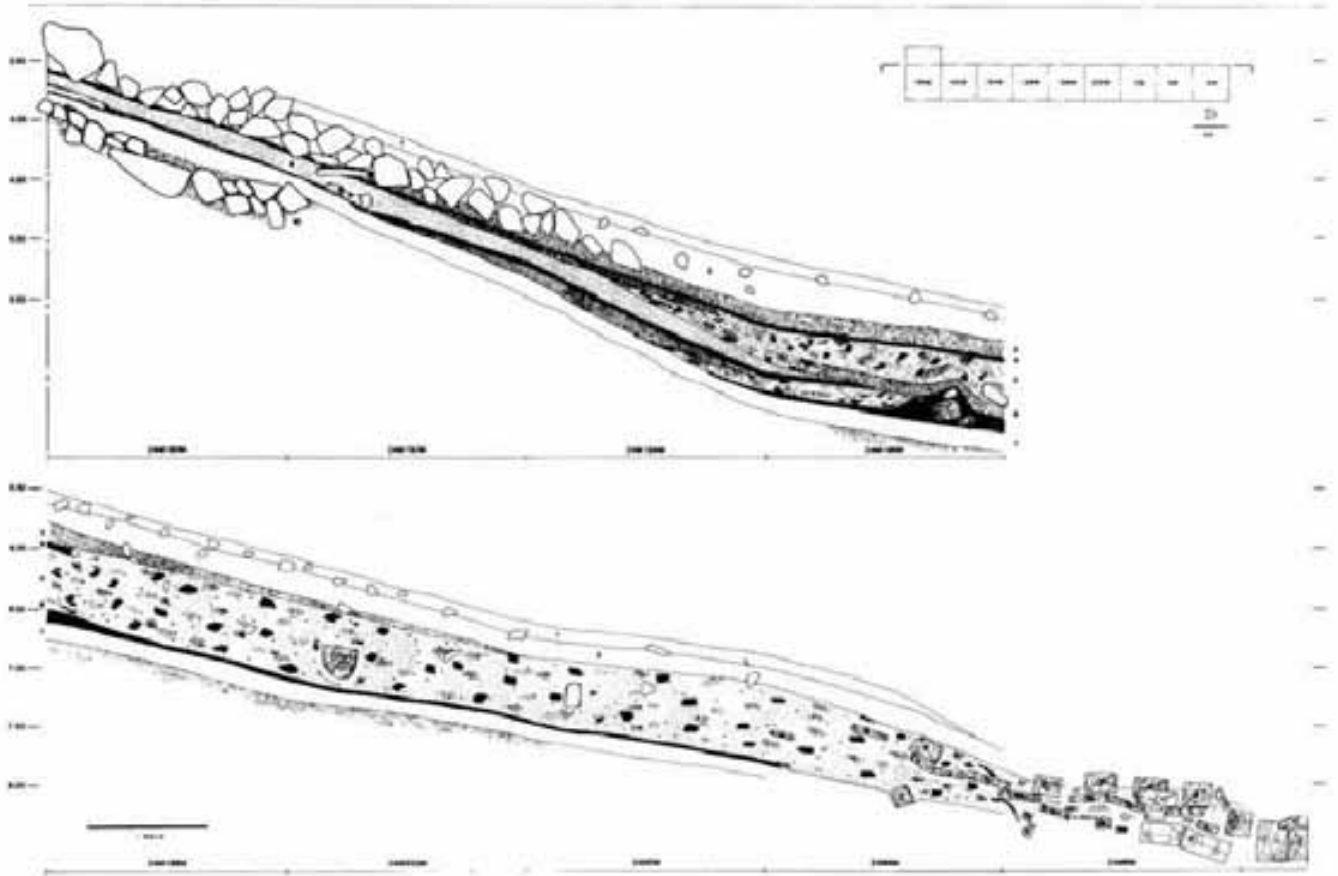
FIGURE 8

Stratigraphic profile drawing linking the wreck site with deposits from Saddle Island.
(Drawing by S. Bourque, Parks Canada.)

Stratigraphically the shore trench excavation was successful in tying together the wreck and deposits from the shore station (Figure 8). However, there appears to be no direct functional relationship between the two sites. The various stratas uncovered were formed by discard processes involving secondary refuse. The result was the formation of an excellent stratigraphic record indicative of events on Saddle Island. This record revealed several interesting periods of activity at the shore station. A large buildup of woodchips (the product of a log-squaring operation) represented an initial period of construction, followed by an extensive deposit of codfish bones indicative of a substantial cod-splitting operation contemporaneous with whaling and finally a large amount of rock collapse indicating abandonment.
