## EVOLUTION OF BUILDINGS' COLOR AT RYAN PREMISES

Buildings (current pictures)	1900s	Pre 1912	1912	1940s	1946	1970s	1991	Present
<p><b>No. 1. Retail Shop. Circa 1860-1874</b></p>

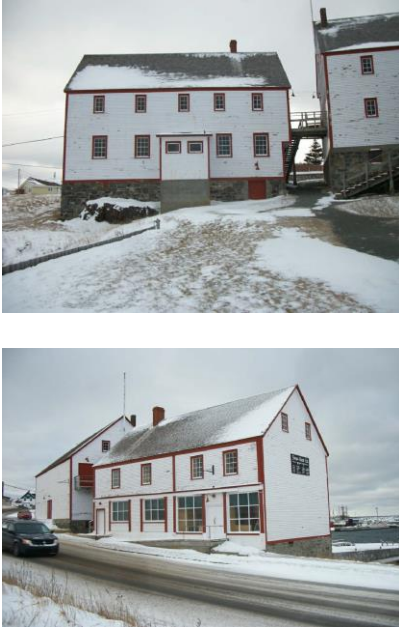
<p>White walls with dark accents at corners (with the result of paint analysis, this dark colour may have been brown-red).</p>

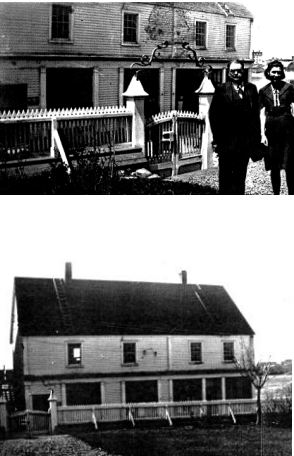
<p>White walls with dark (dark red) corner and dark window trim. Windows on first floor of main façade are also painted in a dark colour. Left door is dark with dark trim.</p>

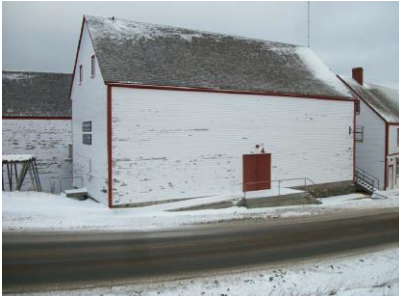
<p><b>No. 2. Retail Store. Circa 1874-1879</b></p>

<p>White (off white/beige) with dark accents (red).</p>	<p>White walls with dark (red) accents at corners.</p>

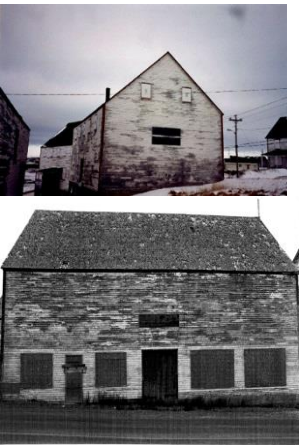
<p>White walls with red trim at corners, roof and windows. Just one red door on main façade (no opening).</p>

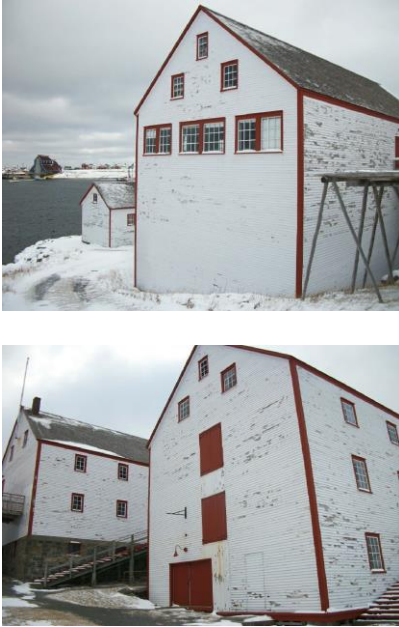
Buildings (current pictures)	1900s	Pre 1912	1912	1940s	1946	1970s	1991-1992	Present
<p><b>No. 3. Fish Store. Circa 1888-1890</b></p>

<p>Do not appear to be painted</p>	<p>All white with no evidence of trim.</p>	<p>White walls with dark (red) accents at corners.</p>

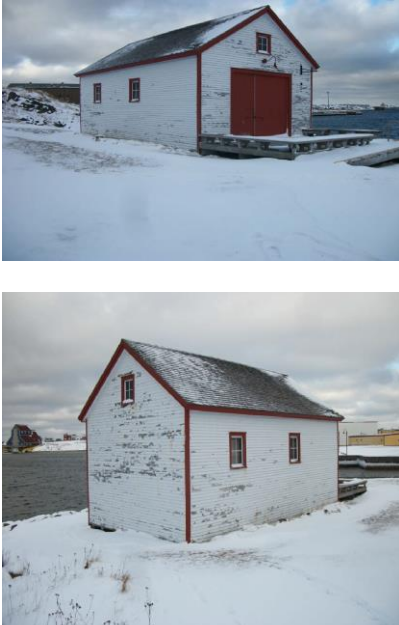
<p>White (off white/beige) walls with white door. No evidence of trims.</p>			<p>White with dark (red) corners, windows and roof trim. Dark door.</p>

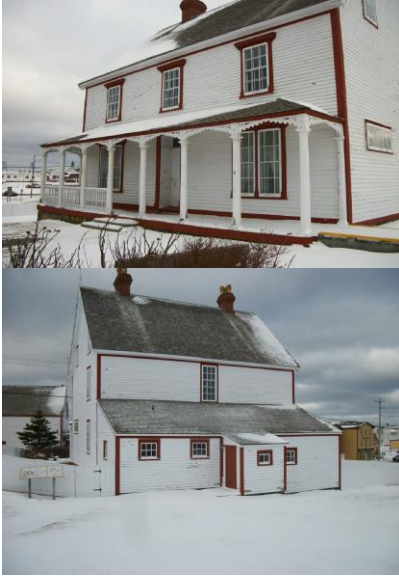
Buildings (current pictures)	1900s	Pre 1912	1912	1940s	1946	1970s	1991	Present
<p><b>No. 5. Proprietors House. Circa 1860</b></p>

<p>May have been with white walls with dark (red) trim. (based on paint analysis)</p>	<p>White walls with no evidence of dark accents at trim.</p>

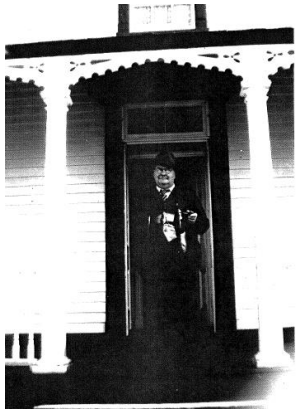
<p>White with dark (red) corners, windows and roof trim. Dark roof. Front door is white with dark (red) trim. Veranda porch posts and decoration are white. Veranda roof is dark.</p>	<p>White with red corners, windows and roof trim. Dark roof. Front door is white with red trim. Veranda porch posts and decoration are white. Veranda roof is dark. W/C ramp trim is yellow. Back door is painted red.</p>
