Archaeological Assessment of the Twin Falls  
Teahouse National Historic Site,  
Yoho National Park

William Perry  
Cultural Resource Services,  
Parks Canada, Calgary

May 1999

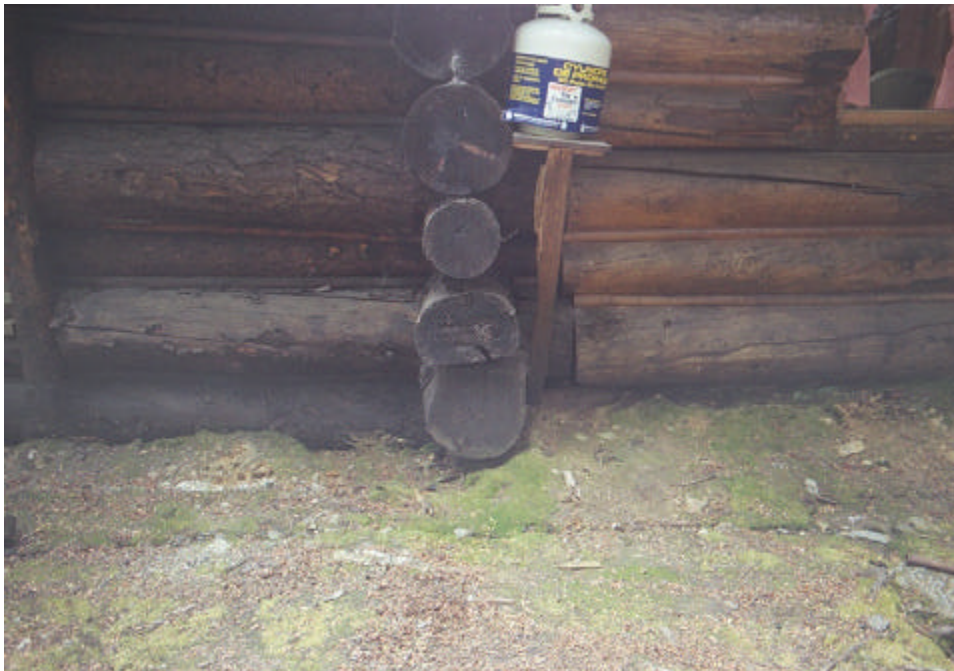
Figure 2: Units 1A and 1B before excavation. Note join in structure between the earlier log cabin and the later annex. Photograph 404T17M.

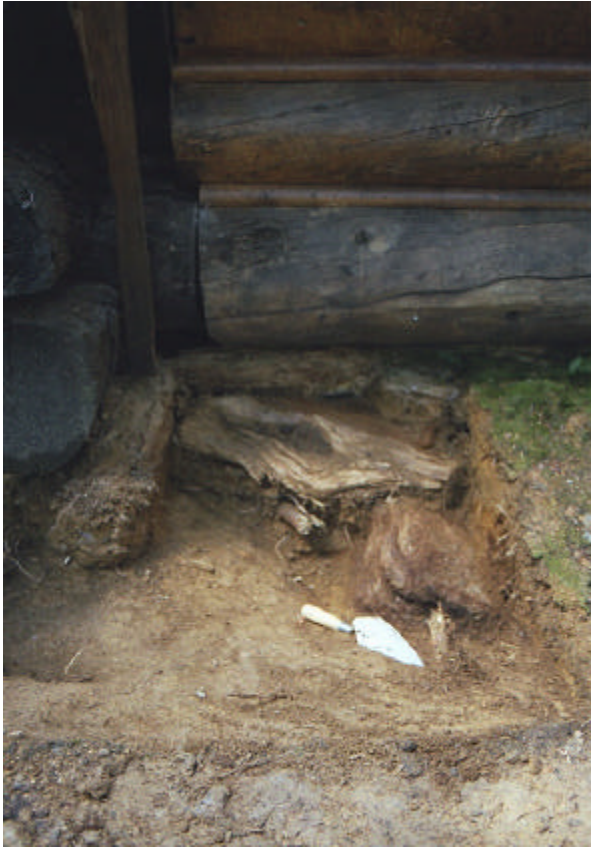
The profiles of units 1A/B indicated a thin layer of ash at about 12cm below the sill log sandwiched by layers of fine-grained orange silt (figures 3 and 4). The profile of unit 1C at the structures' front southwest corner indicates a 10cm thick charcoal layer with ash pockets at about 25cm below the sill log. This layer is sandwiched between an upper orange silt and a lower rocky yellow clay matrix (figure 5). The presence of this burn layer on both sides of the structure likely represents a natural burn event such as a forest fire. This is supported by the overlying natural silt layers showing no evidence of human disturbance.

Figure 3: Post excavation photograph of excavation unit 1B. Photograph 404T20M.

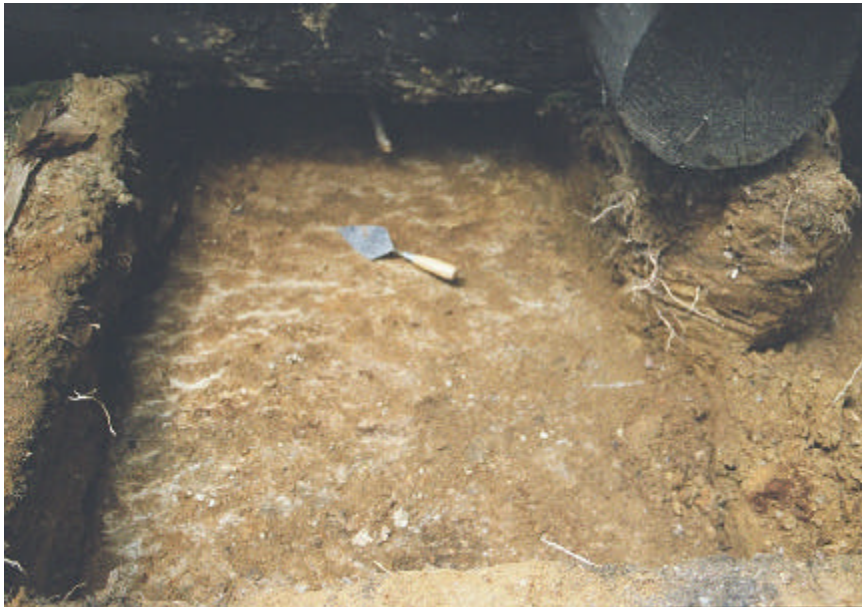
Figure 4: Post excavation photograph of excavation unit 1A. Photograph 404T21M.

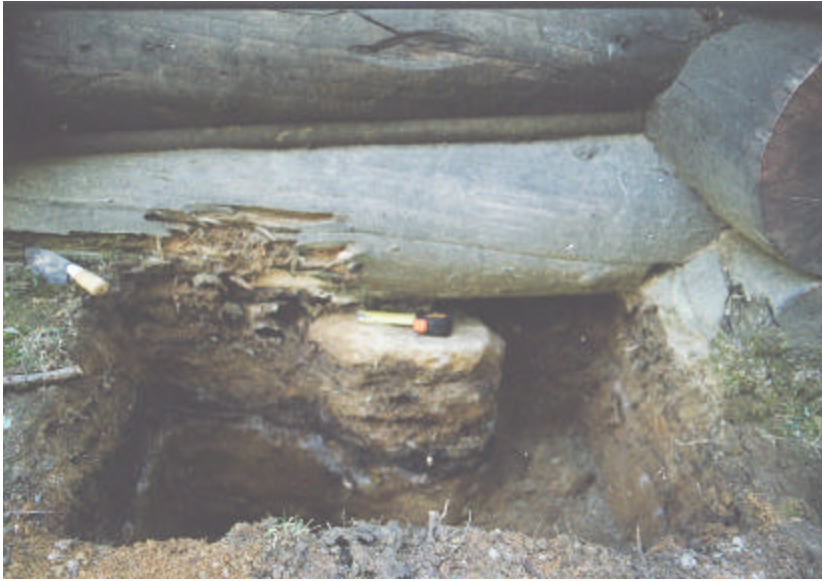
Figure 5: Post excavation photograph of Unit 1C. Photograph 404T22M.

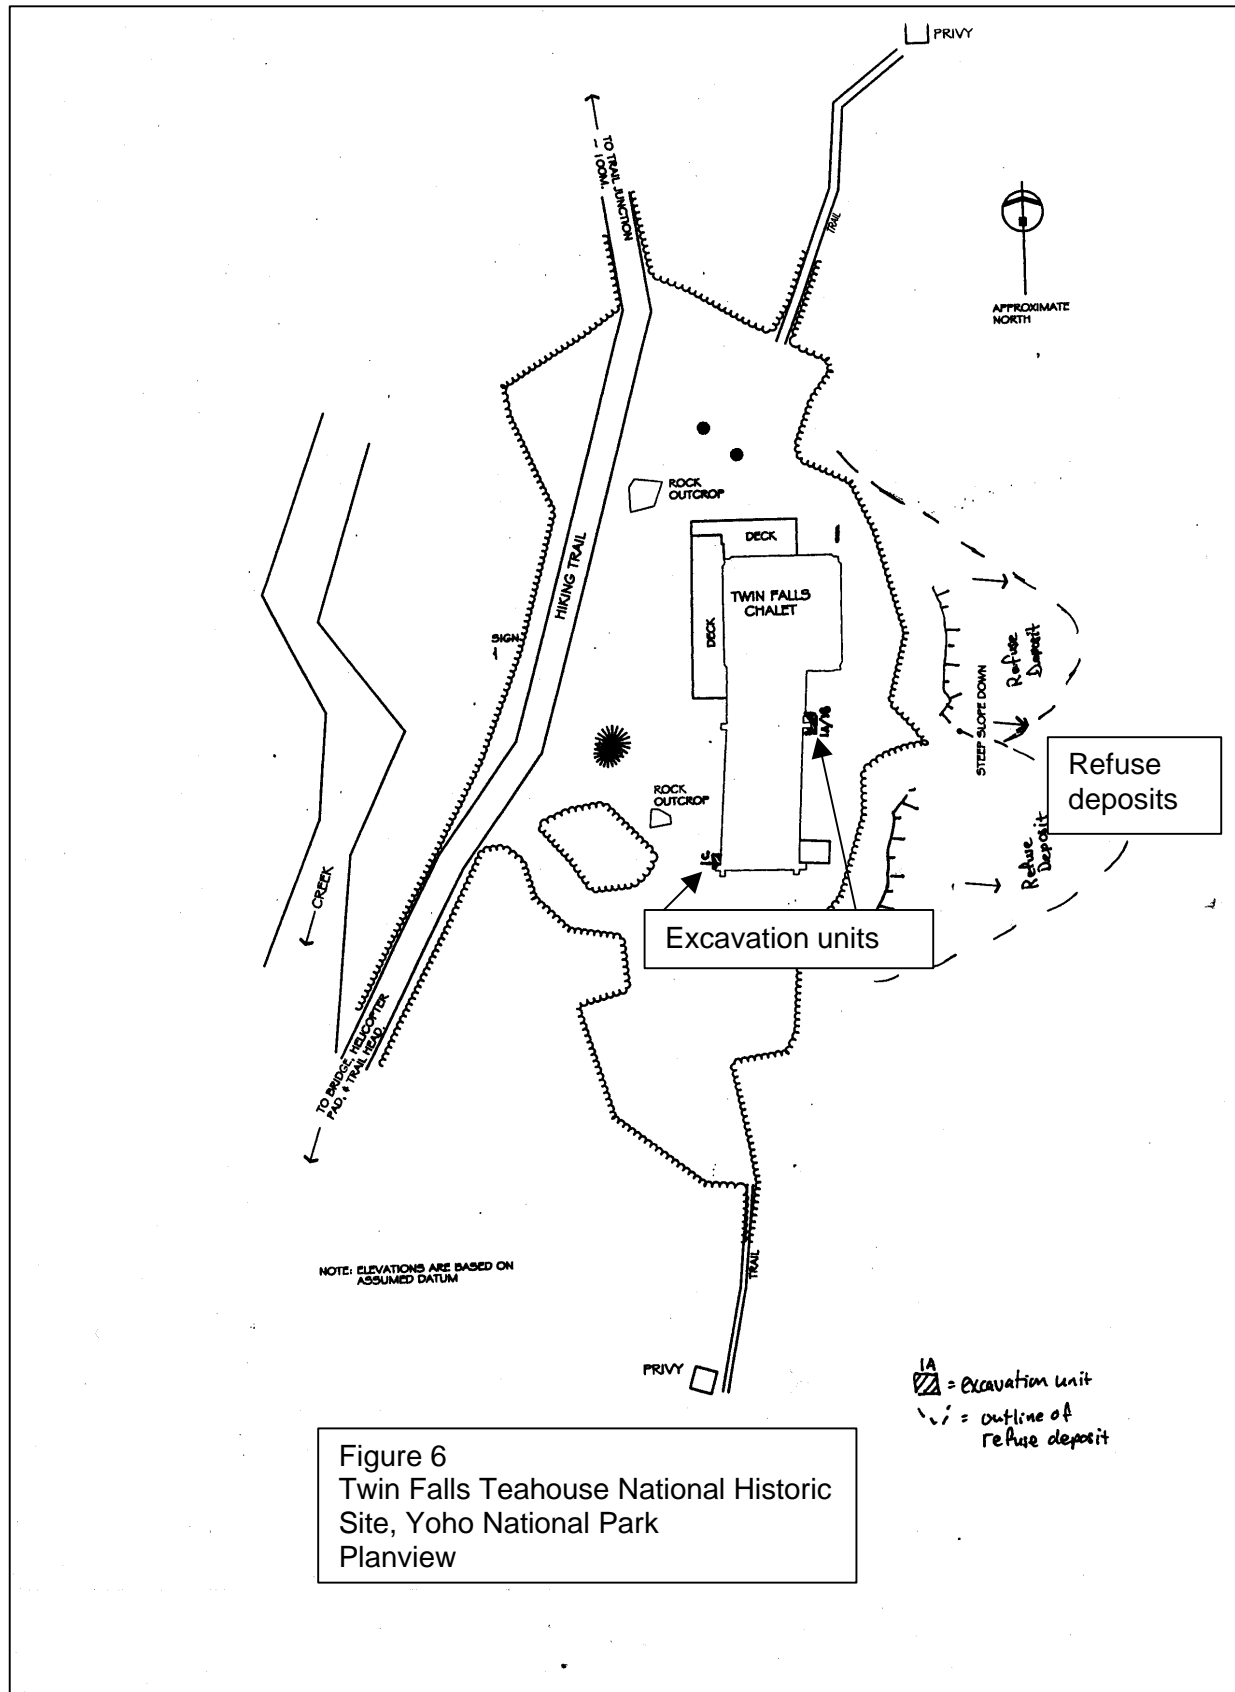
The 1998 archaeological assessment comprised three excavations: two one-metre square units along the structure's rear wall at the join between the 1908 structure and the c.1917 annex (figure 6), and the third unit (one metre by 50 cm) on the southwest corner of the 1908 structure (figure 6). The placement of the units were directed by Janet Gourley-Vallance, Restoration Architect, Engineering and Architecture, Public Works to obtain structural and architectural building sequence information about the teahouse.

In addition, a large historic refuse deposit was noted approximately 50m off the lodge's east side extending out in at least two lobes from the base of the slope (figure 6). Time did not permit an examination or testing of the deposit or its
