Regional hydrogeology in Wood Buffalo National Park

Field Report (Aug 21-30, 2013)

Judit Deri-Takacs

Dept. of Earth and Atmospheric Sciences, University of Alberta

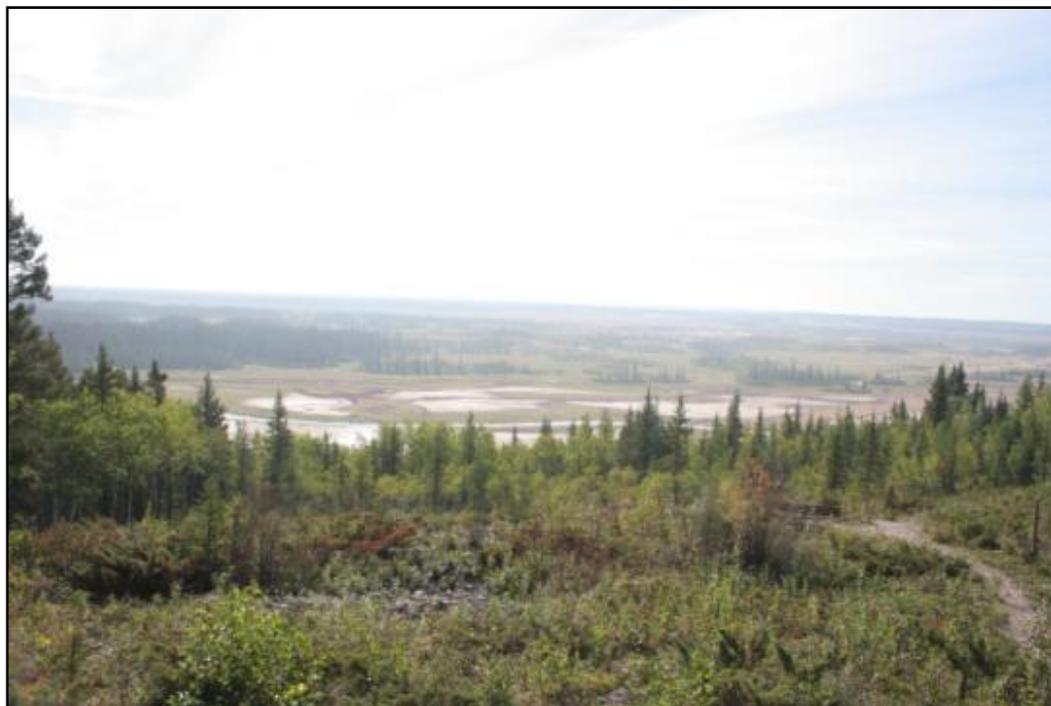
Picture 1. Overview of the salt plains from the Salt Plain Lookout

Extensive salt plains in the National Park can be found at the eastern border of the National Park, approximately 30 km west from Fort Smith (Figure 1). The salt plains are easily accessible from the Salt Plain Lookout (Picture 1). On the salt plains, 4 soil samples were collected for laboratory analysis to investigate their mineralogical composition and spectral features and 5 water samples were collected for analysis of water chemistry. The pH, temperature and electrical conductivity values measured on the field are shown in Table 2.

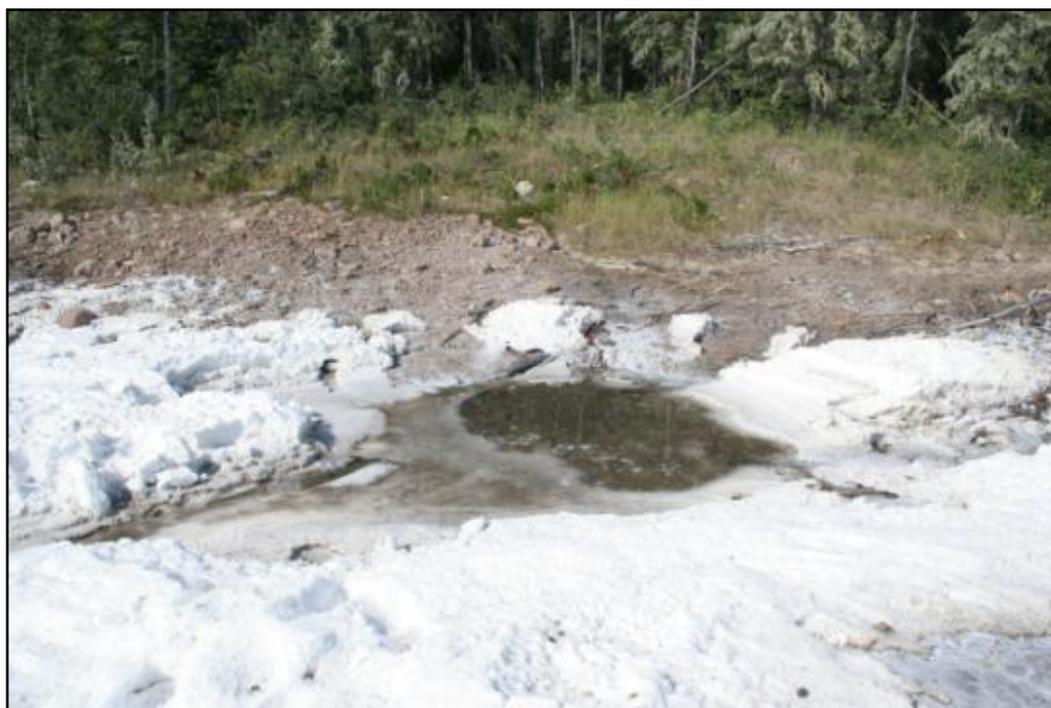
The Salt Plains is located at the edge of an evaporite escarpment where numerous springs with different water chemistry rise to the surface next to each other. During fieldwork numerous saline springs were mapped with extremely high salt content. This high salt content resulted in thick salt deposits around the spring outlet and thinner salt crust farther from the discharging point (Picture 2).

Picture 2. Saline seepage at the edge of the escarpment with salt precipitation around the outlet

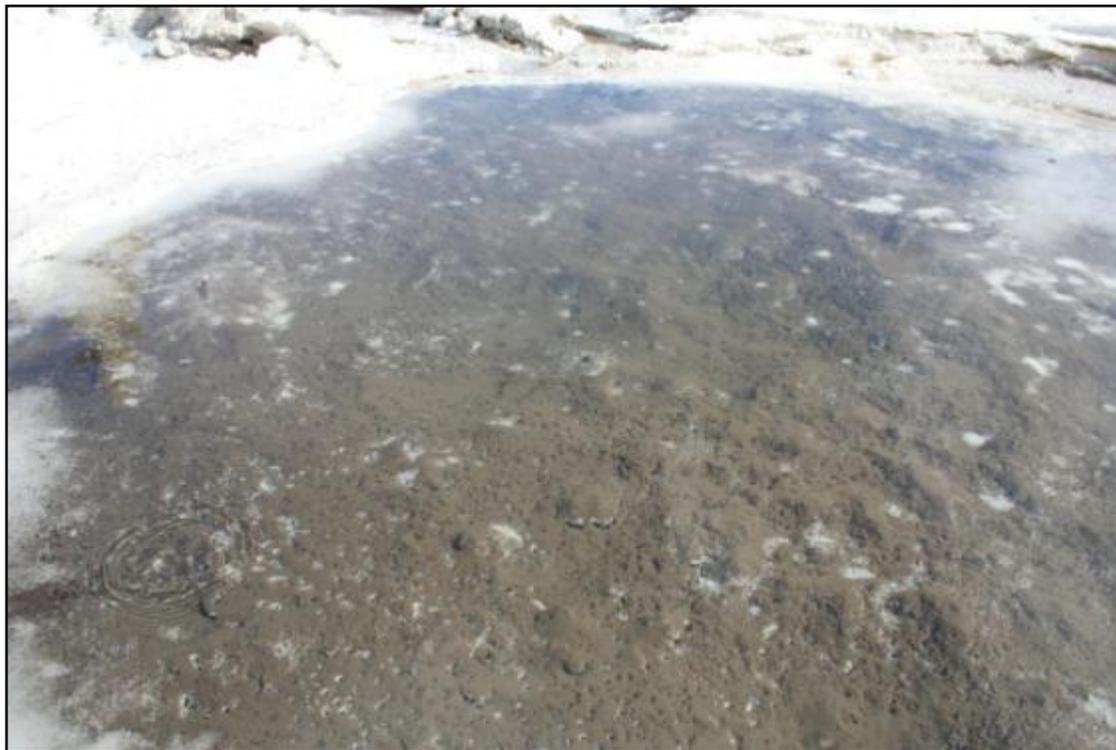
Ascending groundwater was observed as both point and diffuse discharge. Point discharge was represented by springs with a definite outlet, whereas diffuse discharge was observable in a bubbling pond (Picture 3).

Picture 3. Bubbling saline water seepage

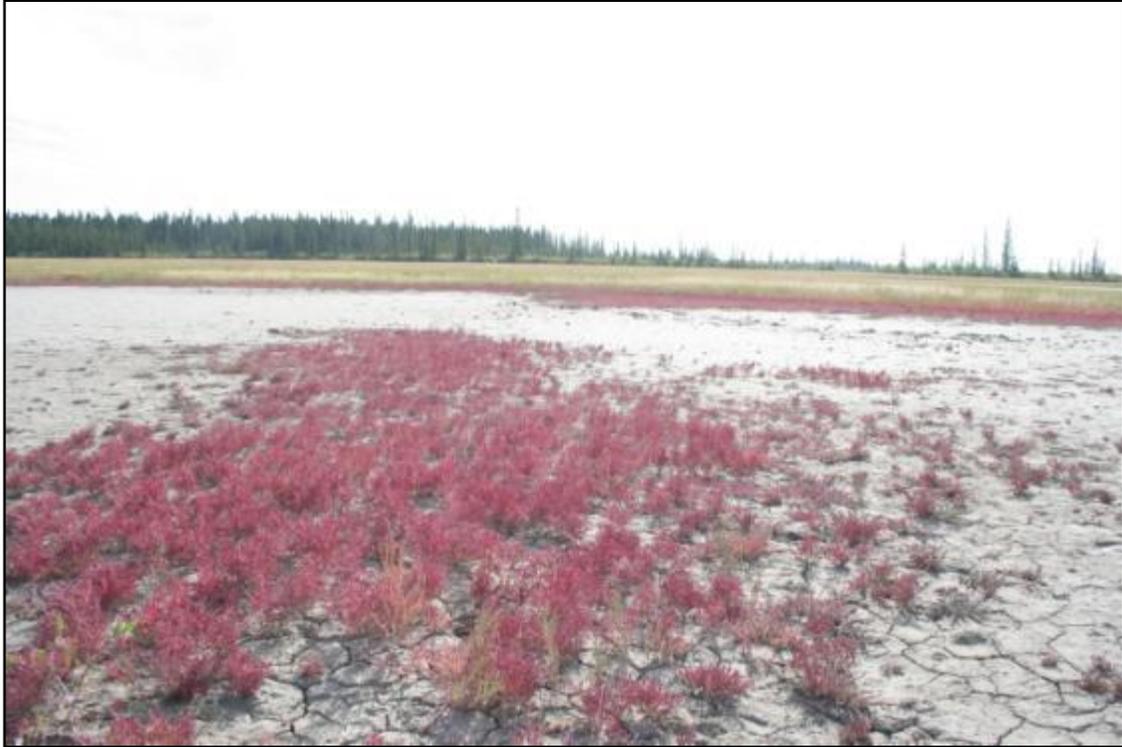
Picture 4. Red swampfire (*Salicornia rubra*)

Typical vegetation on the salt flats was the salt-tolerant red swampfire (*Salicornia Rubra*) (Picture 4).

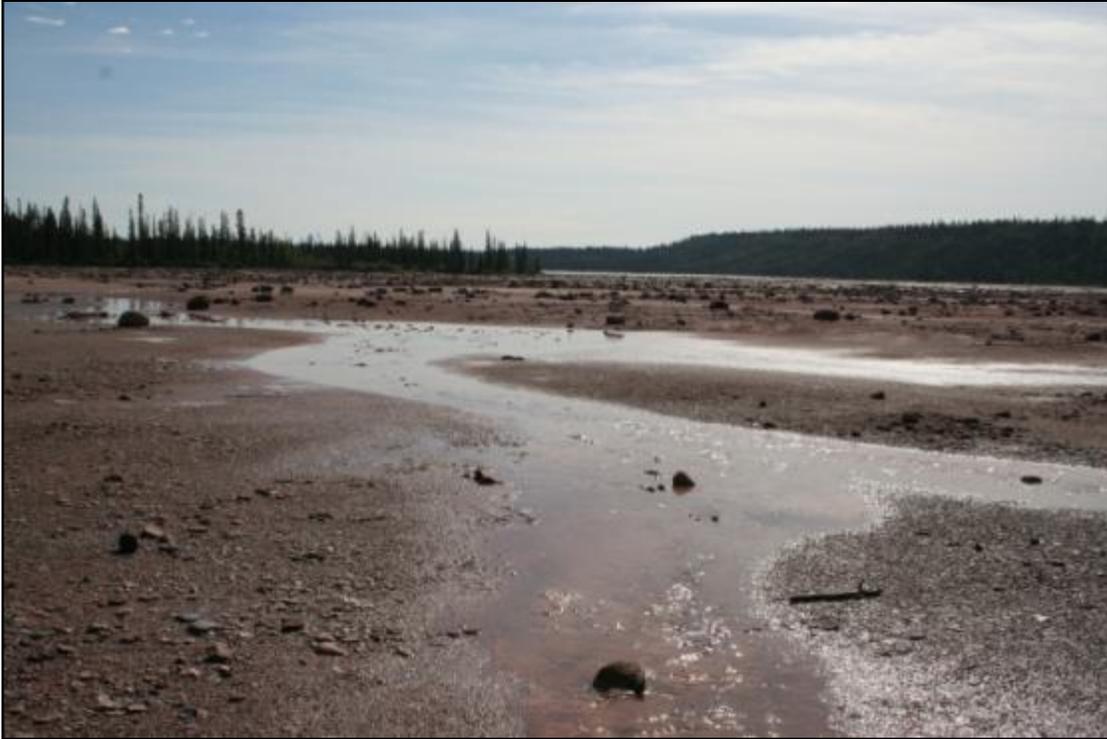
Another outstanding example of soil salinization in the National Park is the surroundings of Grosbeak Lake (Figure 1). Grosbeak Lake itself is easily accessible by a tourist trail from the Pine Lake road. The area is covered by red soil and solitary salt-corroded granite boulders with no to minimal vegetation (Picture 5). At the Grosbeak Lake, 1 soil sample and 2 water samples were collected. The pH, temperature and electrical conductivity values measured in the field are shown in Table 3.

Picture 5. Moon landscape around the Grosbeak Lake

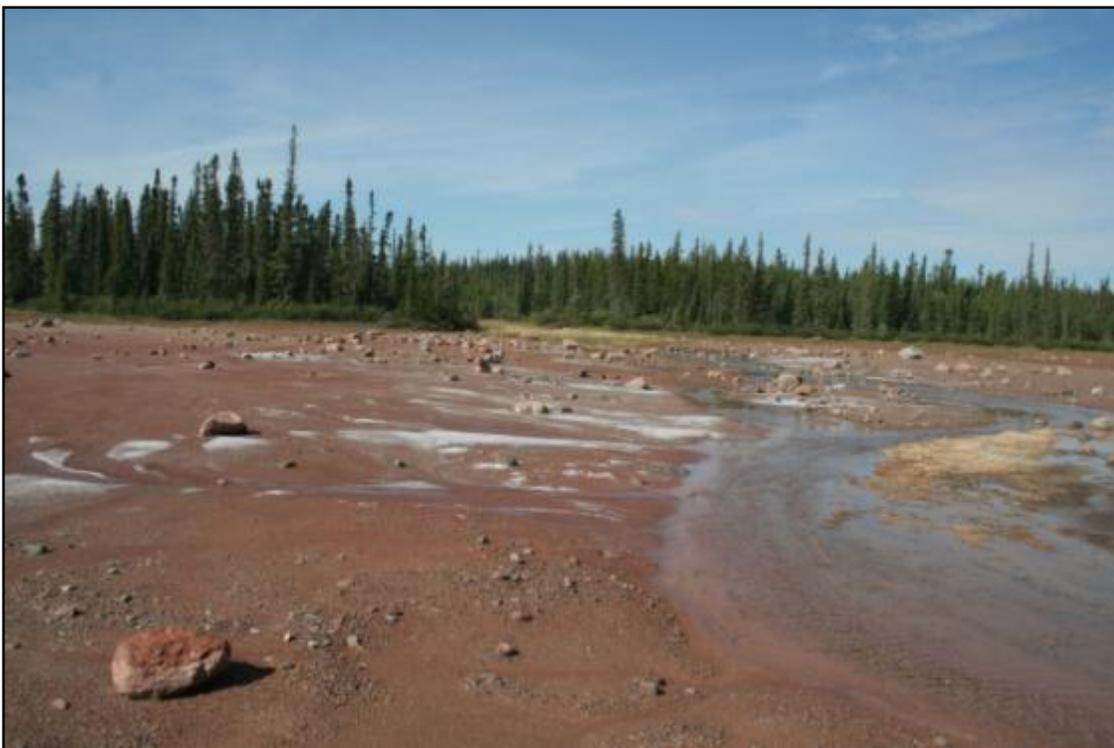
The lake is fed by saline springs discharging along the edge of the plain. Similar to the Salt Plains, salt precipitation indicates the extremely high salt content of the groundwater.

Picture 6. Saline spring and salt precipitation around the Grosbeak Lake

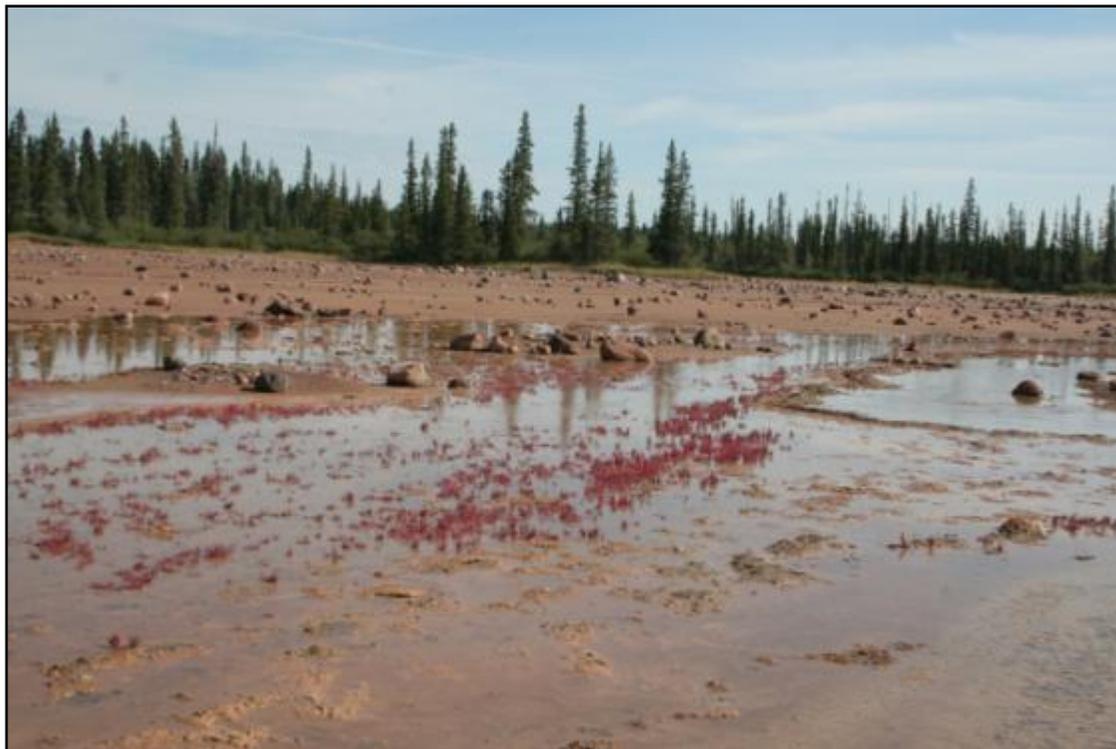
Picture 7. Red swampfire along the shore of saline spring

The only vegetation found on the plain was the salt-tolerant red swampfire (Picture 7).

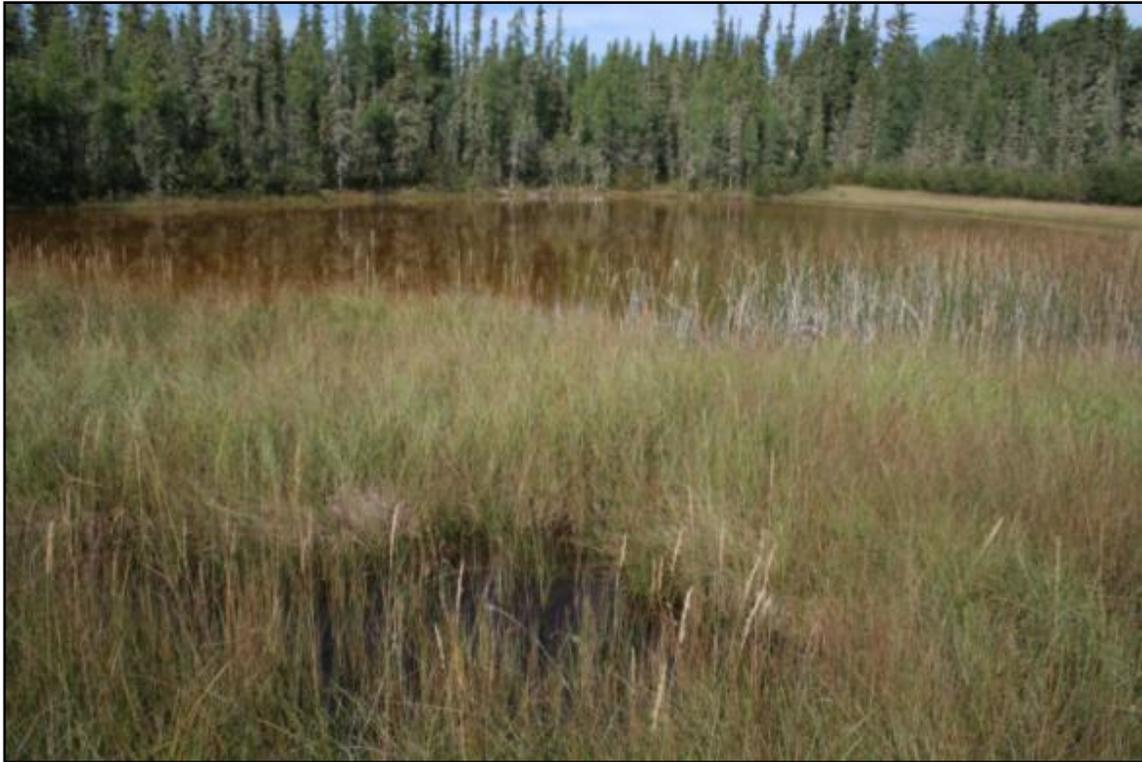
The contrast between the saline spring and the brownish, shallow pond located next to the spring outlet (Picture 8) is apparent. The pond has a quite distinct appearance compared to the surrounding of the saline spring. It is surrounded by quite dense grass and black spruce vegetation and has no salt precipitation around it. Based on the EC values measured on field (Table 3), the total dissolved solid content of it is much lower than that of the saline spring, but still higher than that of fresh water.

Picture 8. Brownish, shallow pond NW from the saline spring outlet

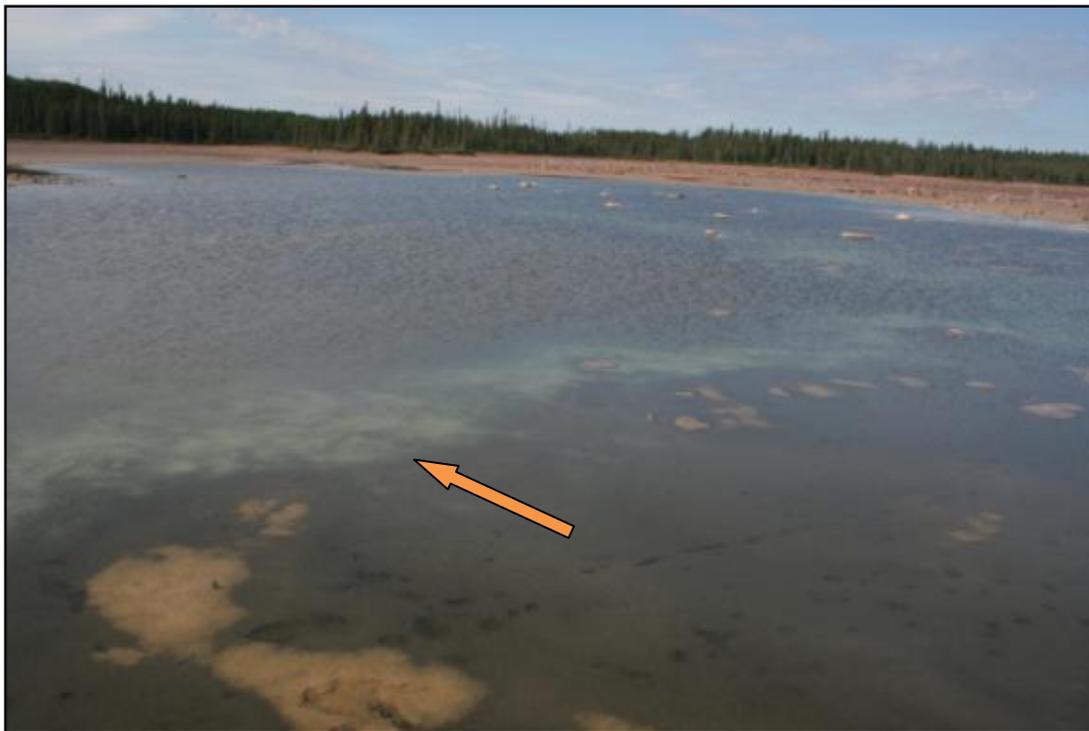
The bluish-greenish coloured spots shown in Picture 9 have been observed in a small lake connected to Grosbeak Lake.

Picture 9. Unidentified bluish-greenish spot in the small lake connected to Grosbeak Lake

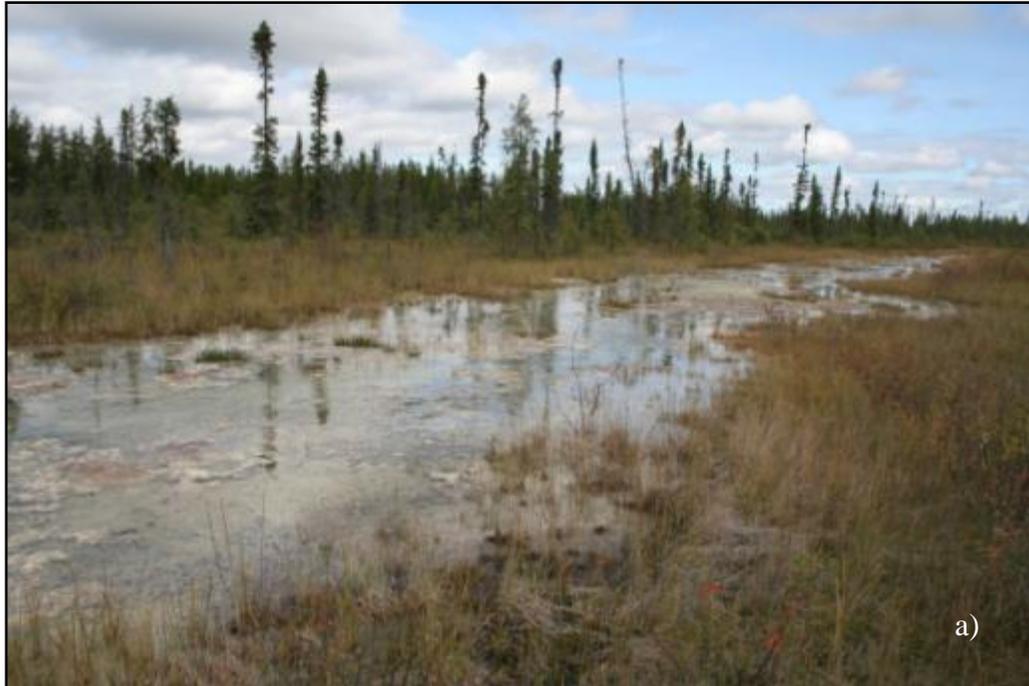
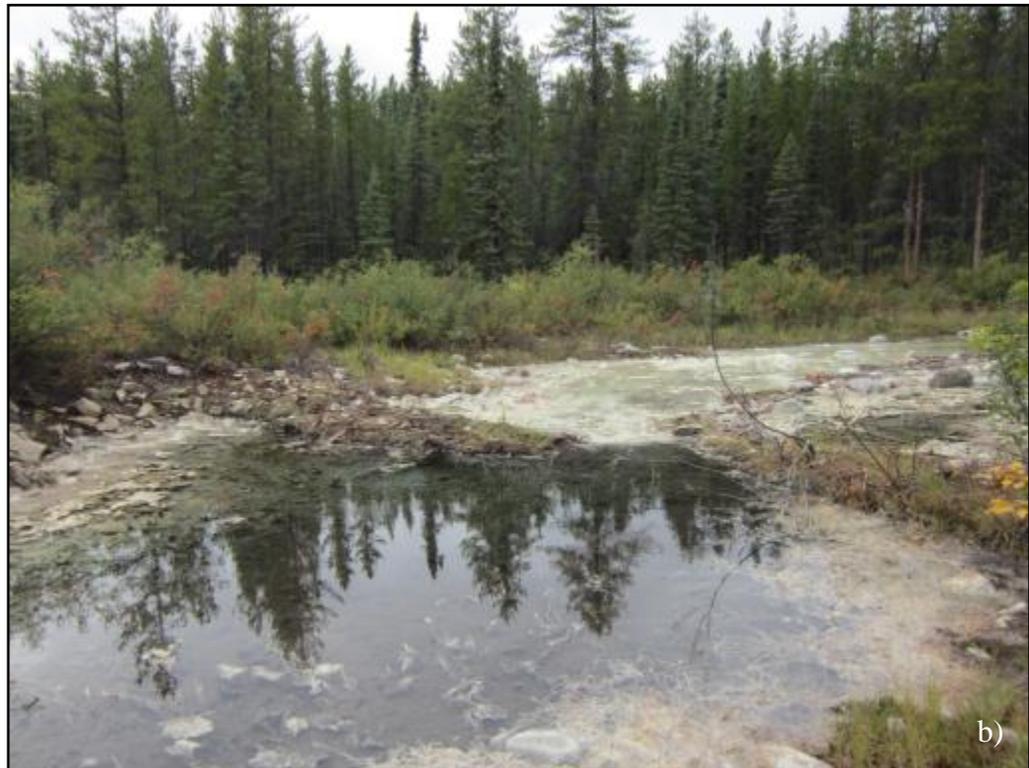
All of the observed sulphur springs possessed the same features despite their different locations. It is easy to identify them either from the air – even on satellite images - or on the ground of their very distinct color and the strong hydrogen-sulfide odor.

Picture 10. a) Sulphur spring south from Nyarling River, b) Sulphur spring at Green Lake

The sulphur springs were selected based on their distinct appearance observed from the air. During the fieldwork, sulphur springs were observed and sampled at three different sites: sulphur spring south from Nyarling River (Picture 10a), sulphur spring near Green Lake (Picture 10b) and Angus Sulphur Spring (Figure 1). All of them were fairly easy to access by hiking. At the sulphur springs/lakes 4 soil samples and 9 water samples have been collected. The measured pH, temperature and electrical conductivity values are shown in Table 4.

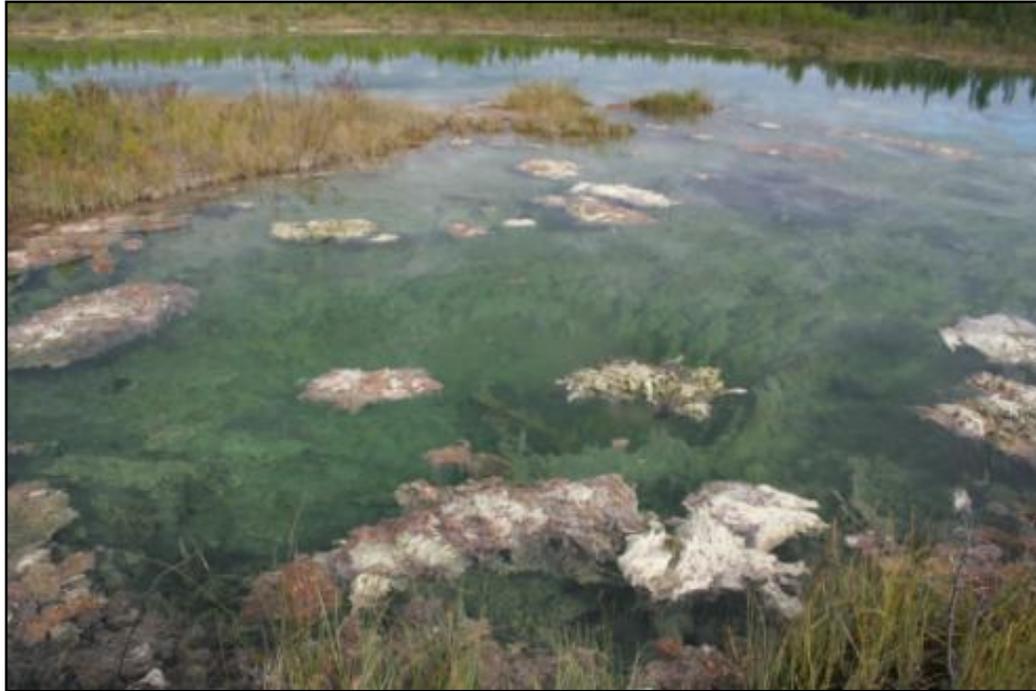
All of the sulphurous springs/lakes have a distinct vivid greenish colour and a strong rotten egg odor caused by hydrogen-sulfide (H_2S) (Picture 11). Although no microbiological analysis has been done in this project, it can be assumed that both the green color and the presence of H_2S may be caused by

Picture 11. Sinkhole fed by groundwater

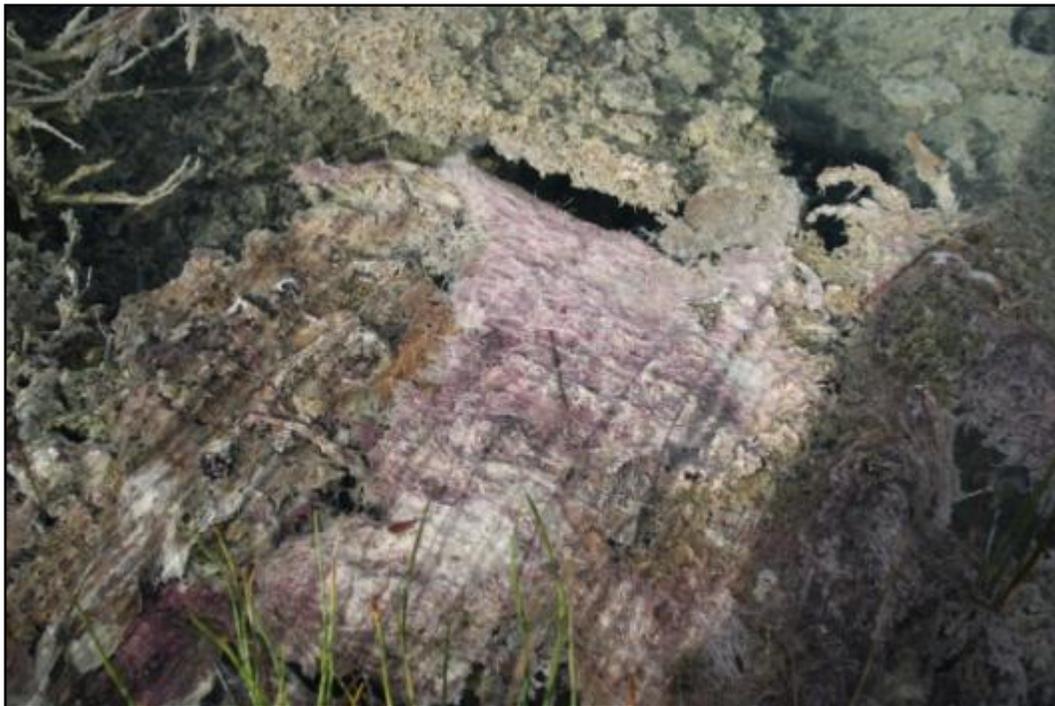
sulphur bacteria activity. Picture 12 shows some bacteria-originated phenomena floating on the surface of the sulphurous lakes.

Picture 12. Bacteria-originated phenomenon on the surface of a sulphurous lake

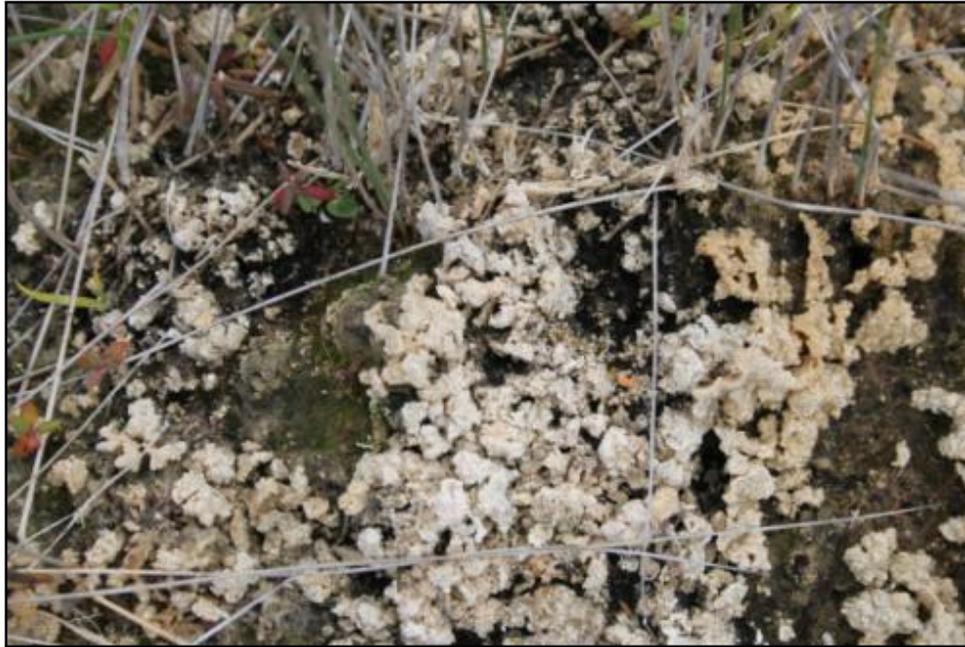
In the surroundings of the sulphur springs/lakes, small mounds with various sizes have been observed. All of the soil mounds were covered by some kind of salt precipitation as it is seen on Picture 13.

Picture 13. Salt precipitation around sulphur springs

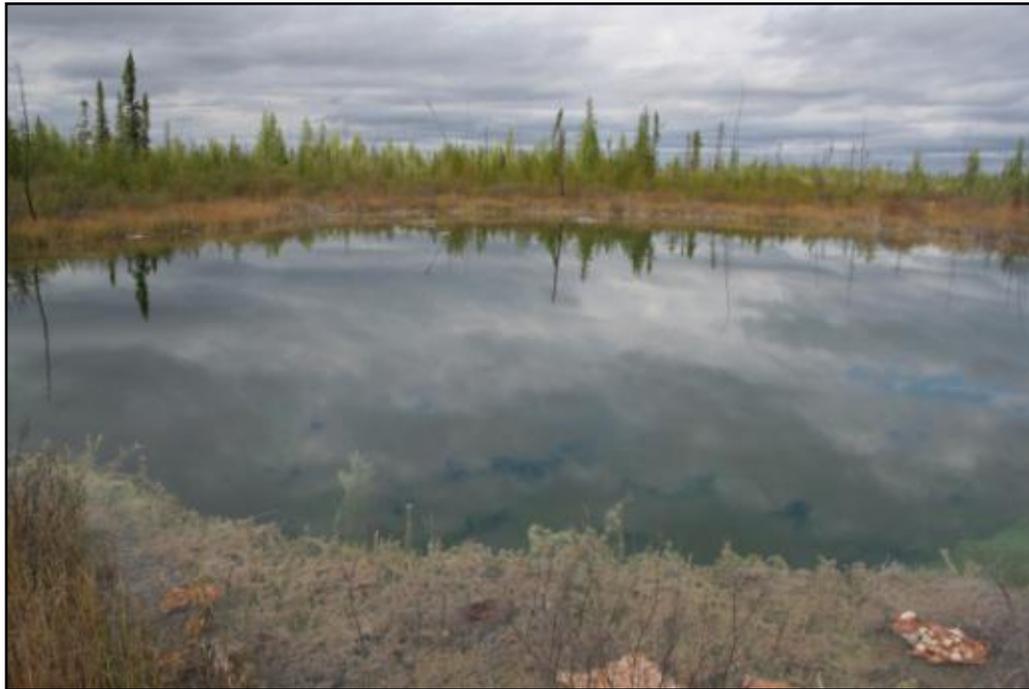
In all of the sulphurous lakes, stalagmite-like formations have been observed in various shapes and sizes (Picture 14, Picture 15). These were found usually soft, easily destroyable formations wrapping some plant remnants.

Picture 14. Sinkhole fed by groundwater with stalagmite-like formations on the shore

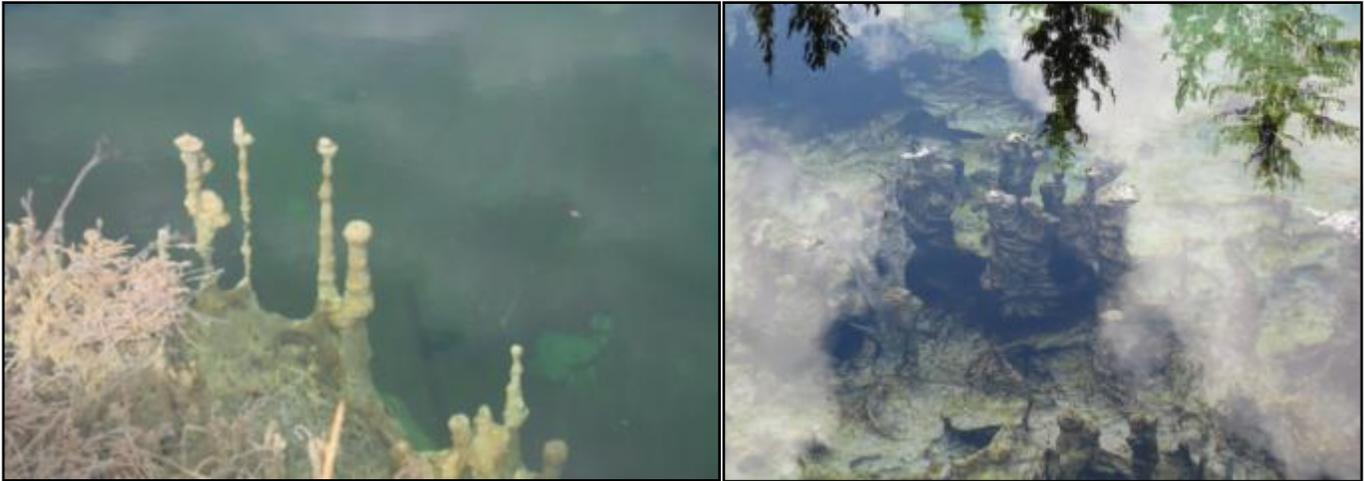
Picture 15. "Pseudo-stalagmites" in sulphurous sinkhole lakes

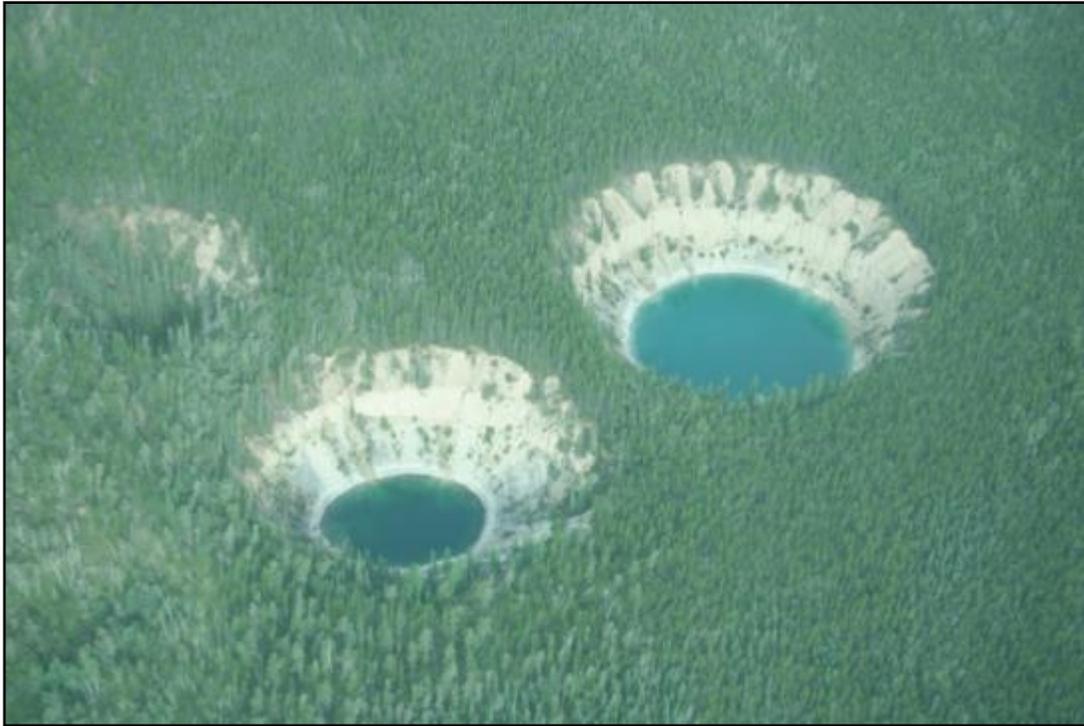
Picture 16. Water-filled sinkholes (location N 60° 20' 18.80" W 114° 18' 46.93")

Due to the presence of soluble rocks, the national park is a strongly karstified area. The dissolution of mostly evaporite formations resulted in a karstic geomorphology. In Wood Buffalo National Park most of the observed sinkholes are filled with water. Because sinkholes filled with water can represent both recharge and discharge area (White, 1988; Salvati and Sasowsky, 2002), the simultaneous examination of chemical composition of the water, the vegetation, topography and morphology is necessary to decide whether the sinkhole is fed by discharging groundwater or it is just a recharge point of the groundwater regime. Picture 16, Picture 17 and Picture 18 show some fine examples of sinkholes observed either from the air or on the ground.

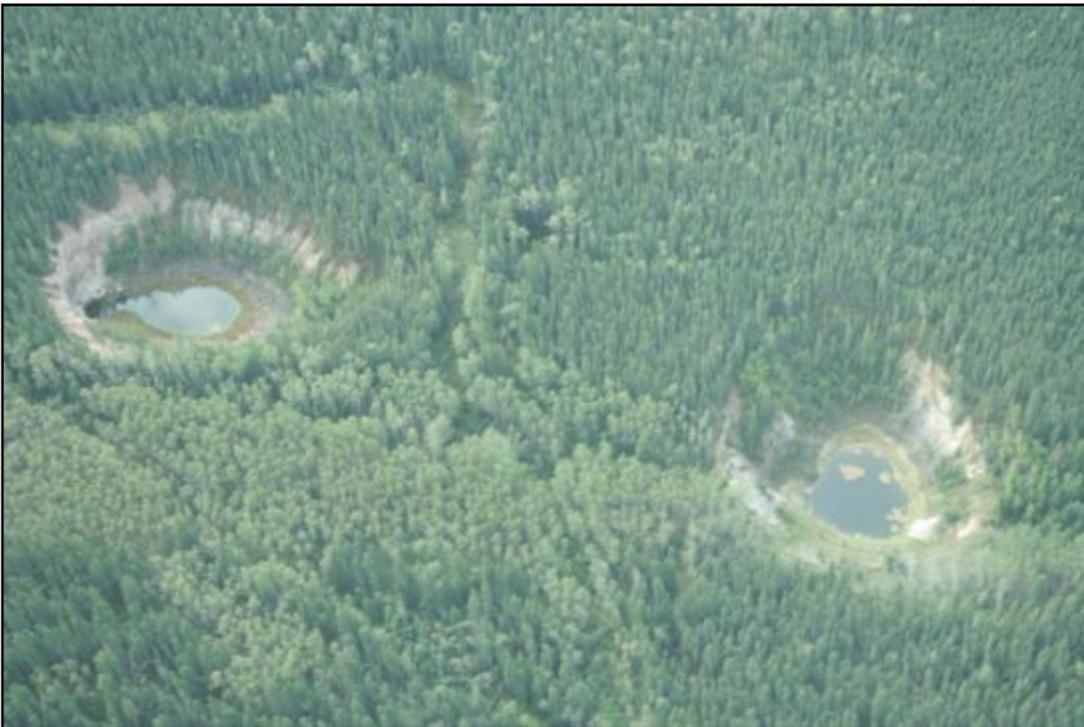
Picture 17. Water-filled sinkholes (location N 60° 18' 06.45" W 114° 21' 02.94")

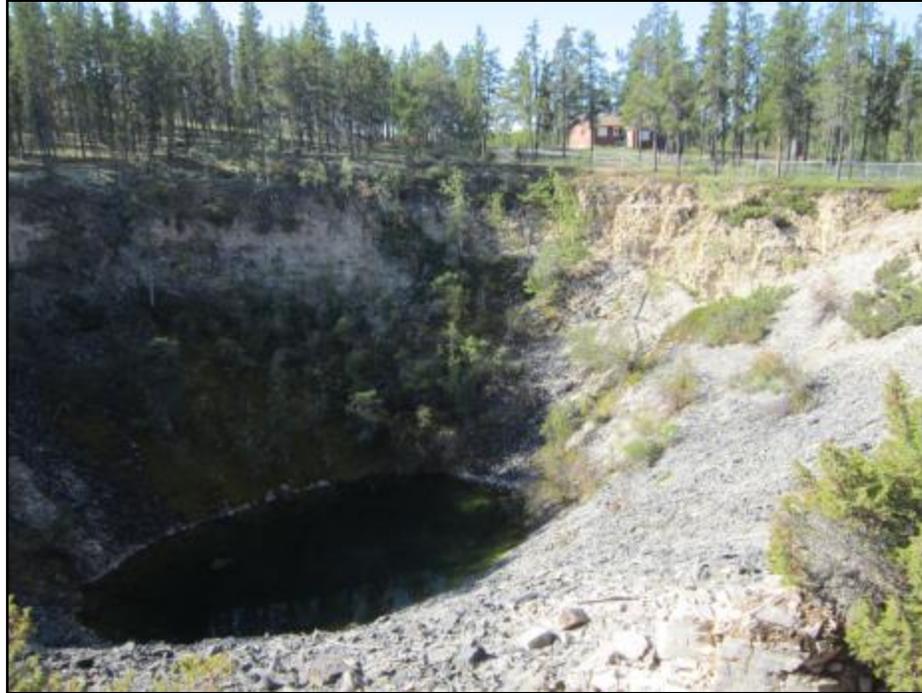
Picture 18. Angus sinkhole

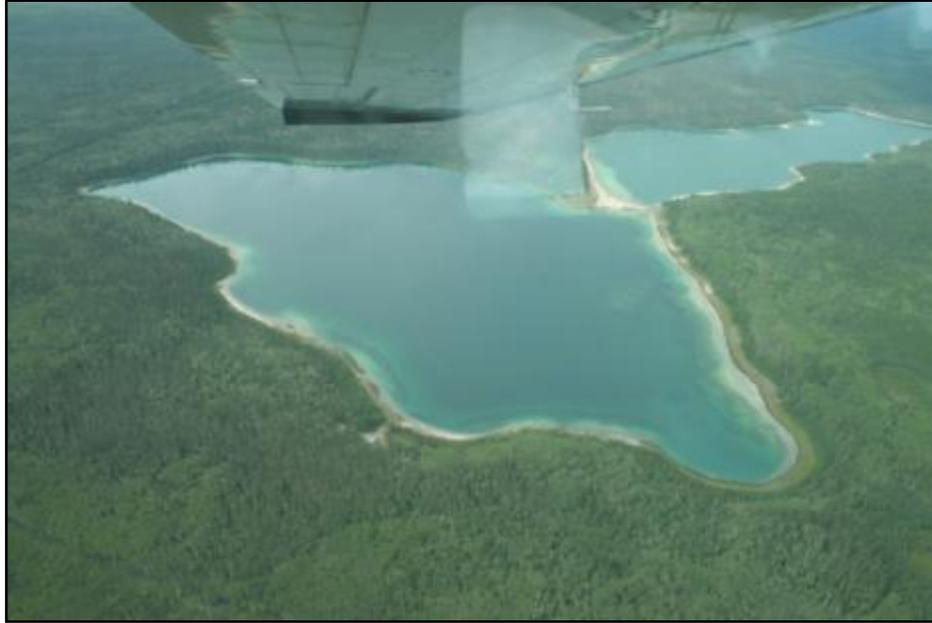
Picture 19. Pine Lake

The project objectives include determining the hydrogeological setting of Pine Lake and its hydraulic connection to surrounding lakes, such as Lane Lake, Lynx Lake, McNeil Lake. For that reason, field observations have been made at Pine Lake and its surrounding (Figure 1, Picture 19). At the Pine Lake, 2 water samples have been collected, one at the northern and one the southern part of the lake. Two more water samples have been collected from sinkhole lakes located near the trail heading to Lane Lake. The measured pH, temperature and electrical conductivity values are shown in Table 5.
