# WRECKS OF HMS EREBUS AND HMS TERROR

## NATIONAL HISTORIC SITE OF CANADA

*REMOTE SENSING SEARCH 2014 AND DISCOVERY OF HMS EREBUS*

UAT Report: 2015-03

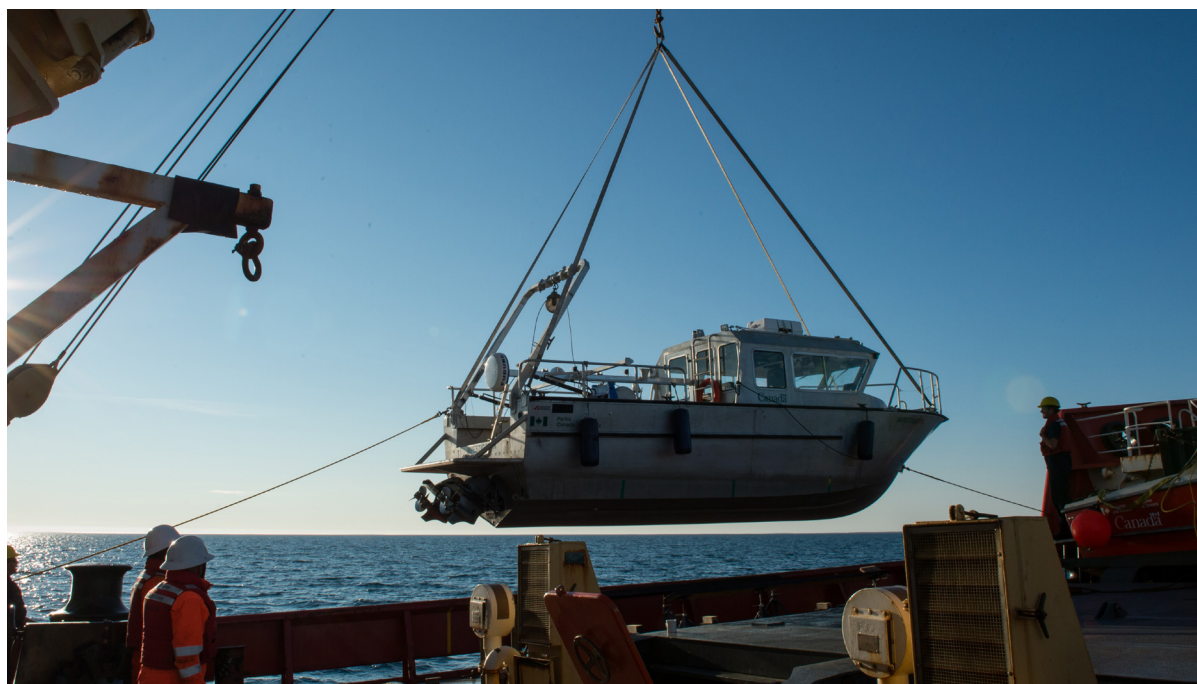
Figure 1.3.1: Parks Canada's RV *Investigator* being craned from the CCGS *Sir Wilfrid Laurier* for a day of survey in Queen Maud Gulf, Nunavut (Photo: J. Moore, Parks Canada, 89M0011EF).

provided its *Arctic Explorer* autonomous underwater vehicle (AUV) with a support team collectively deployed from the *One Ocean Voyager*. As in all previous search seasons, the CCGS *Sir Wilfrid Laurier* was secured for a dedicated search period (Figure 1.3.1). The RCN committed the Maritime Coastal Defence Vessel HMCS *Kingston* to the search and the CHS committed hydrographers to serve on the CCGS *Sir Wilfrid Laurier* and HMCS *Kingston*. The ARF committed the MV *Martin Bergmann* for the full duration of the search (Figure 1.3.2) and the RCN kindly provided three additional crew members for this research vessel: Petty Officer first class Yves Bernard, Leading Seaman Shane Milmore and Leading Seaman Brandon Patey.

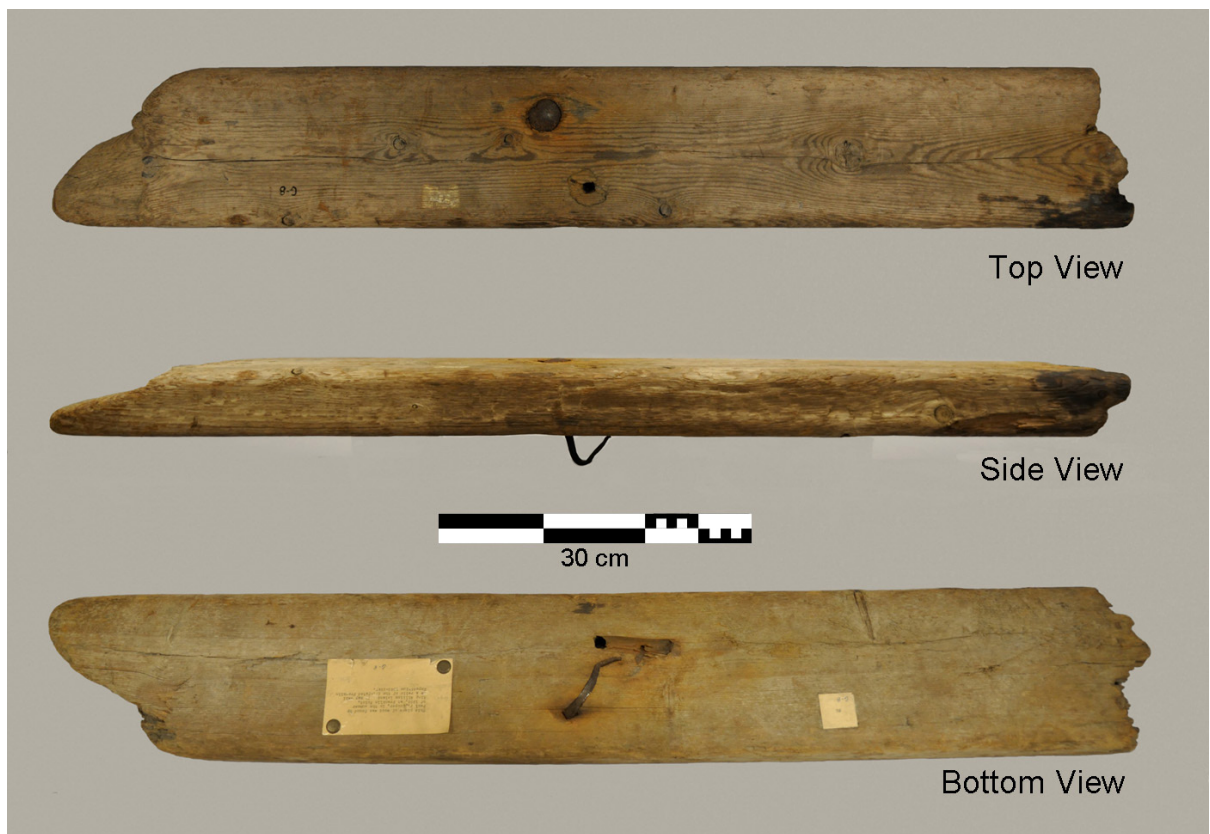
Figure 2.1.5: The Franklin Point plank found on King William Island, believed to have come from either *Erebus* or *Terror* when beset in Victoria Strait (Courtesy: Karen Ryan, Canadian Museum of History, Gatineau).

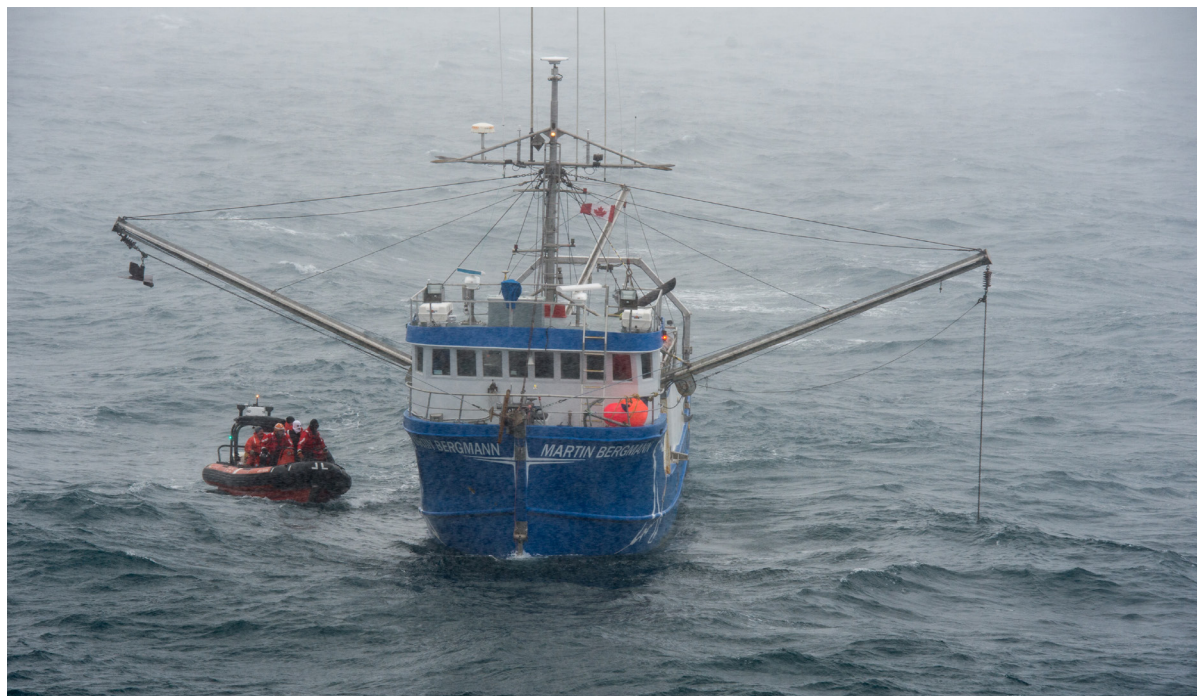
Figure 3.2.1: MV *Martin Bergmann* in the southern search area during a personnel transfer from CCGS *Sir Wilfrid Laurier* (Photo: T. Boyer, Parks Canada, 89Mo302EF).

ARF was able to contribute the MV *Martin Bergmann* for the full duration of the field season in 2014 - four weeks in all. The MV *Martin Bergmann* is a 20 m long and 6.1 m wide wooden fishing trawler converted for Arctic research (Figure 3.2.1). Its wooden hull was covered with fibreglass as part of a previous refit. The vessel has an estimated draft of 2.75 m and a total hull

displacement of approximately 90 tons. Its engine is a Detroit 12V93 turbo 530 hp inboard diesel with a fuel tank capacity of approximately 12,000 L. At Parks Canada's request, the ARF kindly outfitted the vessel with a hydraulic A-frame to better accommodate towed side-scan sonar operations. For shipboard power, the vessel is equipped with two diesel generators installed on the boat deck, a 13 kW and a 8 kW, where they are plumbed into the boat's fuel system, one supplying 120 VAC and the other 240 VAC. The MV *Martin Bergmann* is fitted to accommodate five crew members and five supernumeraries for voyages lasting approximately ten days from re-supply. Remote-sensing equipment for use during the underwater archaeological survey was supplied by Parks Canada.

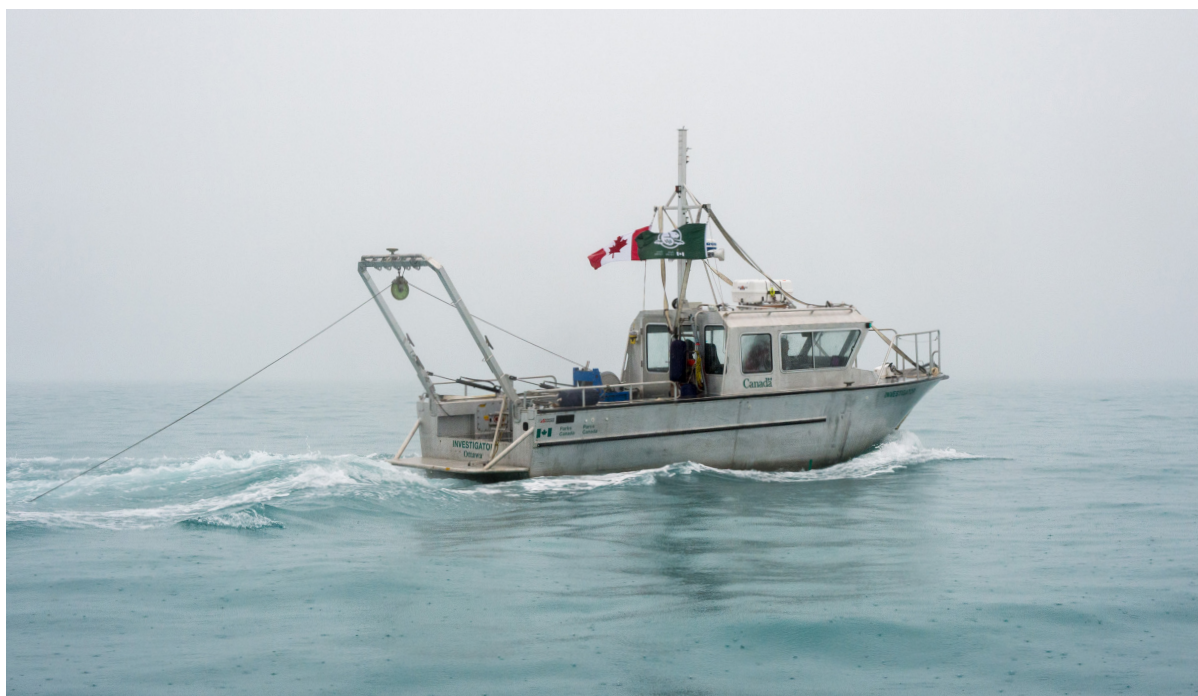
Figure 3.2.2: RV *Investigator* towing side-scan sonar in 2013 (Photo: T. Boyer, Parks Canada, 51M2495EF).

The RV *Investigator* is a custom-built 10 m aluminum dive tender and remote-sensing survey boat fabricated to UAT specifications by Kanter Marine, of St. Thomas, Ontario (Figure 3.2.2). The hull is a transom free design to facilitate the deployment and recovery of remote-sensing equipment, moorings, and archaeological divers from the working deck. The boat has a hydraulically actuated A-frame for towing side-scan sonar from the stern. In anticipation of one day staging surveys from large seagoing ships like the CCGS *Sir Wilfrid Laurier*, the vessel was built with four reinforced lifting eyes at each quarter allowing the

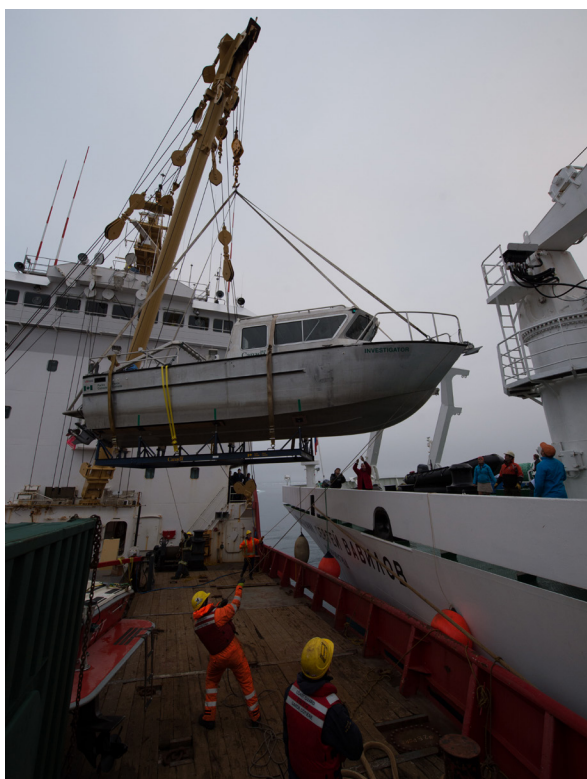
Figure 3.2.3: RV *Investigator* is transferred from the *One Ocean Voyager* to CCGS *Sir Wilfrid Laurier* (Photo: J. Moore, Parks Canada, 51M2822EF).

vessel to be hoisted by crane up to its maximum operating weight of 6,020 kg (Figure 3.2.3). A steel support cradle was manufactured to this end, specifically for use during the 2013 survey, allowing the RV *Investigator* to be loaded onto the CCGS *Sir Wilfrid Laurier*'s well deck. RV *Investigator* is powered by twin 5.7 L Volvo Penta V8 duoprop inboard/outboard gasoline engines, yielding a combined 700 hp. Fifteen 205 L drums of gasoline were procured in Cambridge Bay, Nunavut, and brought aboard the CCGS *Sir Wilfrid Laurier* to meet the fuel requirement for the 2014 survey, with the RV *Investigator*'s onboard fuel capacity exceeding 680 L. Onboard 120 VAC power is supplied by a 6 kW Westerbeke gasoline generator, which also drives the hydraulic pump. In 2014 the RV *Investigator* was loaded aboard the upper deck of *One Ocean Voyager* in Halifax, Nova Scotia, for transport to the Arctic and transferred to the CCGS *Sir Wilfrid Laurier* during a rendezvous in Queen Maud Gulf.

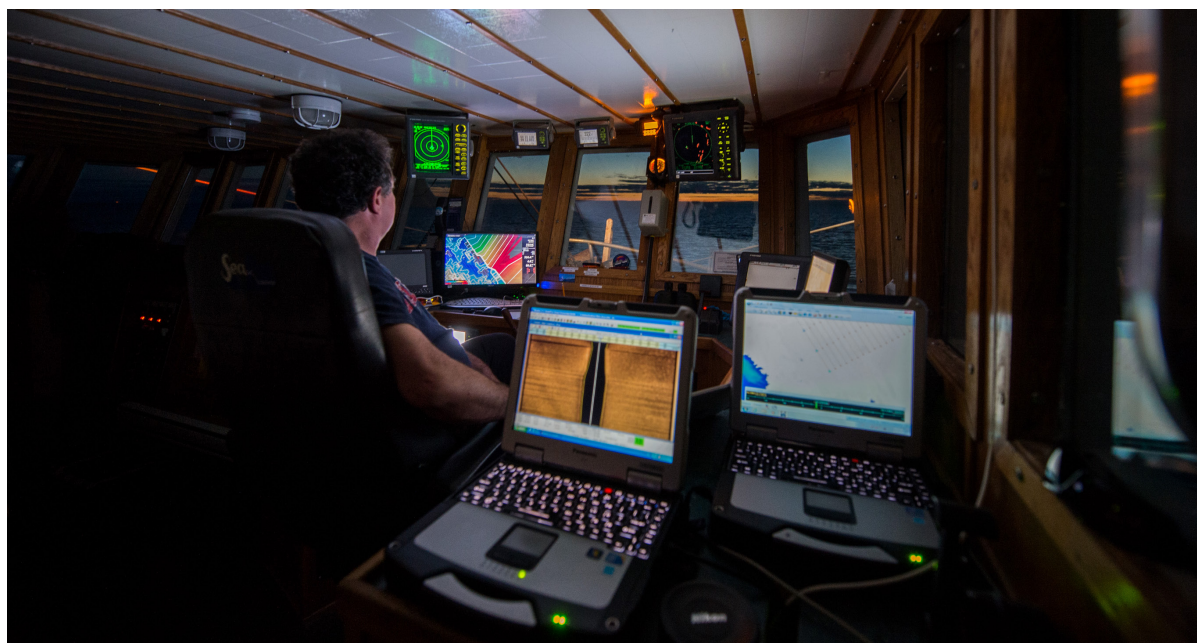
Figure 3.2.4: Night operations towing side-scan sonar from the MV *Martin Bergmann* (Photo: T. Boyer, Parks Canada, 51M2840EF).

Survey navigation software was used on both survey platforms to ensure efficient and thorough area coverage by providing a series of predefined survey lines that could be easily and precisely followed by the helmsman (Figure 3.2.4). This also allowed the line coverage of the two survey vessels to be carefully coordinated so as to avoid unwanted gaps or duplication. On both the MV *Martin*

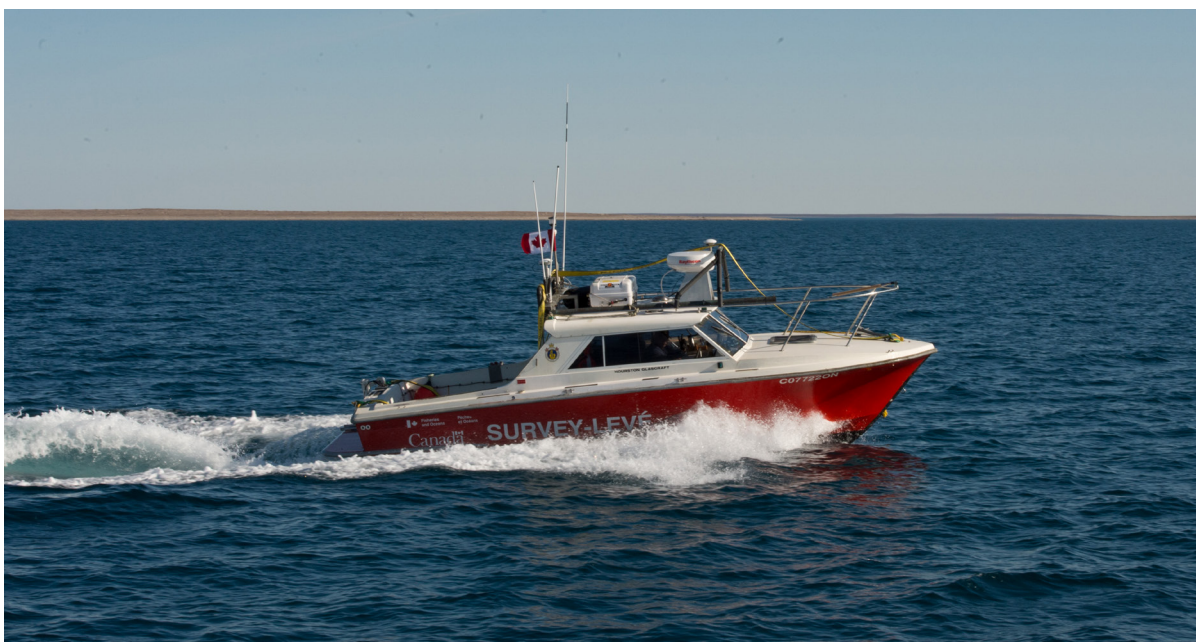
Figure 3.2.5: CSL *Gannet* in the southern search area (Photo: J. Moore, Parks Canada, 89M0025EF).

The *Gannet* and *Kinglett* are 7 m long fiberglass survey boats custom built for DFO by Hourston Glascraft Ltd. of Vancouver, British Columbia (Figure 3.2.5). Both are fitted with antenna guards and reinforced lifting points so as to be easily deployed and retrieved by crane from alongside the CCGS *Sir Wilfrid Laurier*. Welded steel cradles accommodated the launches securely on the well deck of the ship, one to either side of the forward hatchway. The cabin layout of each boat was generally conceived for a crew of two, comprising a coxswain and a hydrographer. Each launch is fitted with a Volvo Penta marine diesel engine with counter-rotating duoprop inboard/outboard stern-drive unit, offering improved fuel economy

and facilitating line steering for extended bathymetric survey work. In 2014, each launch was fitted with an R2Sonic 2022 multi-beam echosounder system (MBES) with Applied Microsystems Limited (AML) sound velocity sensors and a 120-VAC, 6.5 kW diesel power generator.

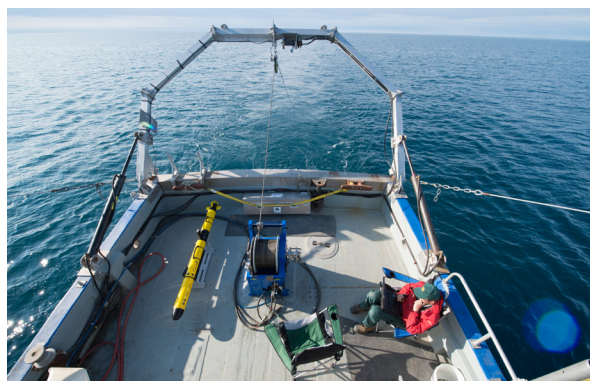
Figure 3.3.1: Towed side-scan sonar operation from the MV *Martin Bergmann* (Photo: J. Moore, Parks Canada, 51M2684EF).

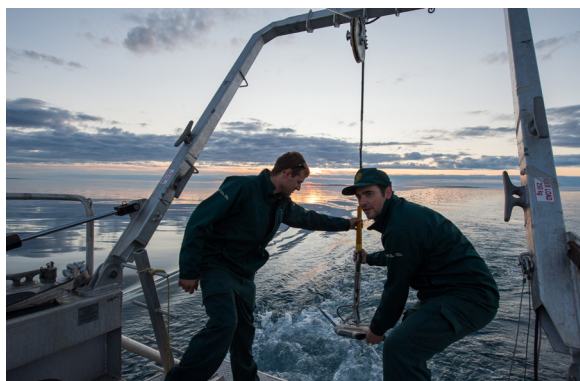
Figure 3.3.3: Retrieval of the side-scan sonar towfish aboard *Investigator* at the end of a day of survey (Photo: J. Moore, Parks Canada, 51M2848EF).

In order to ensure accurate positioning of the towed side-scan data, it was necessary to accurately gauge the longitudinal offset or ‘layback’ of the towfish relative to the survey vessel where the GPS antenna was mounted. This was accomplished by means of a model SD41 digital metering sheave block (manufactured by 3PS Inc.), which uses magnetic sensors set in the turning sheave to precisely monitor the total amount of

deployed cable at any given time. This measured 'cable out' value combined with the indication of towfish depth coming from its integral pressure sensor, are sufficient to provide the sonar processor the trigonometric parameters necessary to determine the XY layback of the side-scan towfish in real time. This block was suspended from the A-frame on either vessel (Figures 3.3.1 to 3.3.3).

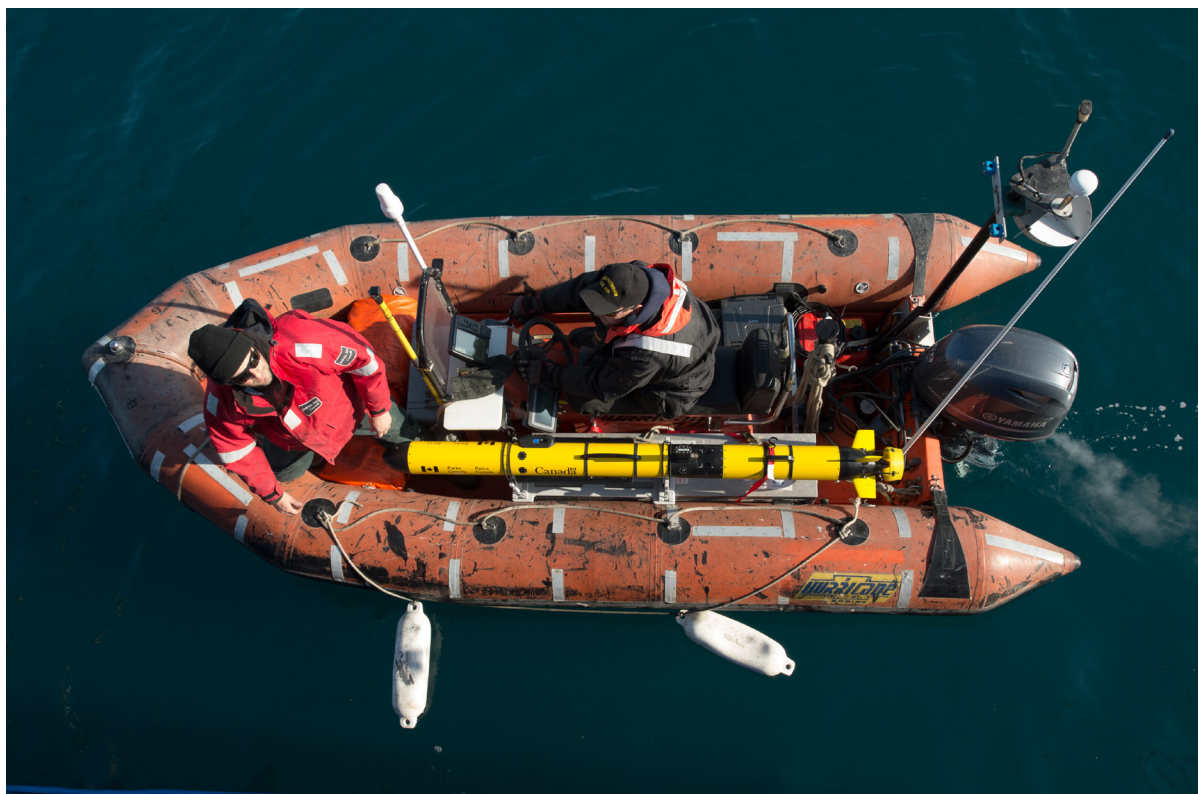
Figure 3.3.4: Ryan Harris (left) prepares to deploy the Iver3 AUV in the southern search area (Photo: J. Moore, Parks Canada, 51M2689EF).

The advantage of an AUV as compared to a towed side-scan sonar system is that the AUV offers a stable platform for sonar survey regardless of surface sea state, producing exceptional imagery in conditions that would thwart towed sonar operations. At 2.3 m in length, the Iver3 AUV can also be deployed manually by two people working from any vessel of opportunity, including small boats, and can even be launched from shore. The Iver3 has a total mission endurance of 10-12 hours, scanning a series of parallel survey lines in the same manner as a vessel-towed sonar.

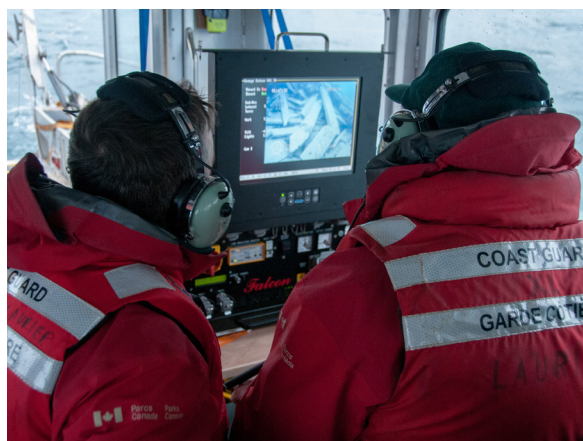
Figure 3.3.7: Preliminary ROV inspection of the wreck of *Erebus*. Ryan Harris (right) pilots the vehicle while Jonathan Moore looks on (Photo: M.-A. Bernier, Parks Canada; 89M0104EF).

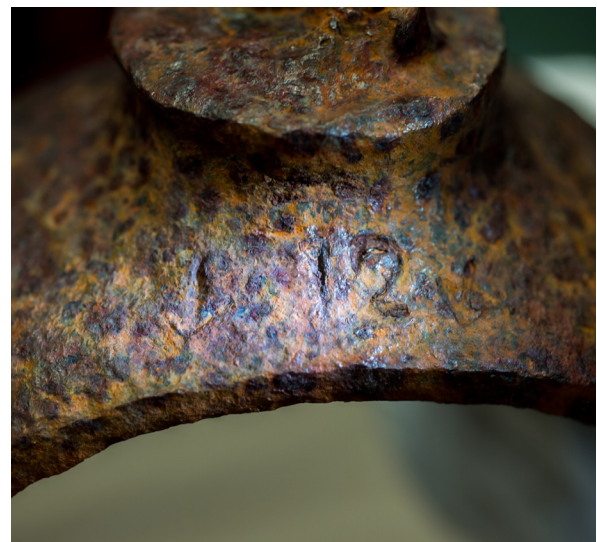
Figure 4.2.2: Close-up of the davit pintle found on shore showing two broad arrow marks and the number 12 (Photo: T. Boyer, Parks Canada; 89MO252EF).

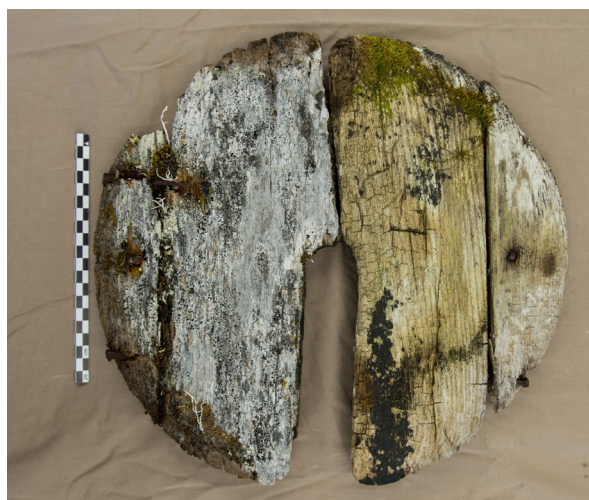
Figure 4.2.3: Wooden artefact found on shore, tentatively identified as a plug for a deck scuttle, top view (Photo: T. Boyer, Parks Canada; 89Mo257EF).

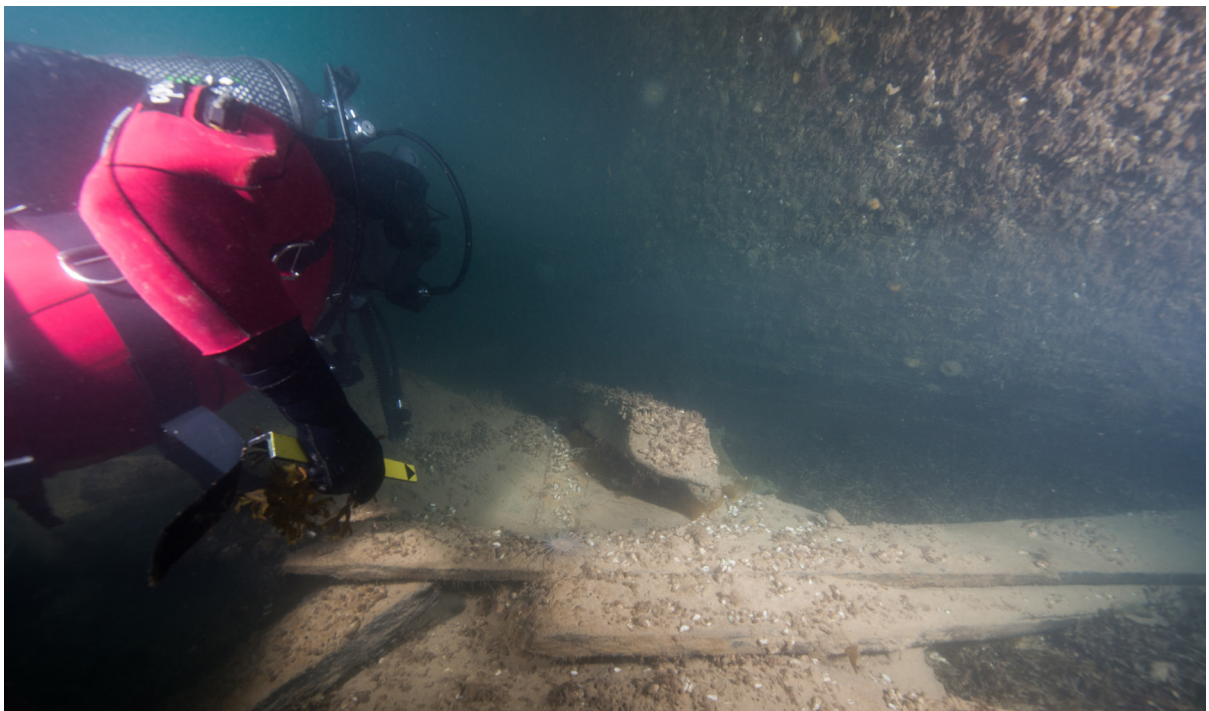
Figure 5.1.1: Scour pocket under the starboard stern quarter of the wreck of *Erebus*. Mussels growing on the outside hull planking can also be seen (Photo: T. Boyer, Parks Canada; 89M0737EF).

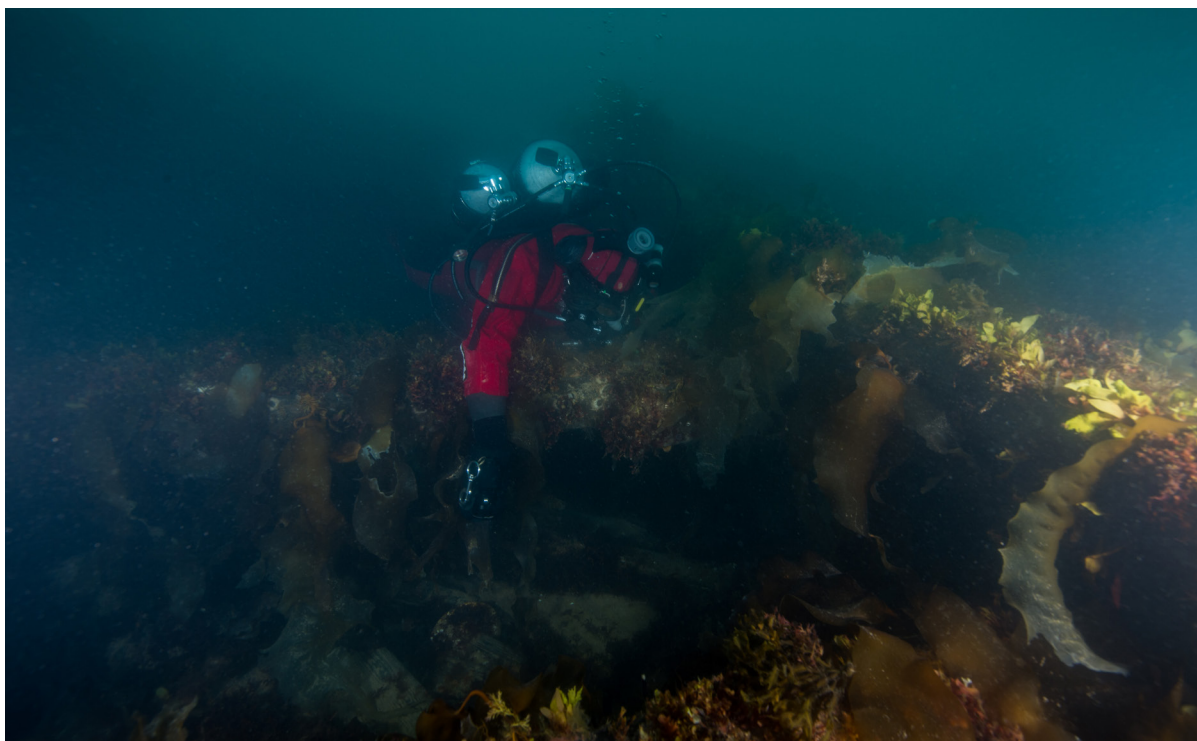
Figure 5.1.2: Marine growth on upper deck beams and planking (Photo: T. Boyer, Parks Canada; 89M00505EF).

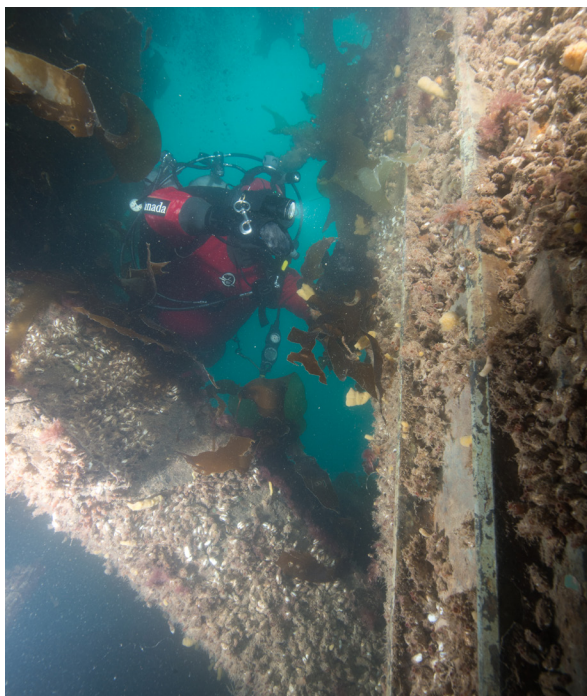
Figure 5.1.3: Filippo Ronca at forward face of the end post of *Erebus* covered with a layer of mussels of as yet unidentified taxonomy (Photo: T. Boyer, Parks Canada; 89M00439EF).

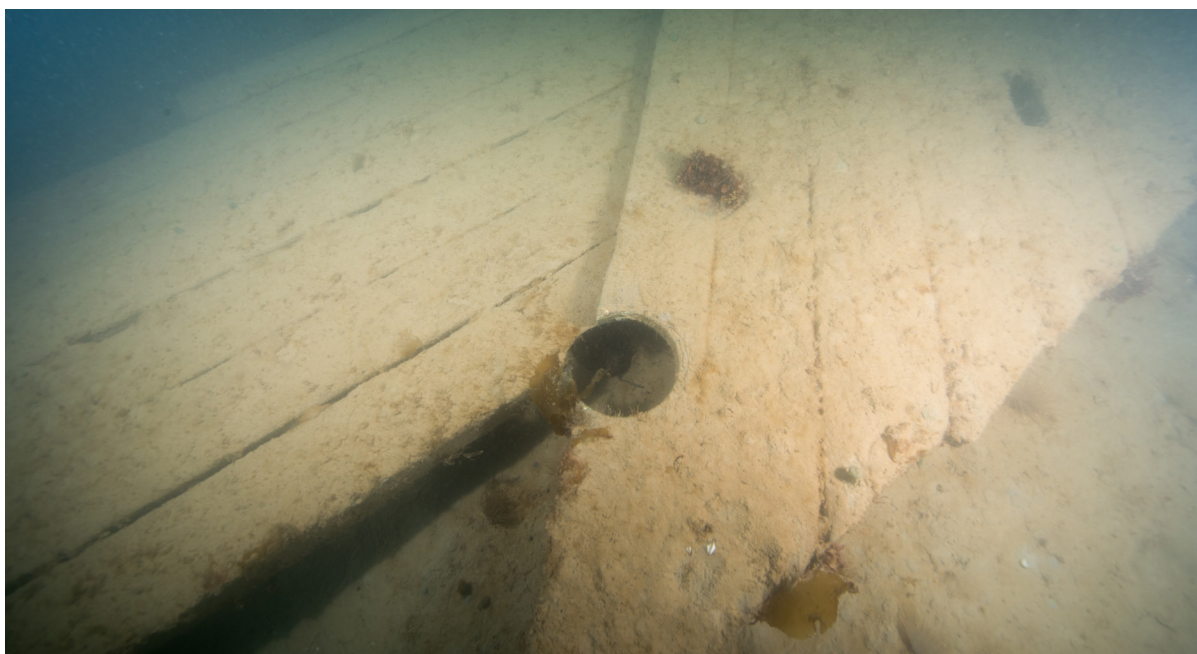
Figure 5.2.2: Detached section of upper decking lying right-side up on the seabed off the port side of the shipwreck. Diagonal planking can be seen, as well as the round opening for an illuminator (centre) and the hole for a rectangular deck prism (top right) (Photo: T. Boyer, Parks Canada; 89M00381EF).

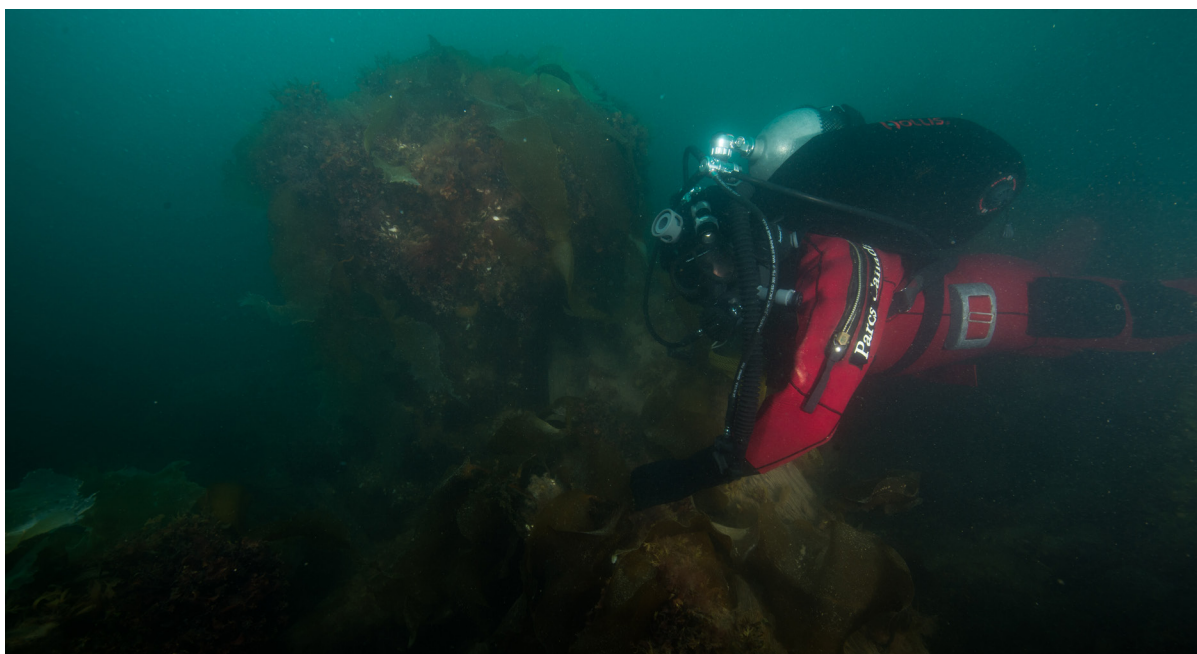
Figure 5.2.3: Capstan covered by marine growth (Photo: T. Boyer, Parks Canada; 89M00633EF).

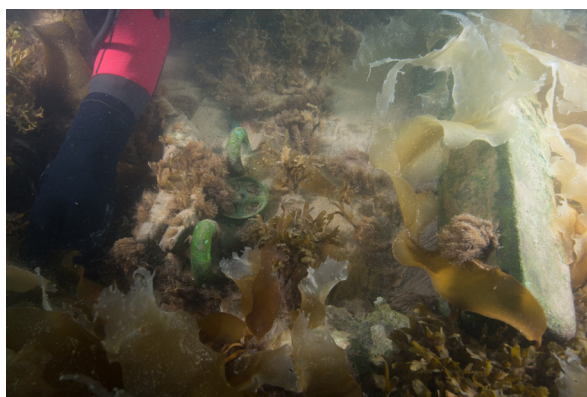
Figure 5.2.4: Copper alloy ring bolts located on the starboard side of the mizzen mast partner and the square heel end of the tiller (Photo: T. Boyer, Parks Canada; 89M00605EF).

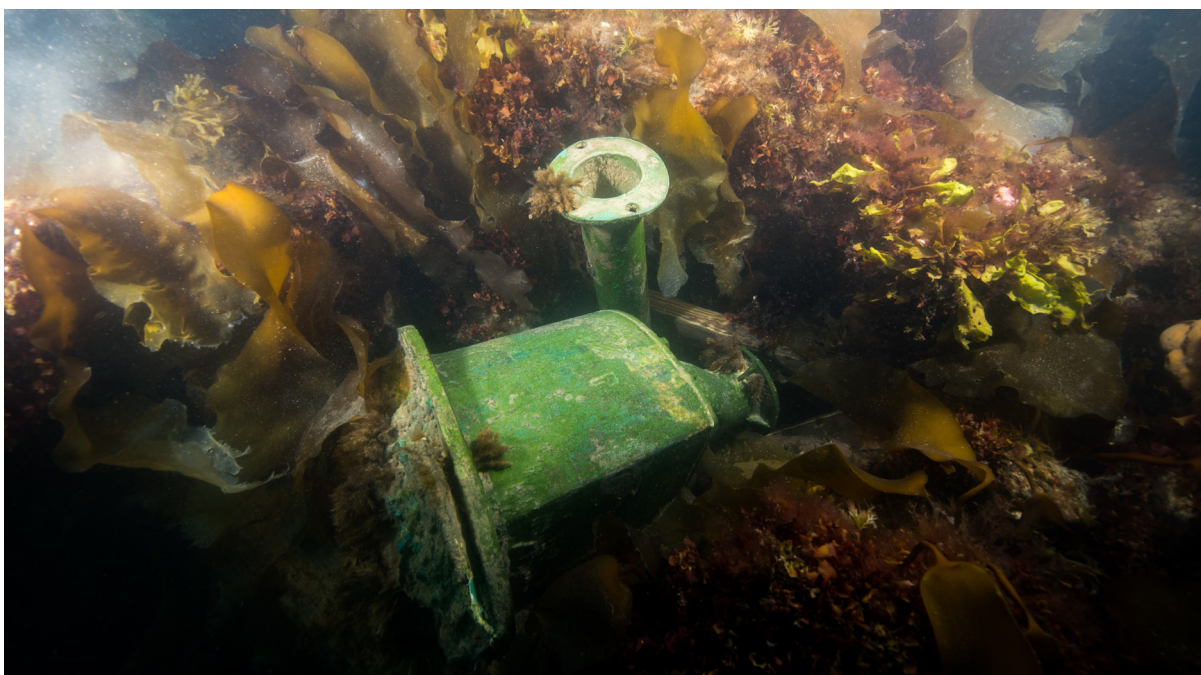
Figure 5.2.5: Partially disarticulated Massey patent bilge pump on the port side of the mainmast atop the wreck (Photo: T. Boyer, Parks Canada; 89M00496EF).

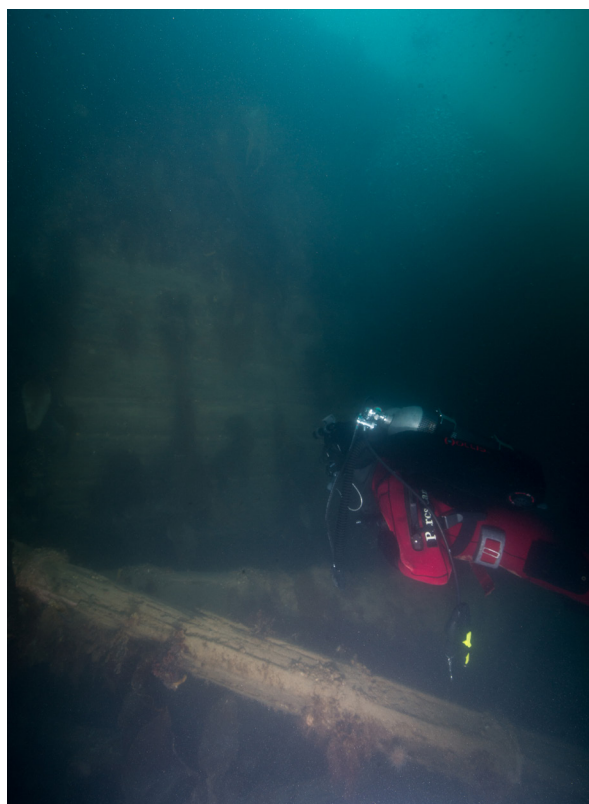
Figure 5.2.6: Starboard side of the wreck with spars (left) lying on the seafloor. The full height of the hull above bottom can be sensed (Photo: T. Boyer, Parks Canada; 89Mo706EF).

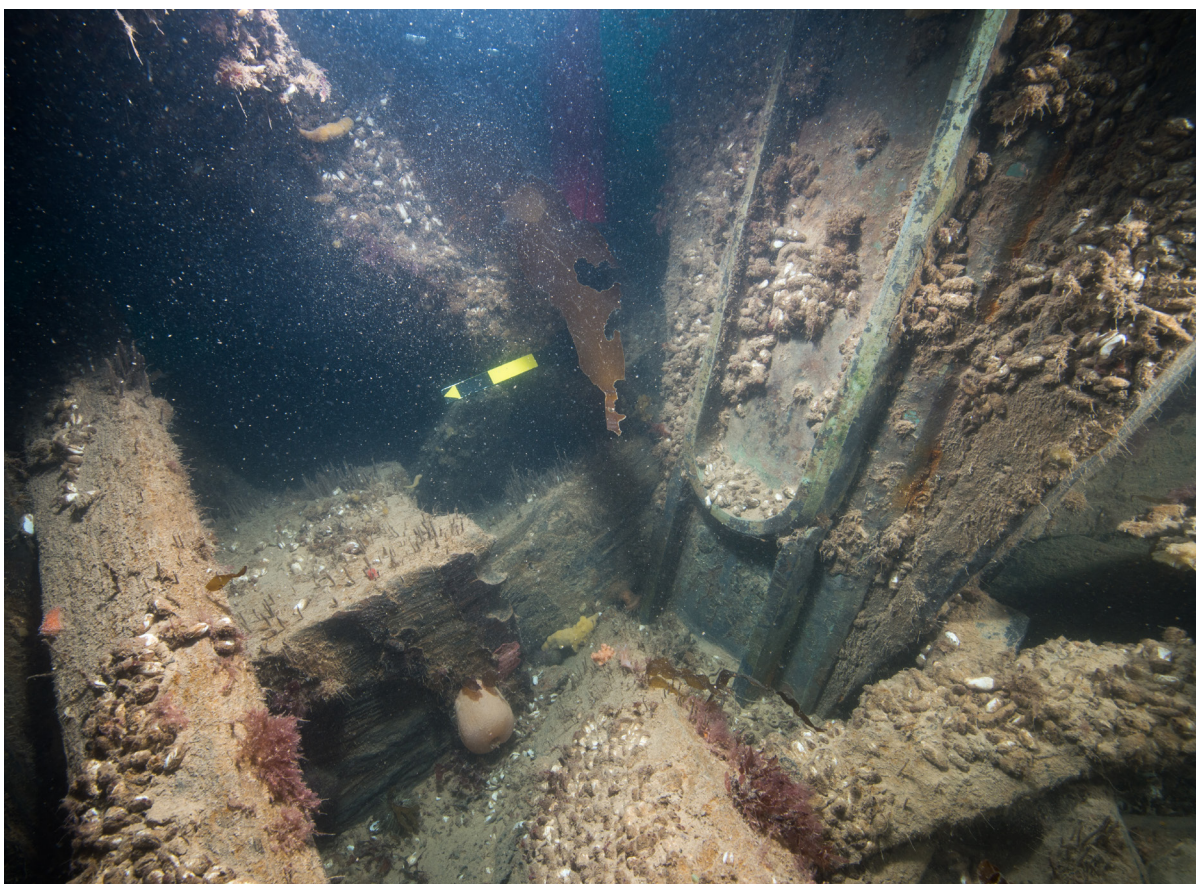
Figure 5.2.8: The end post (right, facing starboard aft) has been displaced from its original location atop the keel. Cast bronze guide rails for lowering and retracting the propeller can be seen on the forward face of the timber (Photo: T. Boyer, Parks Canada; 89Mo592EF).

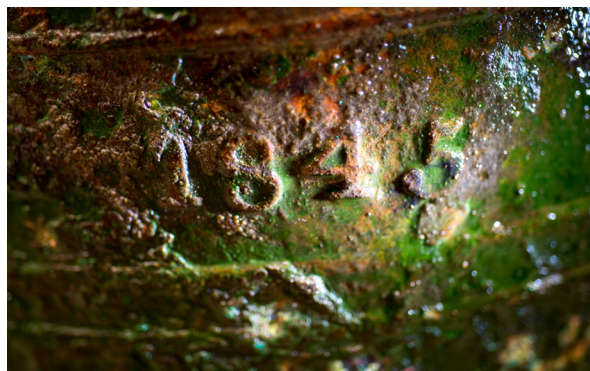
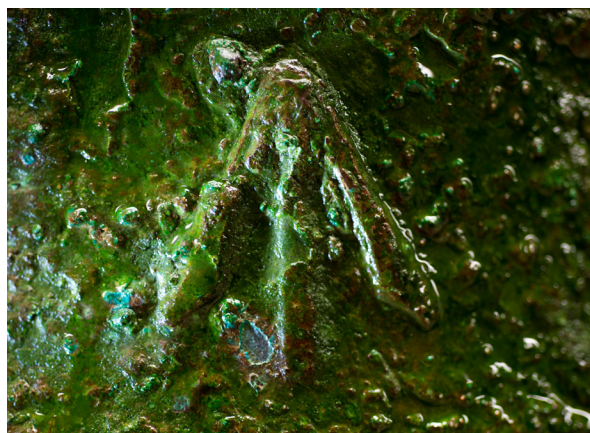
Figure 5.2.10 Detail photos of markings on the bell of *Erebus*: (top) 1845; and broad arrow (bottom). The photos are not at the same scale (Photos: T. Boyer, Parks Canada; 89M00863EF and 89M00871EF).

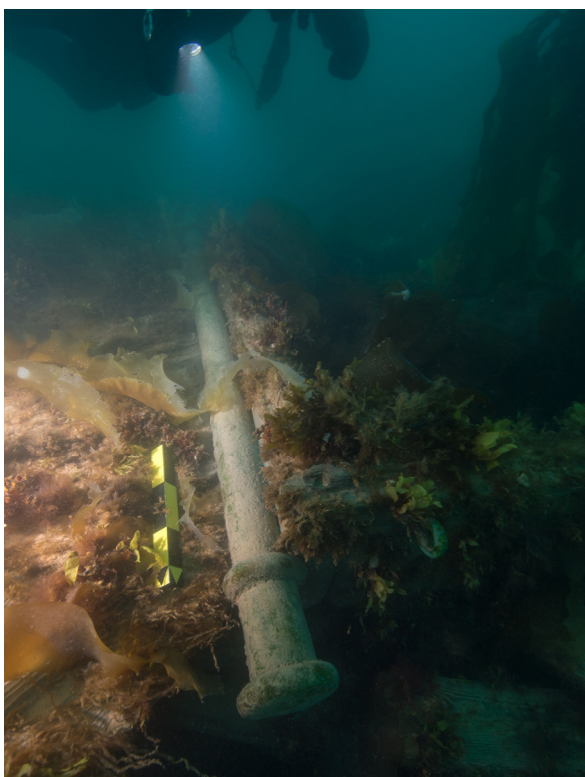
Figure 5.2.12: Head of the tiller on the upper deck (Photo: T. Boyer, Parks Canada; 89M00484EF).

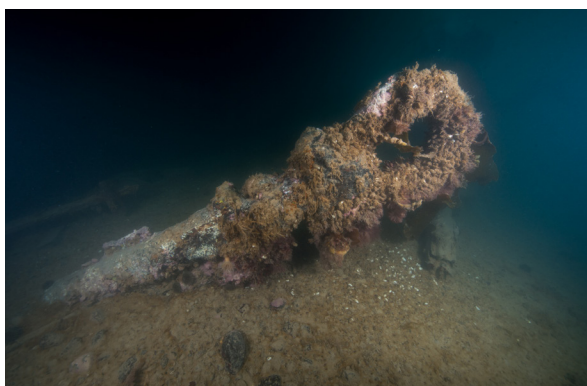
Figure 5.2.14: Anchor lying off the starboard side. The flukes and lower part of the shank are buried leaving only the upper part of the shank and shackle exposed (Photo: T. Boyer, Parks Canada; 89M00696EF).

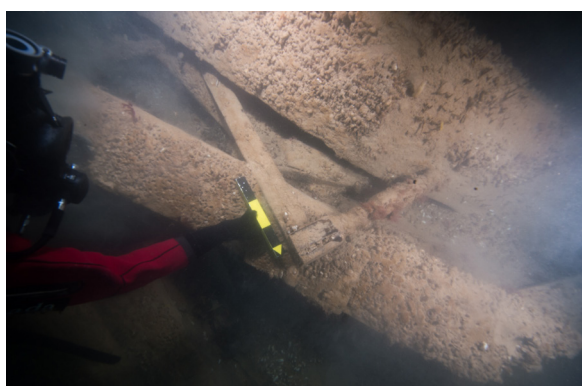
Figure 5.2.15: Turned furniture leg and attached stretcher lying next to the shipwreck off the starboard stern quarter (Photo: T. Boyer, Parks Canada; 89M00740EF).

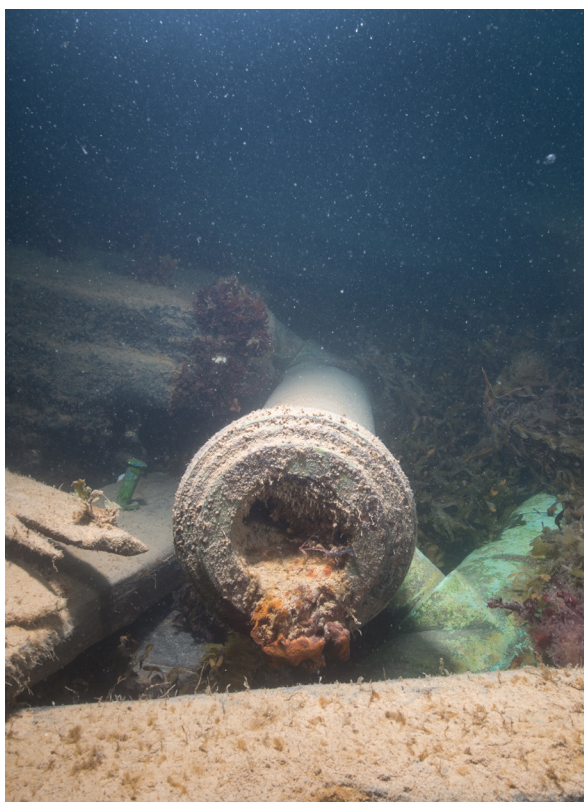
Figure 5.2.17: Muzzle of one of the two bronze cannons lying on the seafloor astern of the wreck. The second cannon lies underneath (Photo: T. Boyer, Parks Canada; 89M00453EF).

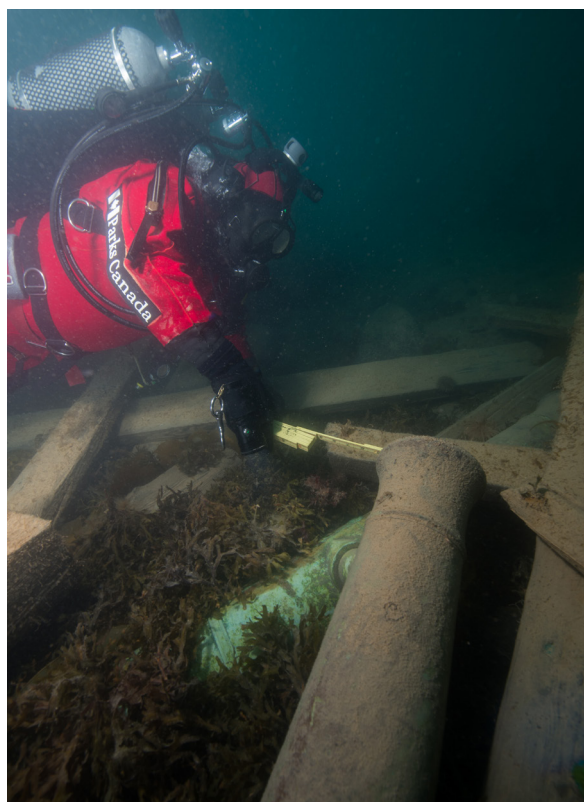
Figure 5.2.18: Underwater archaeologist Filippo Ronca measuring the muzzle bore diameter of one of the two bronze cannons. (Photo: T. Boyer, Parks Canada; 89M00472EF).

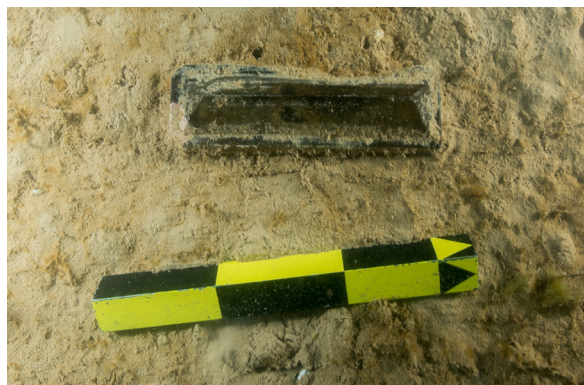
Figure 5.2.19: An elongated pyramid-shaped glass deck prism lying on the dislocated deck section on the port side of the wreck (Photo: Thierry Boyer, Parks Canada; 89M00391EF).

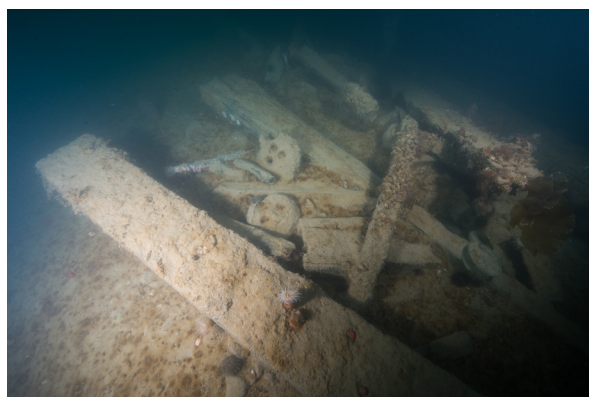
Figure 5.2.20: Rigging elements on the seabed next to the shipwreck. A few deadeyes lie next to chainplates and a copper alloy tackle block (Photo: T. Boyer, Parks Canada; 89M00753EF).
