# Wrecks of HMS Erebus and HMS Terror

National Historic Site of Canada

*HMS Erebus Underwater Archaeological Surveys  
2015 and 2016*

UAT Report: 2017-01

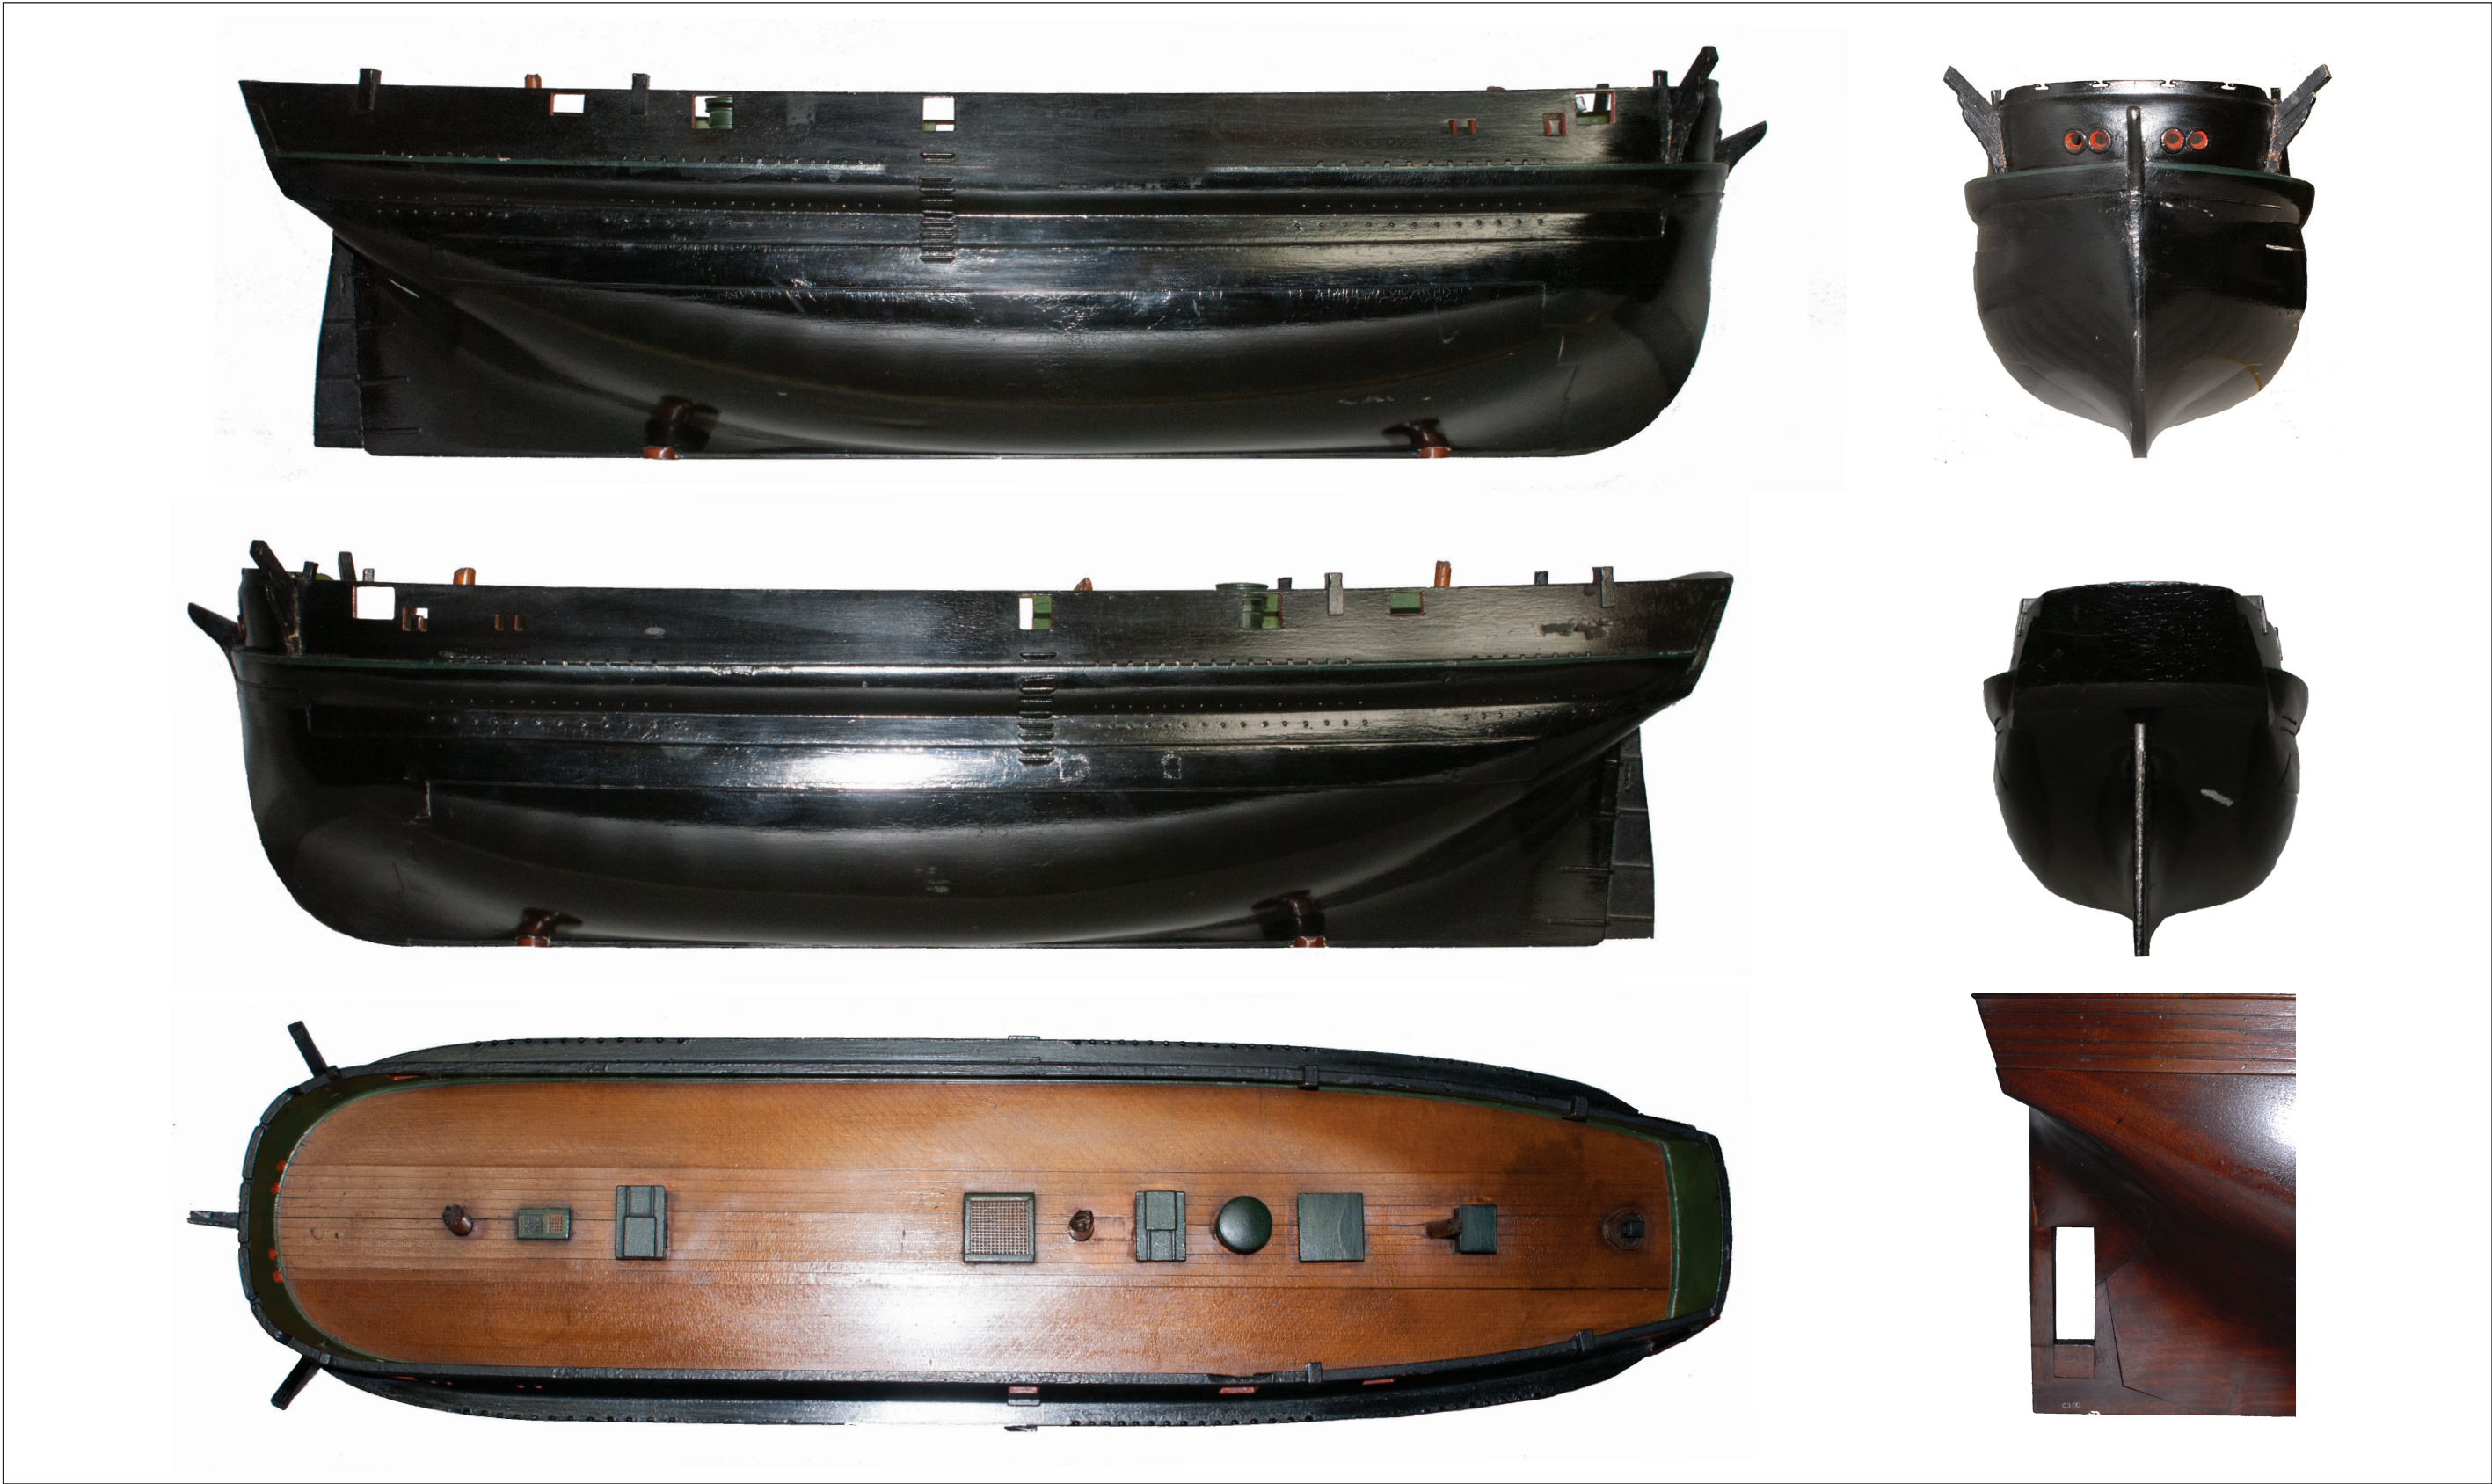
Figure 2.1.9: Compilation of photographs of the 1839 full block model of HMS *Erebus* (SLR0715) and 1845 stern block model of *Erebus* (SLR2253) (bottom right) in the collections of the National Maritime Museum, Greenwich (Photos: J. Moore, Parks Canada).

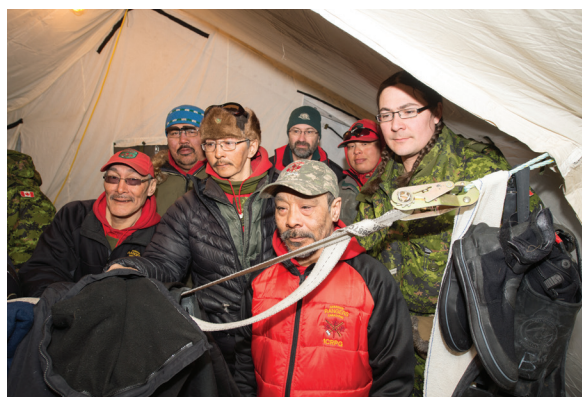
Figure 3.1.3: Team members watch the raising of a cannon from the wreck in April 2015 (Photo: J. Moore, Parks Canada; 89Mo3o73EF)

On April 18, the last day of diving, the principal activity was the raising of a 6-pounder cannon to the ice surface (Figure 3.1.3). Other activities included selected artefact retrieval, equipment recovery, site photos, and installation of a Canadian Hydrographic Service water level recorder. The last dive of this fieldwork episode ended at 16:22 MDT on April 18. Soon break-down and packing of selected camp tents and equipment began, and some Parks Canada staff departed the site. April 19 was devoted to demobilizing and packing gear for a planned LC-130 Hercules flight from the ski-way. The LC-130H arrived at 11:00 and the balance of all UAT staff (and the UAT gear and collected artefacts) flew from the site, arriving at Yellowknife, Northwest Territories, at 15:00 MDT. UAT staff spent April 20 at Yellowknife, sorting gear and preparing for the return to Ottawa. On April 21 UAT members flew from Yellowknife to Ottawa, via Calgary on a commercial carrier with some of the collected artefacts, arriving in Ottawa on the morning of April 22. Parks Canada conservator Flora Davidson remained in Yellowknife to care for some of the larger artefacts, including the cannon, until military air transport to Trenton on April 28. The ice atop and near the wreck of *Erebus* was later cleared of equipment and personnel.

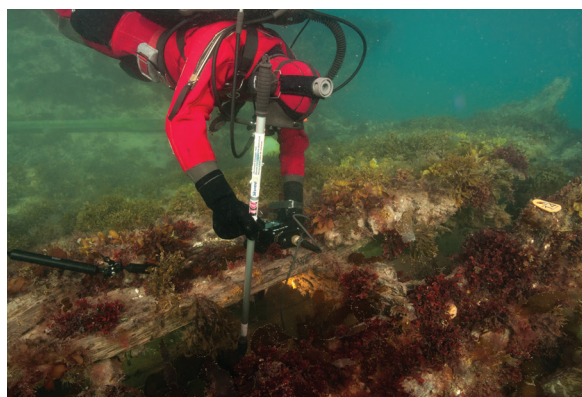
Figure 3.1.8: UAT technician introduces the point of view video camera into an opening in the upper deck at the stern, September 2015 (Photo: M.-A. Bernier, Parks Canada; 89Mo6653EF).

- Mapping and photographic recording of visible in situ artefacts;
- Video imaging of the hull interior (Figure 3.1.8);
- Scouting of future excavation area(s) and potential access points for future interior penetration diving;
- Deployment of ArcticNet current profiler; and
- Visual search of the debris field more than 5 m from the hull for features and artefacts.

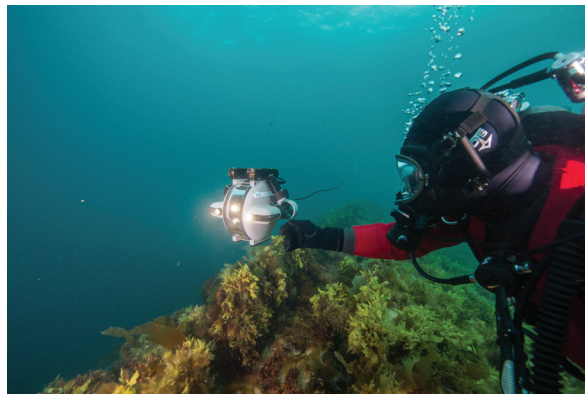
Figure 3.1.10: UAT underwater archaeologist with Deep Trekker ROV above *Erebus*, September 2016 (Photo: T. Boyer, Parks Canada; 89Mo8760EF).

- Ultra-high resolution multi-beam echosounder survey of the wreck and the surrounding debris field; and
- Interior video trial using DeepTrekker ROV (Figure 3.1.10).

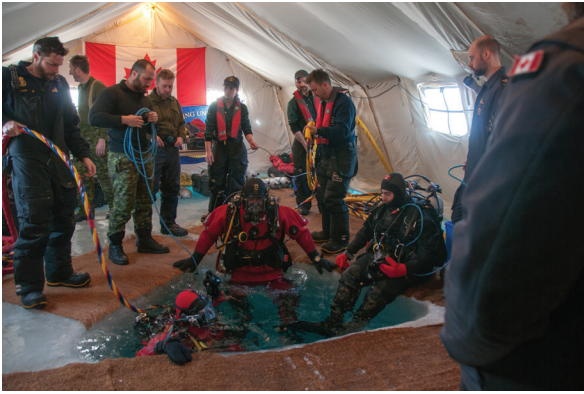
Figure 3.2.3 : Preparations for the Live Dive underway in the *Erebus* diving tent (Photo: J. Boucher, Parks Canada; 89M01840EF).

Two 2-m triangular openings were cut through the ice and tent shelters assembled atop each. All diving was conducted through a hole cut at the port side of the wreck yet a light bronze 6-pounder cannon was raised through a hole at the stern. With the camp directly atop the wreck and with the diving taking place in an a more or less controlled site environment, each dive day could be 12 to 14 hours long. Dives averaged about one hour in duration and from four to six dives were completed per day (Figure 3.2.3).

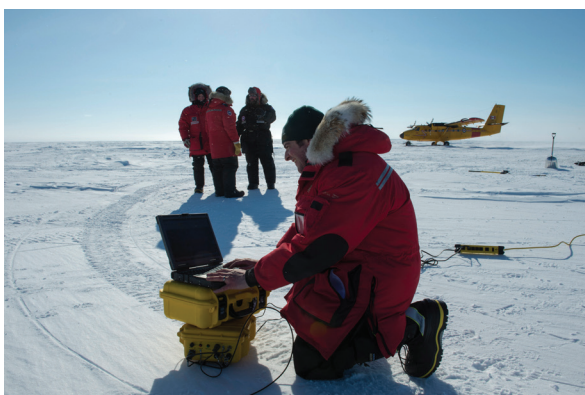
Figure 3.4.1: UAT underwater archaeologist determines an ice hole position at the outset of the April 2015 dives (Photo: P. Reed, Royal Canadian Navy).

Surface positioning for site relocation, navigation, and selected artefact mapping were achieved using two different systems. For positioning the UAT most commonly uses a Novatel Propak-V3-VBS GPS receiver (WAAS enabled) in conjunction with survey navigation softwares SonarWiz 5.0 or Hypack Max 6.2 installed on Panasonic Toughbook computers. Indeed, this configuration was used for the survey operations leading to the discovery of *Erebus*. A similar configuration was used on the ice in April 2015 to position-fix the bow and stern of *Erebus*, as well as two ice holes, relative to a multi-beam echosounder bathymetric model of the wreck site produced by the CHS in September 2014; this model is a georeferenced 3D representation of the wreck with absolute accuracy of 2.5 cm in the x, y, and z axes (Figure 3.4.1).

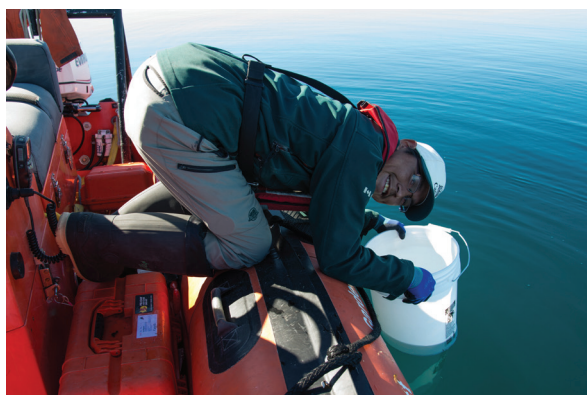
Figure 3.4.5: Parks Canada team member uses an improvised bathyscope to look at the wreck of *Erebus* (Photo: D. Bard, Royal Canadian Navy; 89Mo7166EF).

the vantage point of the Hurricane 472 in particular during Legs 1 and 2 in August-September 2015. Given the relatively shallow seafloor depth and excellent visibility, combined with periods of flat-calm surface conditions coinciding with sunny days, it was possible to locate large debris items and artefacts on the seafloor both with the naked eye and with bathyscopes (Figure 3.4.5). This simple survey method was surprisingly successful and led to the discovery of a second propeller (89M100A1-1) with some nearby finds, 43 m north of *Erebus*' bow, and part of the ship's wheel (89M100A1-1), 29 m to the south of the bow. In both instances, these isolated finds were plotted using a Trimble Yuma 2 GPSmap unit. The propeller and nearby finds were also photographed from the surface. Closer in to the hull, out to a distance of 8-10 m, the site has been recorded in geomatic terms by photogrammetry, side-scan sonar and multi-beam echosounder. Both in situ artefacts and artefacts raised from the seafloor debris field were positioned using perpendicular offsets from the primary baseline. The locations of some debris field features have been sketch mapped by UAT archaeologist within fieldnotes pending more formal mapping.

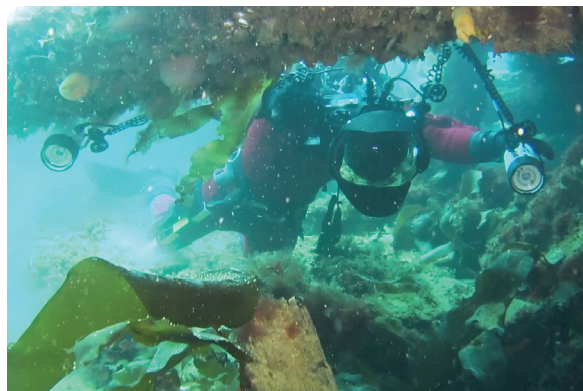
Figure 3.5.1: UAT underwater archaeologist takes photographs under the upper deck (Video Still: R. Harris, Parks Canada; 89M2016R003\_2114).

D4 with a 14-24 mm lens, and the spare system was a Nikon D300s with a fixed 14 mm lens. Both cameras were used in Aquatica housings, each of which was equipped with a glass dome and two Ikelite DS161 strobes for artificial lighting (Figure 3.5.1). For high definition video, the primary camera was a Sony PMW-F55 UHD camera, with Raw 4K recorder, a Duclos 11-16 mm PL-mount lens in a Gates housing, and four Keldan Luna-4X lights (6,000 lumens each). This camera system is of professional film production quality, with complete manual controls, and allows for simultaneous recording in Raw 4K (ideal for colour correction and film production) at the same time as compressed HD (advantageous for both simple review and export to the Web). The UAT also used a Panasonic HVX-200p video camera in a Gates housing with two Keldan Luna-8 lights (6,000 lumens each). In April 2015, surface powered Orcalight Seawolf underwater lights were installed to serve as a chandelier (using ice-screws the fix them under the ice) to illuminate the wreck site, given that natural light was partially blocked by the thick ice and tents above. Whereas this chandelier system generated about 88,000 lumens in total, there was seldom more than 2.5 m horizontal underwater visibility, thereby reducing the number of high-quality photographs that could be used to generate completely satisfactory photogrammetric models.

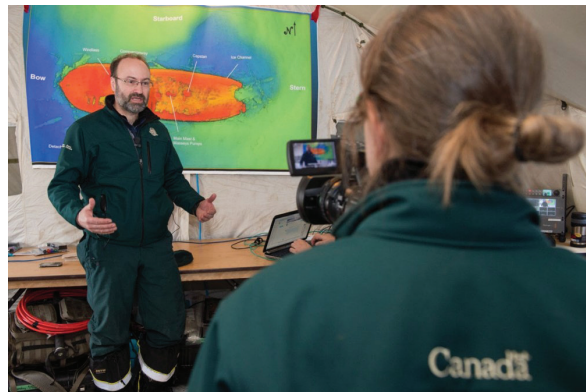
Figure 3.5.2: Live Dive broadcast underway in April 2015 (Photo: P. Reed, Royal Canadian Navy).

An important component of the April 2015 project was the “Live Dive”, a live audio-video link between the site in Queen Maud Gulf and the ROM in Toronto, Ontario (Figure 3.5.2). The original intent was to have a three-way link between an archaeologist diving on *Erebus*, another archaeologist on the ice's surface and a school group of seventh-grade students in an auditorium in the ROM. The full three-way live link could not be completed as planned because of ice-camp tent positioning and the technology available. Whereas the students could not talk directly to the archaeologist underwater, they were still able to hear and see the live tour of the shipwreck from Ryan Harris. Questions were answered by Marc-André Bernier located in a tent a few meters from the dive tent.

In order to generate the link (as undertaken) between the underwater archaeologist diving on the shipwreck and the museum in Toronto, a number of complementary technologies had to be used in concert. First, the audio from the speaking archaeologist underwater had to be mixed to the video, and to do so, an audio line was run from

the microphone in the diver's full-face mask to the camera underwater. To send this now mixed audio-video feed to the surface, a fibre optic cable was chosen for its reliability and quality. To achieve this, an HD-SDI-to-fibre-optic converter was installed in the Sony F55 Gates housing and a 152-m (500 ft.) fibre-optic cable was coiled into the videographer's (Thierry Boyer) umbilical to link the camera to the surface. In the ice camp, the signal was converted back into a HD-SDI signal and run into a video editing station, where it could be either mixed with or used in parallel with a surface image of Marc-André Bernier narrating the images while the diver and camera operator were changing stations. The selected or mixed signal was then converted into an Ethernet signal using a Teradek Cube converter and transmitted via the Internet using a Galaxy Scout satellite antenna and a Skydata system.

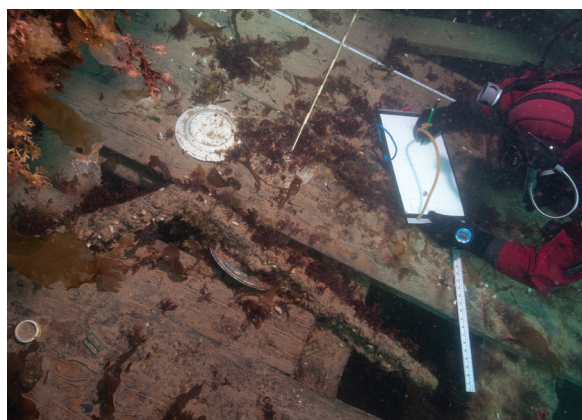
Figure 3.6.1: UAT underwater archaeologist records a plate and other artefacts on the lower deck (Photo: M.- A. Bernier, Parks Canada; 89M06611EF).

Artefact positioning on the seafloor was achieved using the primary baseline established to the south of the site. For artefacts on the lower deck inside the vessel, positioning was achieved relative to upper deck beams and deck planking and other discrete features (Figure 3.6.1). For a few obscured artefacts at the stern, namely the two cannon and a furniture leg, both the baseline offset method and DSM were employed relative to

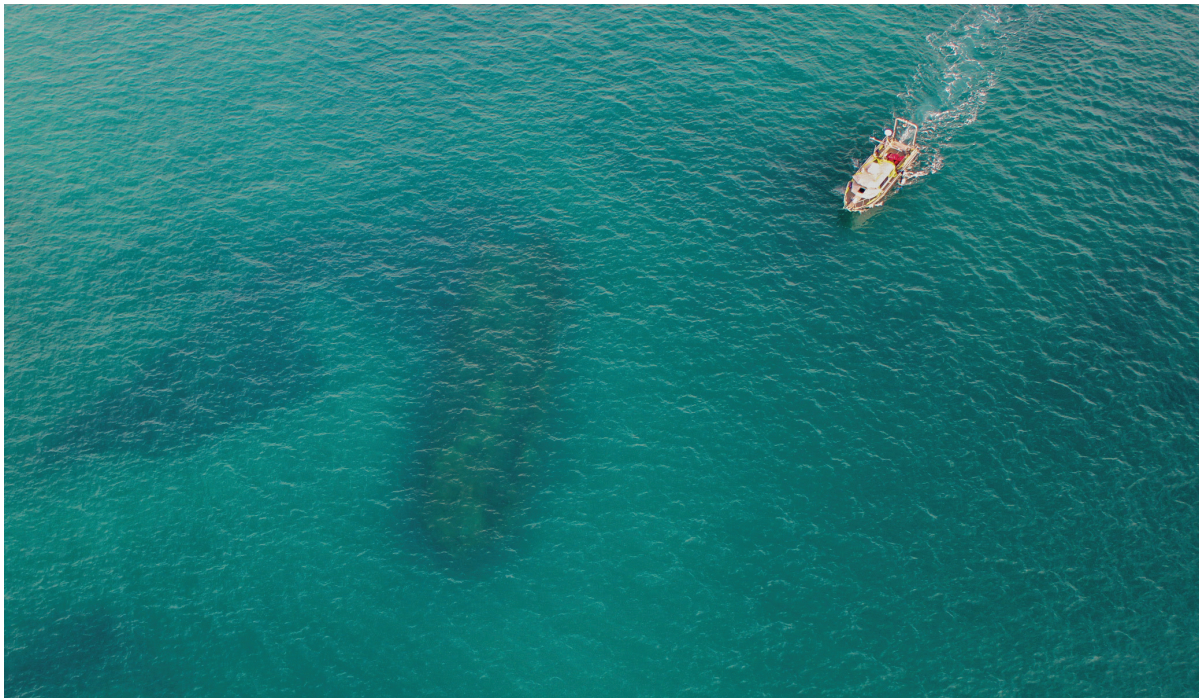
Figure 3.9.1: RV *Investigator* approaches *Erebus* during the 2016 MBES survey (Photo: D. Stenton, Government of Nunavut; 89Mo8853EF).

A pole-mounted R2Sonic (MBES) system, model 2024 was deployed from RV *Investigator* in 2016 (Figure 3.9.1). This MBES system offers variable 200-400 kHz frequency selection, with a high resolution imaging capacity at 700 kHz. Indeed, all MBES surveying was conducted at 700 kHz. Correction for localised variations in the ambient speed of sound in water was achieved by an AML Micro.X direct measurement sound velocity probe that was secured to the faring of the multi-beam head. Sound velocity profiles characterising the full depth of the water column were also periodically collected by periodic deployment of an AML MinosX direct measurement sound velocity profiler. Bathymetry was also corrected for diurnal tide fluctuation and differential positioning using a Novatel Propak-V3-VBS shore-based GPS reference station situated on a nearby island.

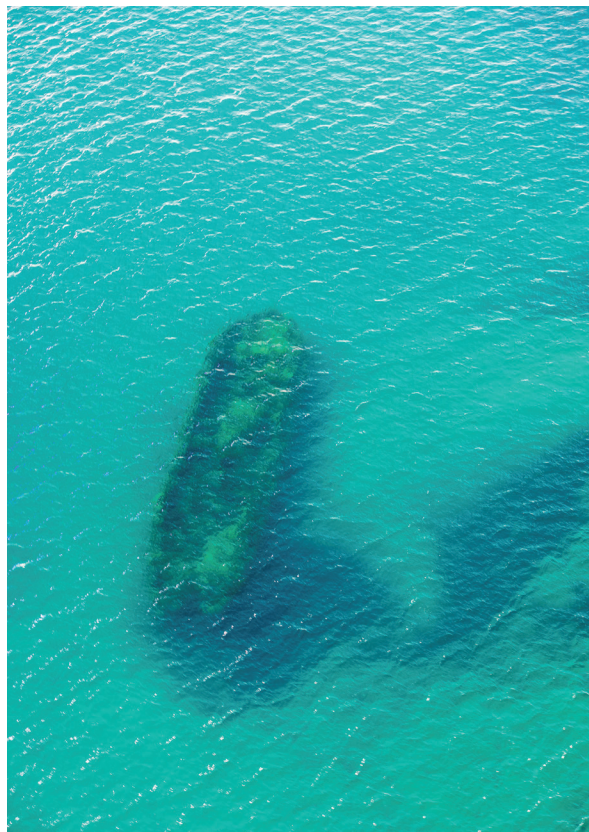
Figure 4.2.1: *Erebus* from the air facing west, August 2015. The stern is in the foreground (Photo: T. Boyer, Parks Canada; 89Mo3937EF).

Based on available data, the *Erebus* is flanked on its north and east sides by shoals (Figure 4.2.1). The nearest shoal is due north from the wreck at a distance of approximately 100 m. In general the seafloor at the wreck slopes from northeast (shallower) to southwest (deeper) (Figures 4.2.1 and 4.2.2). The exception to this trend is a sizable and irregular-shaped scour pocket off the stern that extends forward along the port side and also wraps around the starboard quarter; this pocket is up to 20 m wide and as much as 1.5 m deeper than the flanking seafloor. The stern scour pocket is clearly discernible underwater by divers under good visibility conditions, especially given that it has a steeply sloping edge in places. As well, there is noticeable scouring along the turn of the bilge of both sides of the hull.

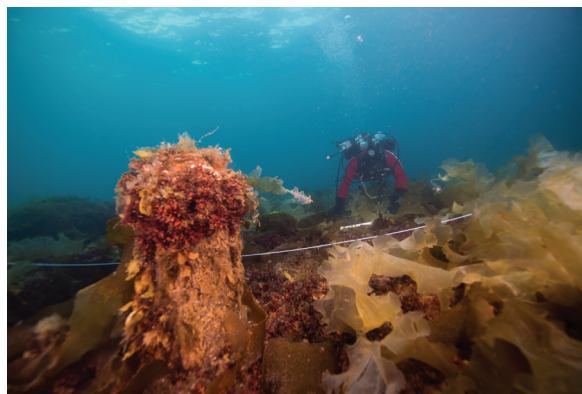
Figure 4.4.1: UAT underwater archaeologist collects biological samples on the upper deck of *Erebus* (Photo: T. Boyer, Parks Canada; 89M03501EF).

All told, 20 algae species and 71 invertebrate species were identified (Ménard et al. 2015), bearing in mind that a study of the interior-dwelling species has not yet been completed (Figures 4.4.1 and 4.4.2). As well, UAT archaeologists observed several as yet formally unidentified fish species on the site, including small cod (*Gadidae*). Individual bearded seals (*Erignathus barbatus*) regularly visited the site. At the time of writing work continues on the study of the marine biology of the *Erebus* site.

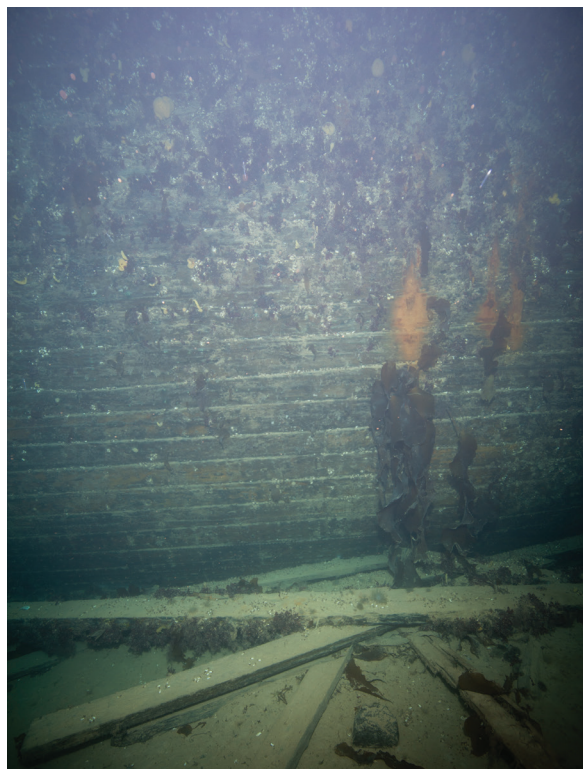
Figure 5.1.1: Port side of the *Erebus*' hull showing outer (doubled) planking (Photo: T. Boyer, Parks Canada; 89Mo1964EF).

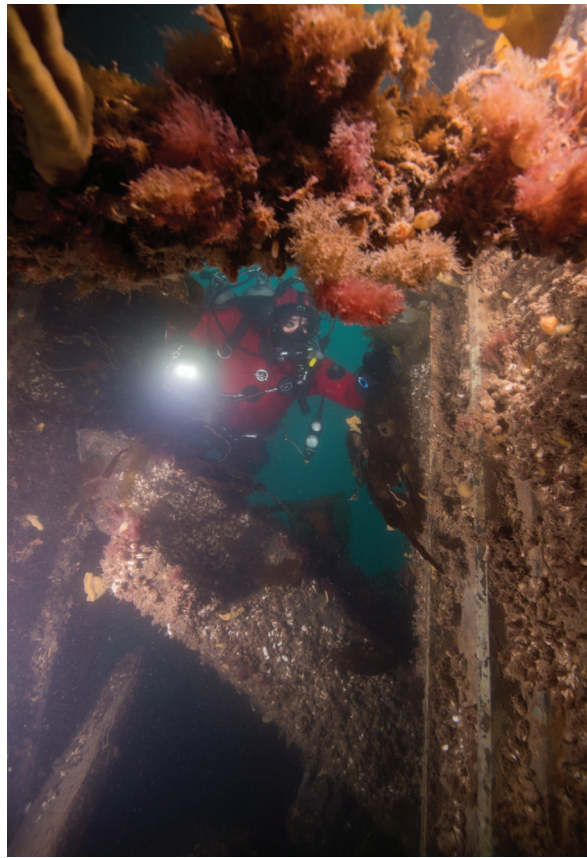
Figure 5.1.2: UAT underwater archaeologist inspects the propeller well of *Erebus*, including one of the tracks that guided the propeller into position (Photo: T. Boyer, Parks Canada; 89Moo437EF).

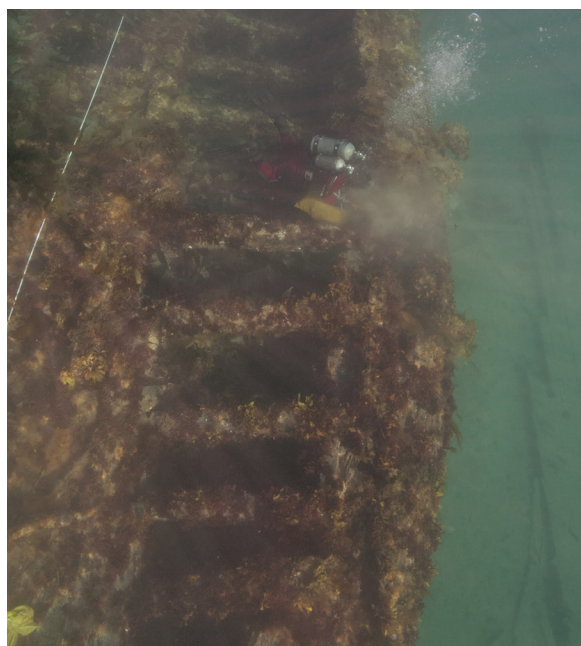
Figure 5.2.3: Port-side deck beams partially collapsed onto the lower deck in the forward section of the wreck (Photo: M.-A. Bernier, Parks Canada; 89M04259EF).

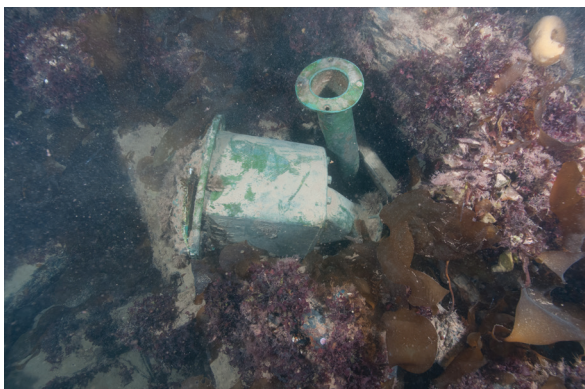
Figure 5.2.5: Copper alloy Massey pump tube and pump head on the port side of the main mast stump (Photo: C. Dagneau, Parks Canada; 89Mo2707EF).

The port side pump head with its associated double action pump tubes are highly distinctive copper alloy features in this area (Figure 5.2.5). The same pump elements are present on the starboard side of the mast, although they are mostly obscured by wooden debris and marine life. It is also worth mentioning that whereas the starboard pump head was clearly visible in April 2015, it was not apparent a few months later in September 2015. This observation illustrates that the site is more dynamic than at first appreciated, as shown by artefact movements on the lower deck induced by a storm in September 2015 (see Section 5.3). Based on the 1839 ship plans, two warping heads were certainly located in this area, just aft of the

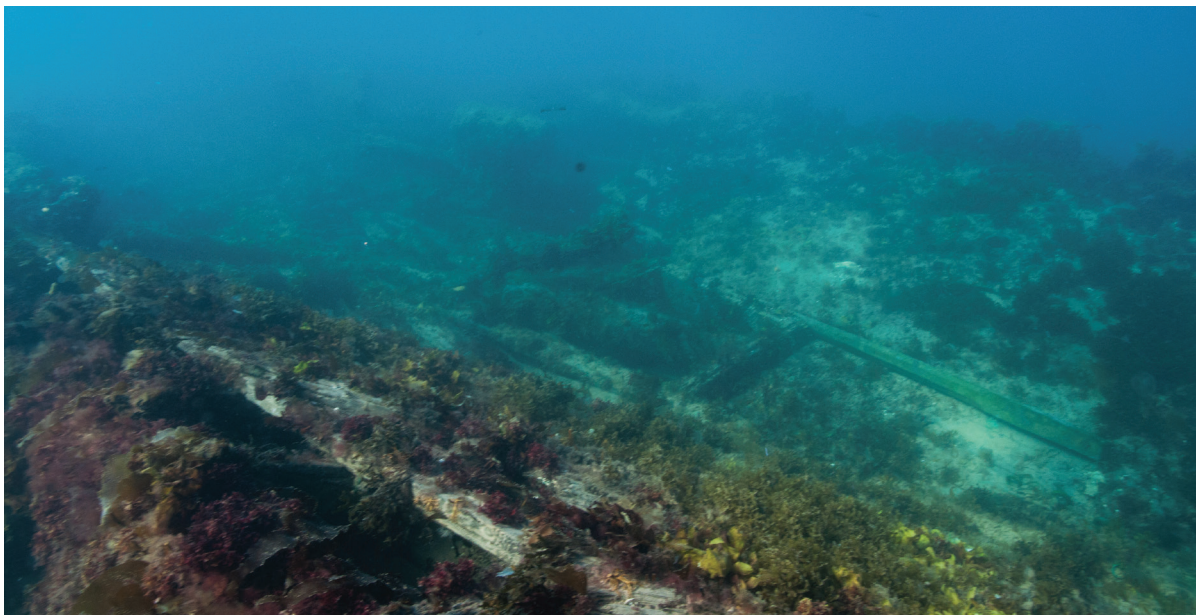
Figure 5.2.6: *Erebus* upper deck near the stern, facing starboard (Photo: M.-A. Bernier, Parks Canada; 89Mo5485EF).

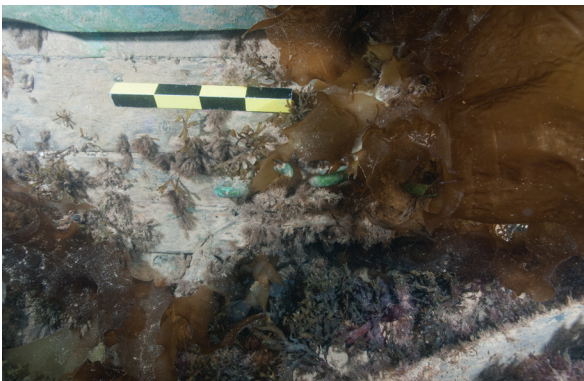
Figure 5.2.7: Brass staple cleats adjacent to the mizzen mast hole (Photo: C. Dagneau, Parks Canada; 89Mo2744EF).

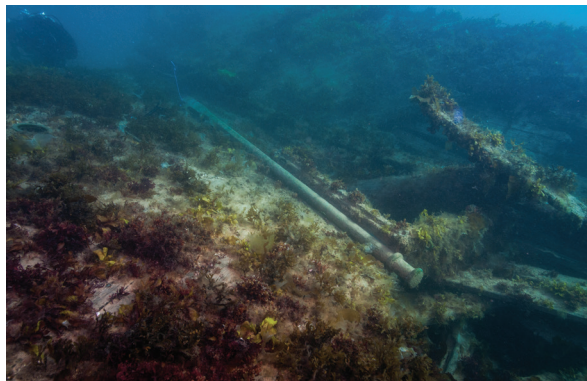
Figure 5.2.9: Tiller on the upper deck near the stern (Photo: M.-A. Bernier, Parks Canada; 89Mo6675EF).

possibly where it was stored before the ship was abandoned, or at a point it came to rest when the stern collapsed. The object is a 3.65 m-long solid brass artefact, made in three different sections. The tiller or fore end, fitted with a double pommeleon for attaching the steering rig, is circular in cross section (diameter 9.0-10.2 cm). The midsection is octagonal in section (diameter 11.3 cm) and the aft section is square in section (10.5 cm sided) (Figure 5.2.9).

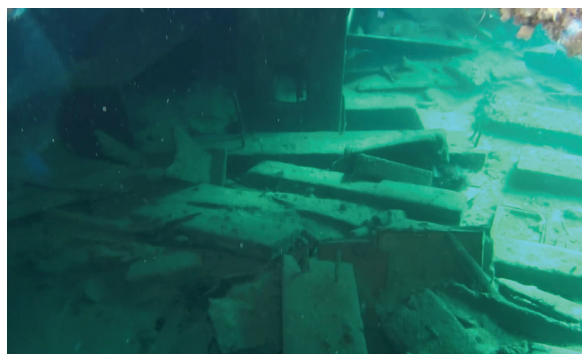
Figure 5.3.1: View of the “Sick Berth”, facing aft, with the bowsprit step in the middle (Video Still: R. Harris, Parks Canada; 89M2016R003\_1449).

debris and silt on the lower deck, to the extent that its surface is obscured (Figure 5.3.1). This debris includes some upper deck planking with copper alloy dumps still articulated. Interior partitions, as shown in the lower deck plan (*Terror and Erebus, Plan of Upper Deck (as Fitted) 1839*) (see Figure 2.1.7) have either collapsed completely or partially, with the cupboard spaces around the main mast partly in place. There is minimal vegetation growth save for the undersides of the upper deck beams and planking. Current-borne sediments have accumulated on horizontal surfaces such as shelves along the starboard side of the hull and on the deck itself. The inner plank lining of this space is preserved on the starboard side; some of this planking bears preserved white paint.

From the vantage point of the bowsprit partner, the bowsprit step (with mortise and reinforcing timbers) is clearly visible. It appears to have reinforcing timbers that secure it to the upper deck beams. At the point where the step passes down through the lower deck there is at least one small opening (scuttle) that presumably opened to the “Store Room” one deck below. Near to the step, on the starboard side, are two seaman’s chests and a wooden bench resting on their sides. On the port side of the space, adjacent to the bowsprit partner, is a copper alloy pipe that stands vertically and passes up through the upper deck. Its heel at the lower deck level is not visible. It appears to have been wrapped by cordage and fabric. Its function is not known as it does not appear in any contemporary ship plans. A cast metal object, possibly a stove part, rests nearby and this could be related to the pipe, which might be a chimney. Another notable feature in the Sick Berth is a thick copper-alloy sheet with a shaped, projecting corner. Parts of the sheet are buried by silt and its function is unknown. Others include a case bottle with attached metal cap, and a belaying pin. Overall the

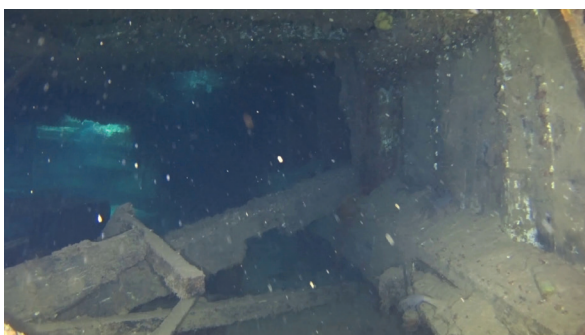
Figure 5.3.5: Forward end of the starboard side of the forecastle, facing the bow. This part of the forecastle is underneath an in situ part of the upper deck. The shelf piece to which the seaman's tables were affixed is visible at the bottom right (Video Still: R. Harris, Parks Canada; 89M2016R003\_10921).

vertical and horizontal partition planks still partly in situ (particularly on the starboard side), which likely represent cupboards with shelves that flanked the foremast. The forward ladder-way leading to the orlop deck below is also filled with wooden debris. There is minimal vegetation growth save for the undersides of the upper deck beams and planking in this area. Interior video obtained via the fore hatch and two different openings on the starboard side also show a door frame, piles of wooden cask staves, many deck planks and broken furniture or bulkhead components. An upright seaman's chest, without its hinged lids, is in this lot, close to the in situ, port-side bilge pump tube (see Figure 5.3.2). In 2016 close-up views inside the chest revealed silt-covered contents in both of its compartments, probably including textile (see Figure 7.5.1). Interior video recording of the starboard side of this zone under the articulated upper deck revealed what appear to be at least three outboard mounts for mess tables, affixed to a longitudinal shelf piece (Figures 5.3.2 and 5.3.5). These mounting positions are clearly

depicted in the lower deck plan of *Erebus* (*Terror and Erebus, Plan of Lower Deck (as Fitted)* 1839) (see Figures 5.3.3 and 5.3.4). In addition, what could be the broken inboard end of a mess table is amidst wooden debris.

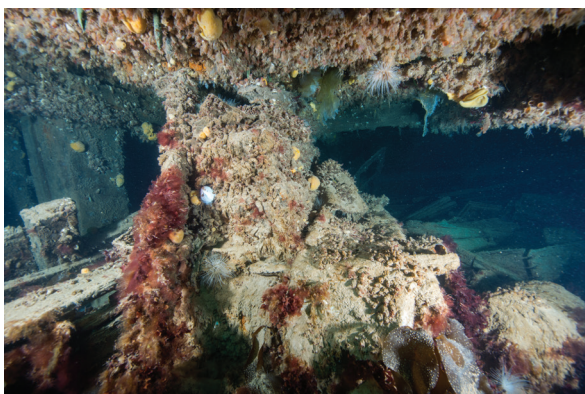
Figure 5.3.6: Port side of the galley stove (Photo: T. Boyer, Parks Canada; 89Mo863oEF).

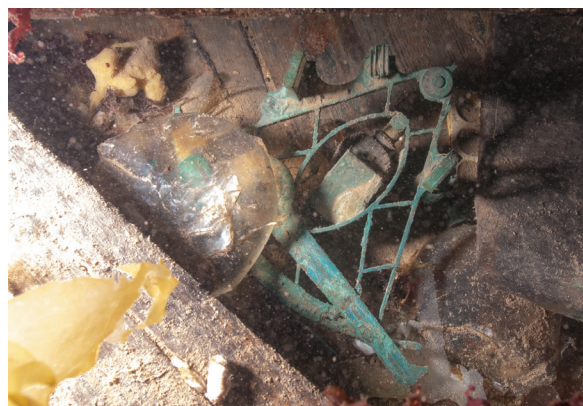
Figure 5.3.9: Sextant and two glass hemispheres in sub-operation 36J (Photo: M.-A. Bernier, Parks Canada; 89Mo6631EF).

situ (see Figure 5.3.8). Further examination, removal of overlying timbers and excavation will ultimately be required to better understand the extant features and artefact potential. Indeed, few artefacts were observed on the surface in this zone, except for several unidentified copper-alloy rings near a bed place. Farther forward however, a cluster of artefacts associated with officers were both observed and recovered. A notable find (not recovered) was a sextant found in sub-operation 36J, in an area corresponding to the cabins of the Mate and First Mate in the 1839 lower deck plan of *Erebus* (Figure 5.3.9).

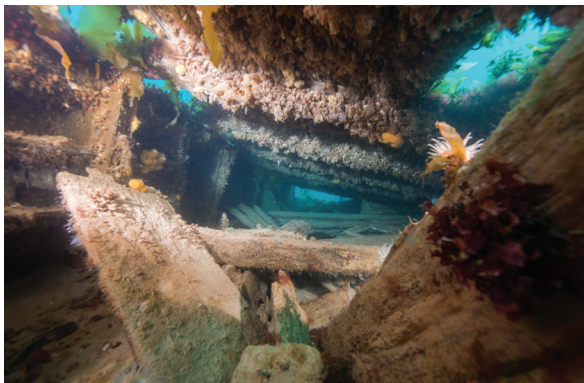
Figure 5.3.11: View looking aft along the starboard side of the hull (from sub-operation 40M) along the range of officers' cabins (Photo: T. Boyer, Parks Canada; 89Mo8736EF).

Upon the removal of kelp growth, in 2015 it became possible to look under the upper deck at the stern from sub-operation 40M clear aft through to sub-operation 52M (Figure 5.3.11). From this vantage point, collapsed timbers and deck beams were clearly visible, as were fitted shelves along the interior starboard side of the hull side, akin to those shown in the *Illustrated London News* picture of Fitzjames' cabin and the 1839 lower deck plan. One of these shelves is boxed, in that it has a vertical plank to retain its contents. As well there are the parts of vertical cabin walls where they meet the interior of the starboard hull.

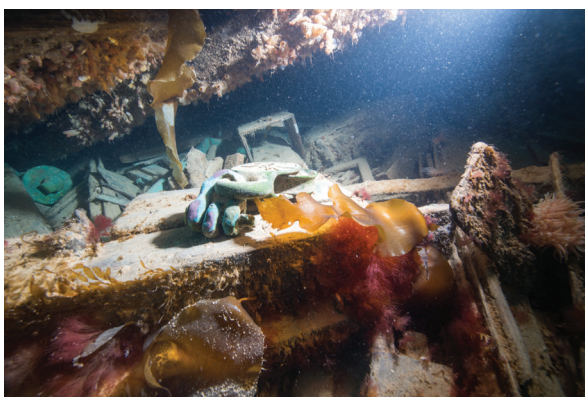
Figure 5.3.12: View looking into Franklin's cabin, facing the bow, at sub-operation 52M. Note the breech of the small gun at the top left (Photo: T. Boyer, Parks Canada; 89Mo8736EF).

Much of the interior of the surviving Captain's Cabin, officers' cabins, Ward Room and Gun Room farther forward can also be viewed from the vantage point of sub-operation 52M (Figure 5.3.12). Looking forward from here, collapsed deck beams, planks and furniture are visible, most of which is blanketed with some silt and plant and animal life. In places along the starboard side, fitted fore-aft planking and vertical trim that overlies the hull framing are in situ as is possible white paint on selected surfaces. A reinforcing feature of the hull is visible in this area, one that is described by Rice (Ross 1847:328):

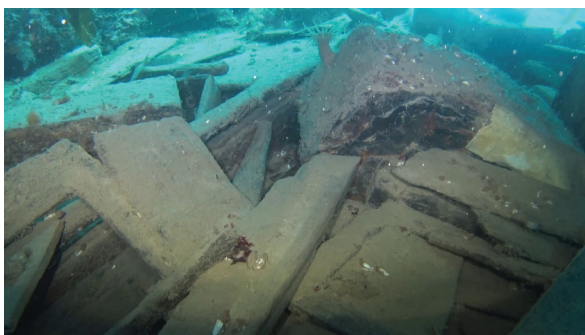
Figure 5.3.13: Inside view of Franklin's stern cabin from 2016 ROV video, showing a possible heating stove at top right (Video Still: R. Harris, Parks Canada; 89M2016R003\_5644).

An ROV was flown into the starboard-side void under the collapsed upper deck, in the zone corresponding to the Captain's Cabin, Captain's Bed Cabin, part of the Ward Room and Surgeon's Cabin (Figure 5.3.13). The ROV captured excellent images of features and artefacts in this zone: the small gun first observed in April 2015; masses of collapsed fitted furniture; cabin planking; a five-pane skylight window frame (with in situ mullions

but no glass panes visible) that corresponds with the five-pane skylight over the Ward Room as shown in the profile plan of *Erebus* (*Terror and Erebus*, Profile (as Fitted) 1839); collapsed fitted cabin paneling; paint on cabin interior planking; a possible door frame or skylight frame without mullions; an overturned heating stove, which is most likely the stove in Franklin's cabin shown in a May 1845 *Illustrated London News* article (see Figure 5.3.10); lead sheet draped over the stove; a large-diameter copper-alloy tube, possibly associated with the stove; a second possible stove; and importantly, the presumed bed places in the Surgeon's cabin and Captain's Cabins, as well as "Lockers" in the Captain's Cabin that are in situ and intact.

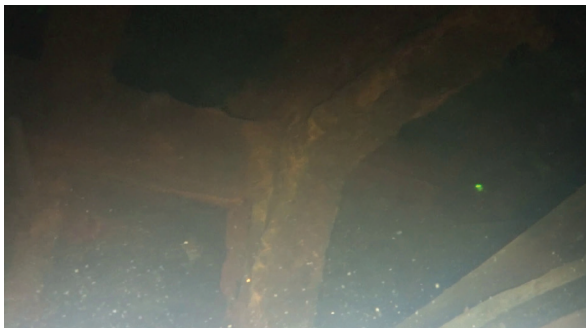
Figure 5.4.1: Underside of the lower deck as viewed from the "Bread Room" in the orlop deck (Video Still: R. Harris, Parks Canada; 89M2016R003\_12628).

A pole-mounted video camera recorded down through the fore hatch both at upper deck level (sub-operations 28L/30L) and at the lower deck level; these two hatches are superimposed but at lower deck level the vertical path is obscured by debris. The camera reached the "Bread Room" in *Erebus*' fore hold, as depicted on the 1839 orlop and hold deck plan (*Terror and Erebus, Plan of Orlop and Hold. (as fitted).* 1839). This revealed deck beams, iron knees, possible carlings, the insides of hatch coamings, stanchions, and possible horizontal and vertical supports for partitions (Figure 5.4.1). There are some fallen or partly fallen wooden partitions in the field of view. The orlop deck itself was not imaged. The area corresponding to the Bread Room and the passageway connecting the Bread Room with the Carpenter's and Boatswain's Stores in the bow was also investigated by ROV. The passageway partition walls, comprised of wooden stanchions and horizontal tongue and groove planking, have partly collapsed. The stanchions and the header and footer

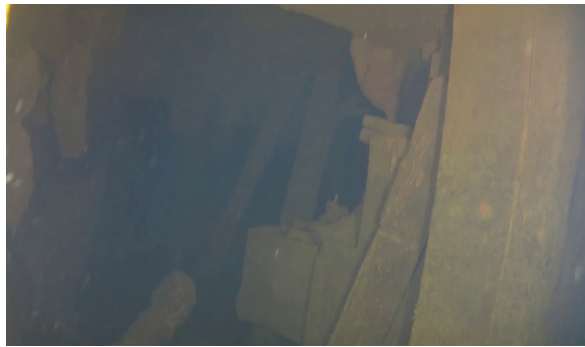
Figure 5.4.2: View into the "Carpenter's Storeroom" (Video Still: R. Harris, Parks Canada; 89M2016R003\_13213).

Most of the imagery was of the port side of the Bread Room and the central passageway. Sizeable "rusticles" extend downwards from the undersides of the lower deck structure, and much fine silt blankets the orlop deck itself, debris and other visible features. Imagery revealed views of the following features: a tapered hatch ladder situated in the starboard aft corner of the hatch leading from the lower deck to the orlop; the port-side hull interior and underside of the lower deck showing deck beams, the beam shelf and at least one iron hanging knee articulated to a beam; at least one lower deck beam stanchion; the aft face of the forward watertight bulkhead with caulked diagonal planking; one (possibly two) compartmented shelf or crate with silt accumulated on it yet with some unidentified contents visible; and a splayed cask. Interestingly, the ROV also revealed several as yet unidentified and sizeable wooden hoops on the port side of the Bread Room, some of which appear to mate into sets. Views through the open doorway (given that the door itself is not in place) from the Bread Room passageway forward into the "Carpenter's Storeroom" show what appear to be a fitted shelf and associated bin on the starboard side of the hull (Figure 5.4.2).

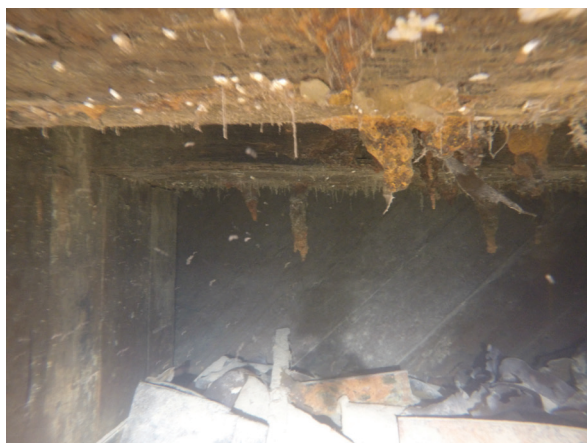
Figure 5.4.3: Interior view of the fore hold, facing the bow, showing transverse watertight bulkhead, wing bulkhead (at left) and debris and artefact accumulation (Photo: J. Moore, Parks Canada; 89Mo2777EF).

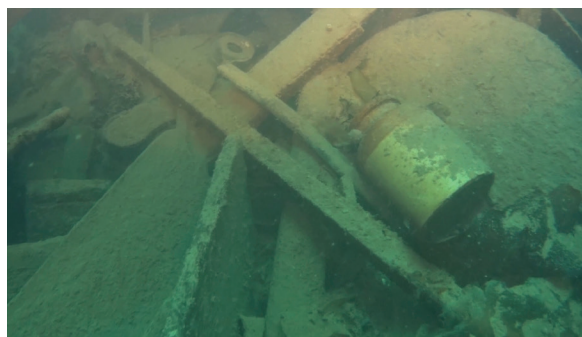
Figure 5.4.4: Selected artefacts in the fore hold including a "Mustard Pot", barrel components, and footwear (Video Still: R. Harris, Parks Canada; 89M2016R003\_4321).

The orlop deck itself in the field of view is obscured by a significant accumulation of jumbled wooden debris and artefacts, as well as dead kelp. All of the kelp and some of the artefacts and debris could have originated from both the lower and upper decks above, given the porosity of the lower deck in this zone. Observed artefacts include: two mustard pots; a pair of sea boots in an excellent state of preservation; footwear parts; splayed casks and cask staves and heads; unidentified

poles; a probable stoneware container; a long arm with a copper-alloy butt plate; possible box, crate or furniture parts with dovetail joints; tongue and groove planking; a possible leather pouch; three Preston patent illuminator frames; a bilge pump piston with leather gasket; a mass of folded fabric or leather; lead sheet; a deadeye; deck beam stanchion(s); and a small unidentified box (Figure 5.4.4). There are many more artefacts and features in this zone that will undoubtedly be revealed with further imagery and investigation. Indeed, by rights, the top of the Sylvester's Patent Heating Apparatus (Battersby and Carney 2011) should be visible in this space and it is quite possible that it is captured by the video imagery but is just short of being visibly identifiable.

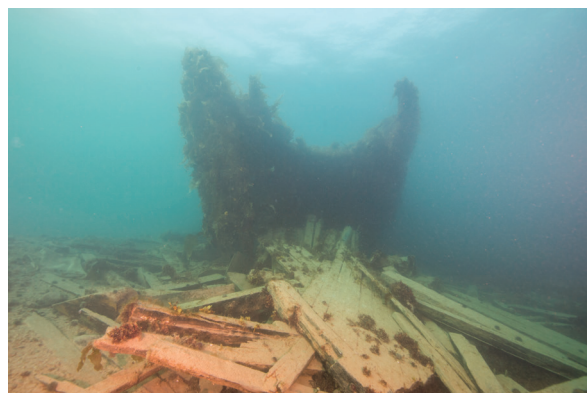
Figure 5.5.1: Debris off the stern, facing forward (Photo: T. Boyer, Parks Canada; 89Mo8496EF).

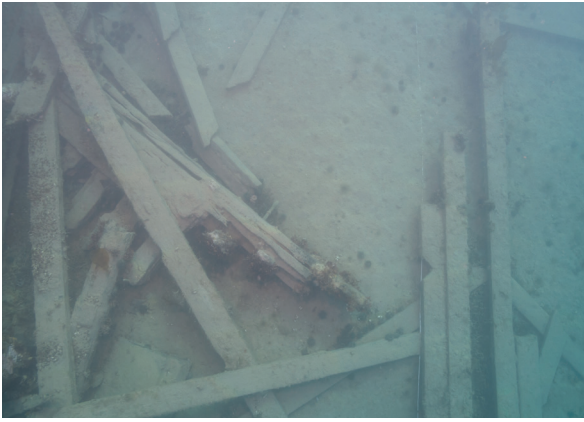
Figure 5.5.5: Bulwark section on the port side of the wreck, from above (Photo: J. Moore, Parks Canada; 89Mo4061EF).

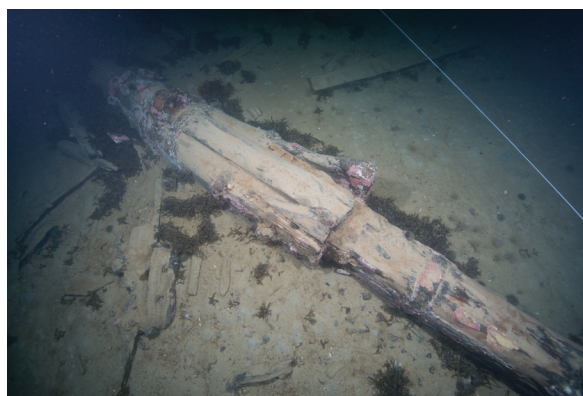
Figure 5.5.7: Part of a mast off the port bow (Photo: T. Boyer, Parks Canada; 89Mo2688EF).

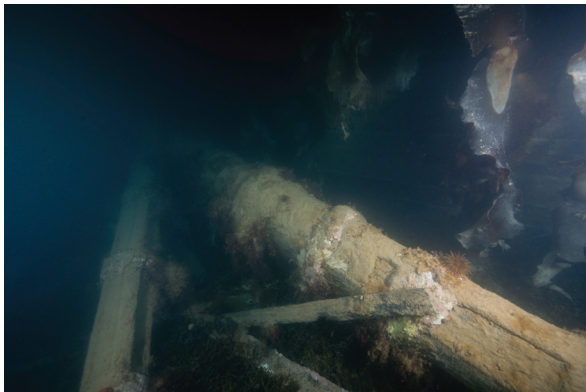
Figure 5.5.8: Unidentified spar, possibly a yard, on the starboard side of the wreck (Photo: T. Boyer, Parks Canada; 89M00698EF).

Farther aft, a sizeable spar is centered in sub-operation 22N and farther aft still there is a concentration of seven spars or parts of spars along the starboard side between sub-operations 36P to 46N/46P. These are unidentified and their provenance in the overall rig is unknown. The largest example here appears to be a sizeable yard with a dozen or more bands around its circumference (Figure 5.5.8). A gaff with a bevelled and lined jaw is in sub-operation 46N; this could be the spanker or topsail gaff for the mizzen mast (Figure 5.5.9). One possible spar (or davit) part has a metal heel

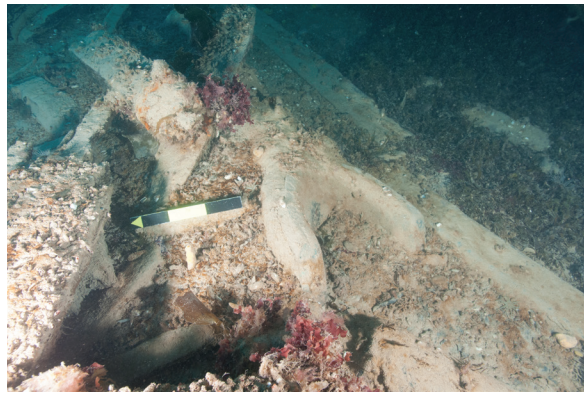
Figure 5.5.9: Gaff at the starboard quarter showing its jaws at right (Photo: J. Moore, Parks Canada; 89M05438EF).

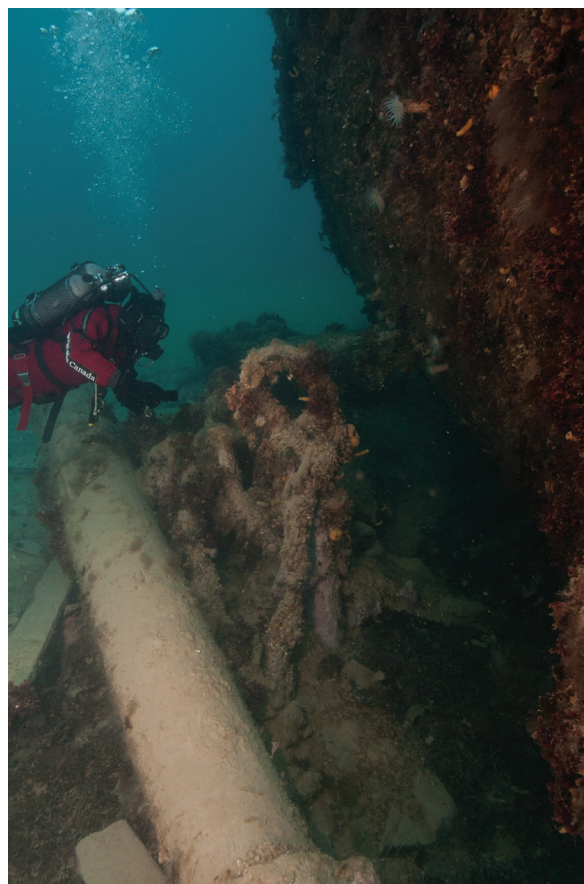
Figure 5.5.10: Spar, starboard bower anchor and anchor chain at the heel of the bow (Photo: J. Moore, Parks Canada; 89Mo6487EF).

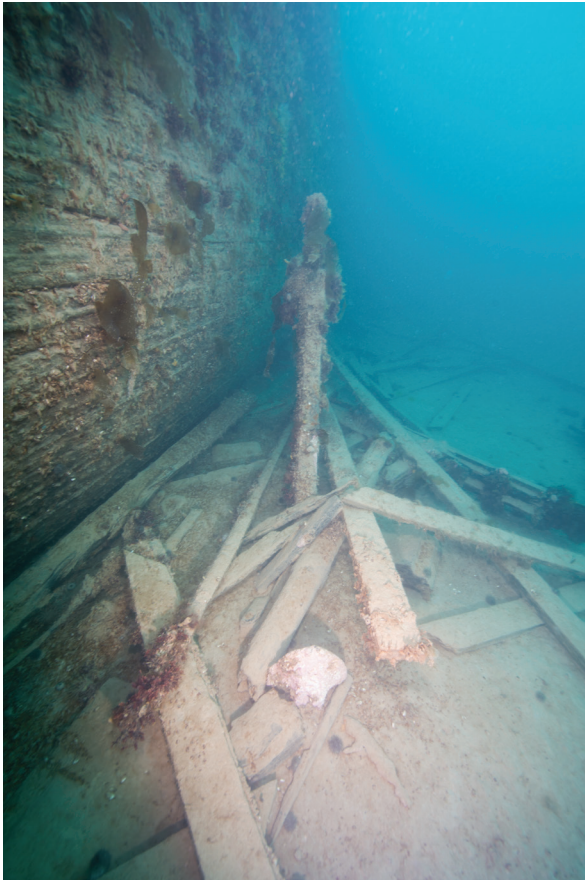
Figure 5.5.11: Large anchor on the port side of the hull (Photo: T. Boyer, Parks Canada; 89M008723EF).
