# Wrecks of HMS Erebus and HMS Terror

National Historic Site of Canada

*HMS Erebus Underwater Archaeological Surveys  
2015 and 2016*

UAT Report: 2017-01

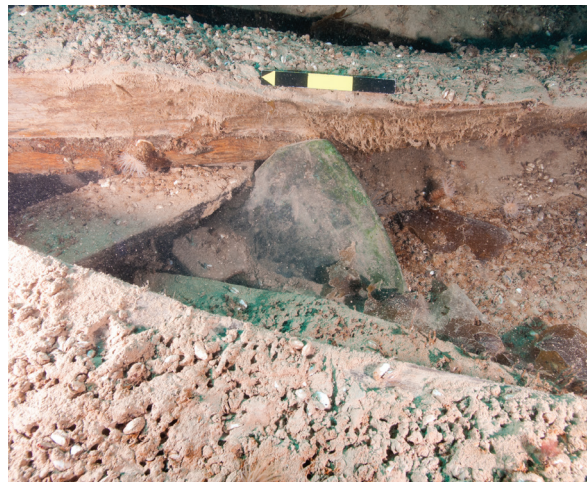
Figure 5.5.12: Propeller blade projecting above sediment at the stern (Photo: J. Moore, Parks Canada; 89M005420EF).

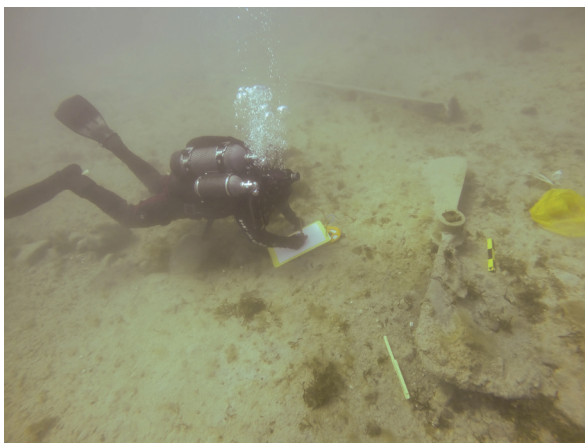
Figure 5.5.13: Parks Canada underwater archaeologist records the propeller situated 43 m north of the wreck's bow (Photo: J. Boucher, Parks Canada; 89M004523EF).

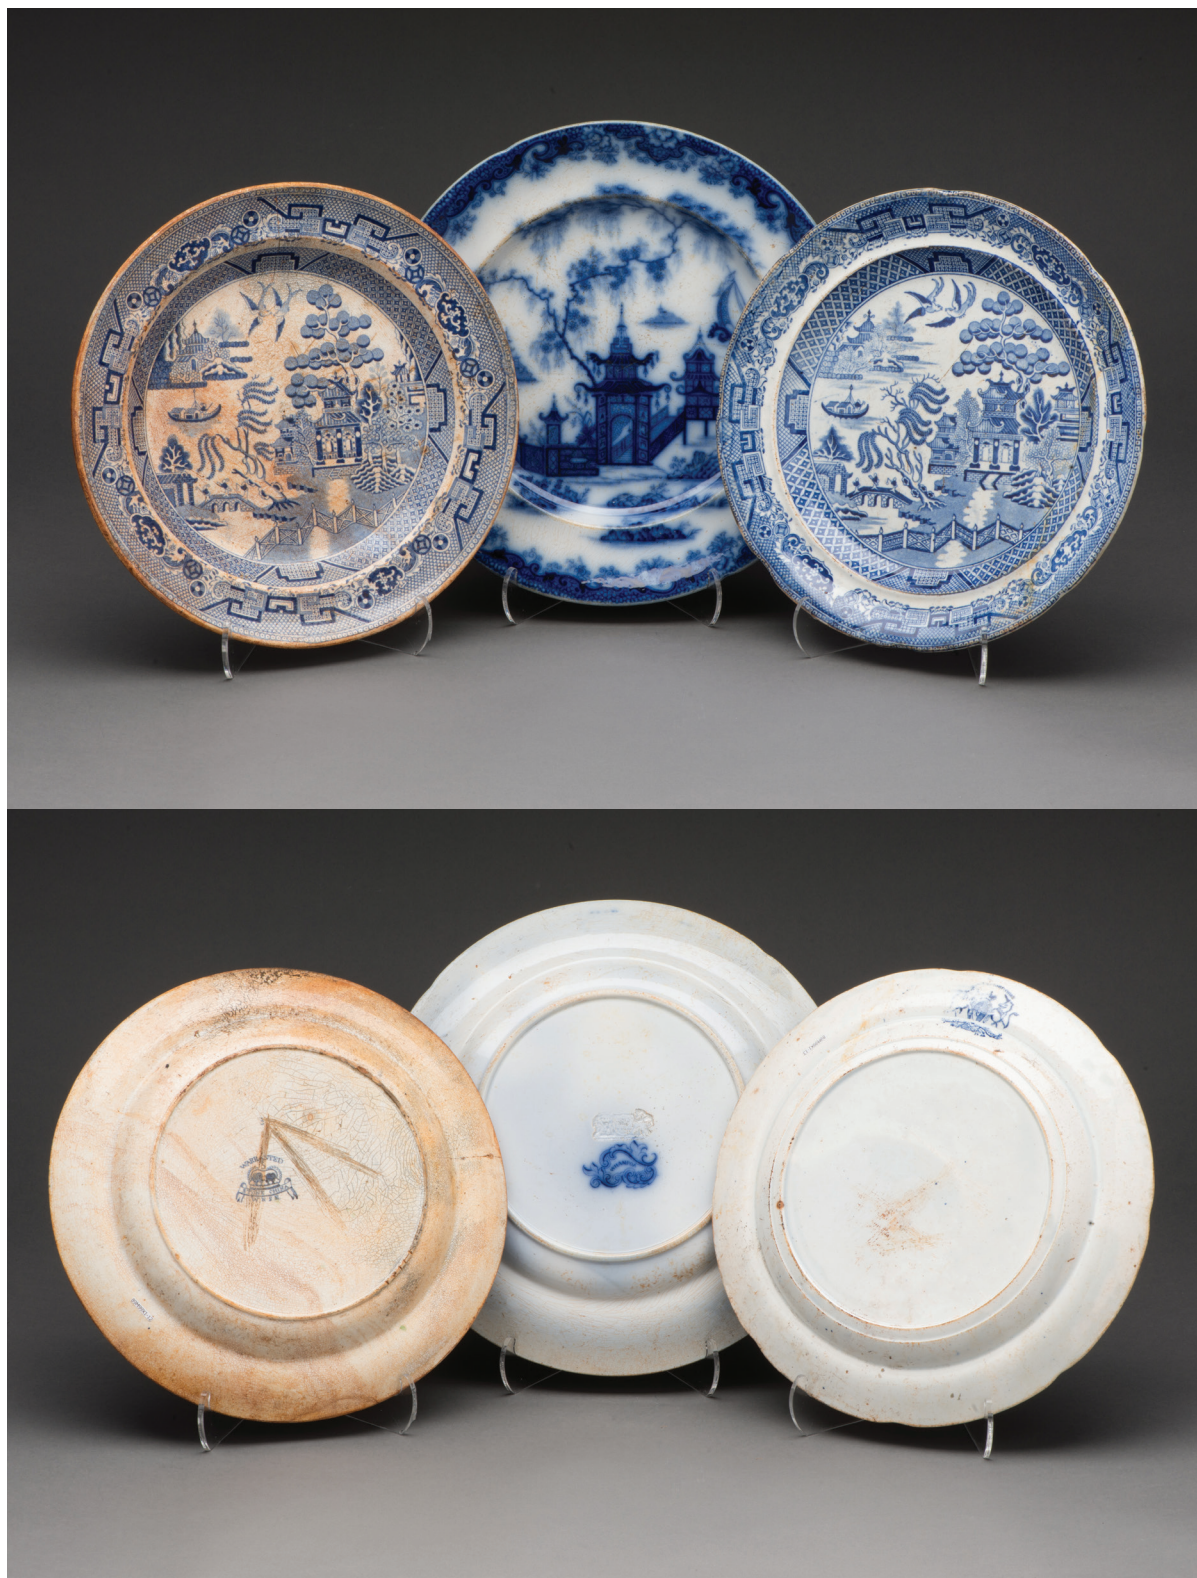
Figure 6.1.1: Examples of blue transfer-print whiteware dinner plates showing maker's marks and graffiti. From left to right: 89M99X1-11, 89M99X1-12, 89M99X1-13 (Photos: M. Wilson, Parks Canada; RA3867EF, RA3871EF ).

Six British white fine earthenware dinner plates (24.0 to 26.5 cm diameter) are part of this group, all blue transfer-print whiteware or white granite (Figure 6.1.1). They were found in the forward port side area of *Erebus*, in the lower deck living quarters next to the galley. Five are decorated with a very common blue willow pattern (1815-present), which is not surprising, as blue willow plates represent the most common (and affordable) transfer-print wares used in the nineteenth century (Miller 1991:8-9). Two of the willow plates are stamped “STONE CHINA” and “W & S E”, referring to William and Samuel Edge, Staffordshire Potteries, in operation between 1841 and 1848 (Godden 1991: 1436). Interestingly, two plates and a bowl show crude graffiti on their reverse sides: a broad arrow, what seems to be an anchor or a modified broad arrow, as well as a number “4” (Figure 6.1.2). Four plates and the same bowl also bear respectively a different number of cut marks on their foot ring. It may well be that these different graffiti symbols and cut marks relate to specific messes and/or individuals within a mess unit aboard *Erebus* (Table 6.1.1). Similar marks are often found on fine ceramics in British colonial military contexts, for example on the HMS *Swift* and *Infatigable* wreck sites, and Fort Wellington NHS (Elkin et al. 2011:197-199; Carabias 2016:pers. com.; Sussman et al. 1994: 243).

The relatively low value of these plates and the presence of a broad arrow suggests that these were ship’s property, probably stored in a nearby cupboard. Indeed, three of them were found close to each other on the lower deck, in sub-operations 28-30K (89M99X1-11, 12 and 13). Navy transfer wares of the same period sometimes bore the mess number in the middle of their obverse or reverse sides. The Whampoa flow blue plate was a more fashionable flatware for the period, popular in 1840-1860 (Figure 6.1.1, center). On its back there is a printed floral crest, as well as an impressed Royal arms with the inscription: “Opaque Granite China” and “W R & Co”. This maker’s

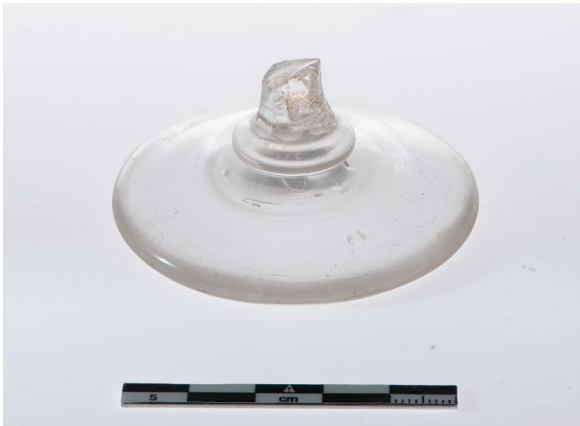
Figure 6.1.4: Foot of a drinking stem glass, 89M34K200-1 (Photo: M. Wilson, Parks Canada; RA3926EF).

The foot (diameter 6 cm) of this colourless drinking stem glass is broken at the base of its octagonal stem. The heel under the base is subtle at only 0.6 cm deep (Figure 6.1.4). The underside of the foot bears a lightly incised mark that reads "S" or "2"; it could be a property mark, in which case it might have been the personal property of

a crewmember - certainly an officer. It could also be a number showing that this glass was part of a set, possibly managed by a steward in charge of the shipboard wares. A similar glass foot with octagonal stem is depicted in *Glass of the British Military, ca. 1755-1820* (Jones and Smith 1985).

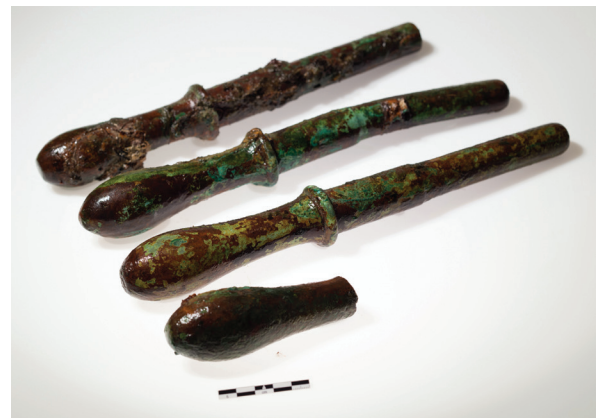
Figure 6.2.1: Belaying pins and fragment found on the upper deck, from top to bottom 89M48M100-1, 89M44N100-2, 89M50M100-1 and 89M40N100-1 (Photo: T. Boyer, Parks Canada; 89M07648EF).

Three belaying pins and one belaying pin fragment were found resting directly on the upper deck and recovered (Figure 6.2.1), none of which were found in situ in a pinrail, although there are examples of this on the wreck. Only a representative sample was raised to the surface in September 2015 and there are more examples in situ. The overall length of the complete examples, which share an identical form, range from 31 to 33 cm, with a handle diameter of 3.7-4.0 cm. The ship was equipped with many of these pins on the upper deck, in fife rails at the masts but chiefly in pinrails along the inboard faces of the port and starboard bulwarks. These pins were used to attach, or belay, a variety of the ship's running lines. Unlike wooden belaying pins commonly associated with sailing ships, these pins are solid bronze. Two of the pins exhibit damage: 89M44N100-2 is slightly bent while 89M40N100-1 has been broken, most likely when the ship's rigging collapsed, during or after the ship's sinking.

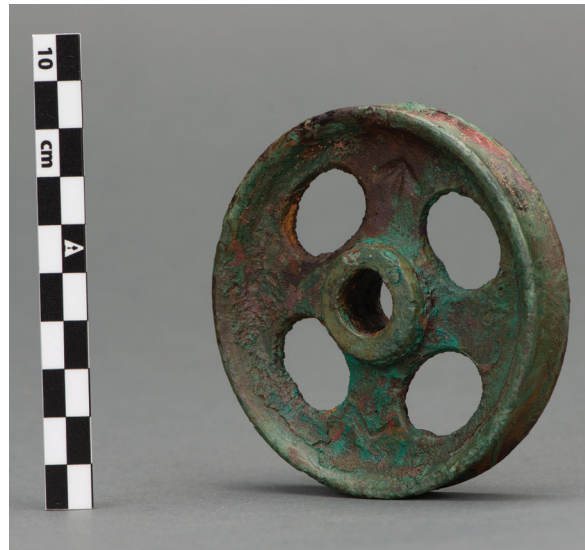
89M40N100-3

Figure 6.2.3: Copper alloy block sheave, 89M40N100-3. Note the broad arrow on the upper middle of the sheave (Photo: T. Boyer, Parks Canada; 89M07578EF).

This copper alloy sheave (8.2 cm diameter) has a typical late nineteenth century “wheel pattern”, with four rays around a central reinforced axle (Figure 6.2.3). Two broad arrows are visible on the better preserved side of the artefact, the other being covered mostly with corrosion product. The groove has a U-shape of 0.3 cm deep.

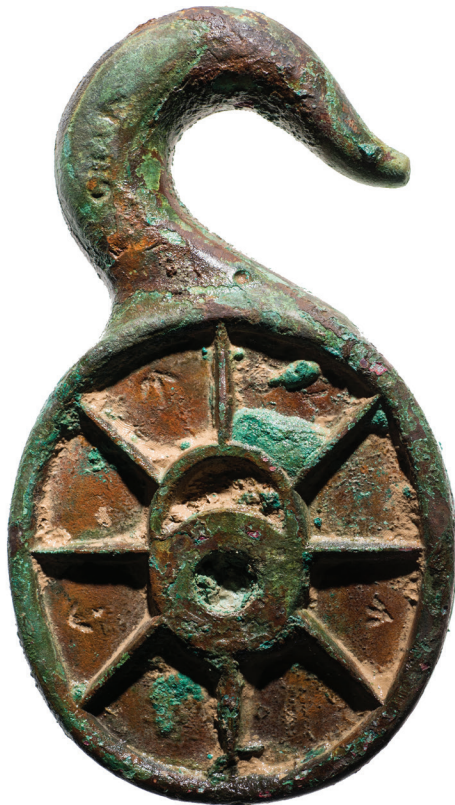
Figure 6.2.4: Solid bronze hook block with an embossed ray pattern, 89M99X1-4 (Photo: T. Boyer, Parks Canada; 89Mo7391EF).

This high quality hook block made of solid bronze has an ovoid shape with an embossed ray pattern (Figure 6.2.4). There are two broad arrows marks on each side, with the inscription “6¼” on one side, referring to the regulation size of the block in inches (15.9 cm or 6.25 in.). “CHAIN” is stamped on the hook, possibly a mark indicating that the hook can or should be attached to chain or otherwise simply a maker’s mark. The sheave is made of the same alloy, but the iron pin is mineralised and degraded. This solid and seemingly versatile block might have been rigged to a boat davit (to raise or lower ship’s boats from the upper deck) or formed part of the ship’s standing rigging (Nordbok 1975:109-123). Recently in April 2017, similar blocks were observed on the wreck of the *Terror*; further study of in situ examples on this exceptionally well-preserved wreck should shed light on the blocks found on *Erebus*.

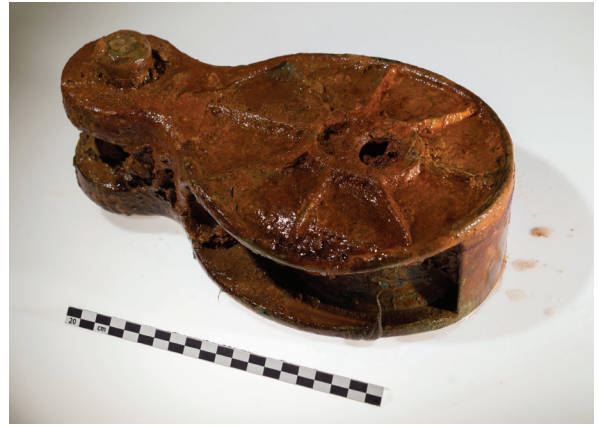
Figure 6.2.5: High-quality single block fitted with an integrated shackle, 89M28M100-1 (Photo: T. Boyer, Parks Canada; 89Mo7682EF)

This distinctive, high-quality single block fitted with an integrated shackle was found on the fore, starboard side of the upper deck (sub-operation 28M); all of the artefact is brass and ongoing research aims to determine if its presence on a Royal Navy ship fitted-out in 1845 is unusual or novel (Figure 6.2.5). The block per se is 19.8 cm long, and total length of the entire object is 28.0 cm. The two ears forming the shackle are made to accept a large through bolt with a round head. The iron block pin is now absent. The case is reinforced (and possibly decorated) with a radial pattern of raised lines moulded on both sides, similar to hook block 89M99X1-4. A broad arrow is visible on the better preserved side, while corrosion product obscures most of the other side and the sheave. Remnants of cordage are corroded to the sheave, inside the shell. The block was partly crushed by a heavy force, possibly as a result of the sinking of *Erebus* and the collapse of its rigging. Its size might be marked on the block which will be confirmed following conservation treatment.

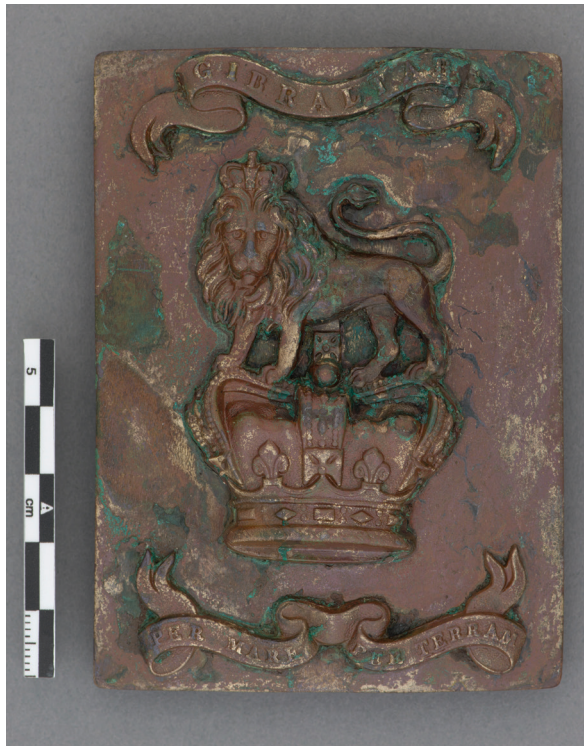
Figure 6.3.3: Royal Marines shoulder belt plate decorated with a crowned lion *statant guardant* above a crown, and two banners, 89M32J200-1 (Photo: M. Wilson, Parks Canada; RA4201EF)

This rectangular brass shoulder belt plate (9.5 by 7.5 cm) is decorated with a crowned lion *statant guardant* above a crown, and two banners (Figure 6.3.3). It is made from a slightly concave 1-cm-thick plate with affixed decorative elements. It appears not to be gilded, as no traces of gold were found on its surface (Kavousanaki 2015). The top banner marked "GIBRALTAR" refers to the first battle honour won by the Royal Marines in 1704.

The banner at the bottom of the plate bears the inscription "PER MARE, PER TERRAM", which is the corps' motto, meaning "By Sea, By Land". The two banners and the central crest were added to the plate using small eye-shaped through pins. These pins are locked in place by three small rods visible on the underside. One of the rod holds the central crest and the two others lock the two banners in place. On the underside there are also four hooks to fit on the belt.

The artefact was found face down on the lower deck on the port side of the forecastle, near two uniform buttons (89M99X1-9 and 10) from a British Royal Marine other ranks standard uniform. This belt plate is also part of the 1827 Royal Marine uniform pattern (Parkyn 2014:240-242). Based on its material, design and quality, it likely belonged to one of the two sergeants (non-commissioned officers) from the Woolwich Division that sailed with the expedition (Bradley 2015:pers. comm.), namely Daniel Bryant from *Erebus* or Solomon Tozer from *Terror* (Anon 1845).

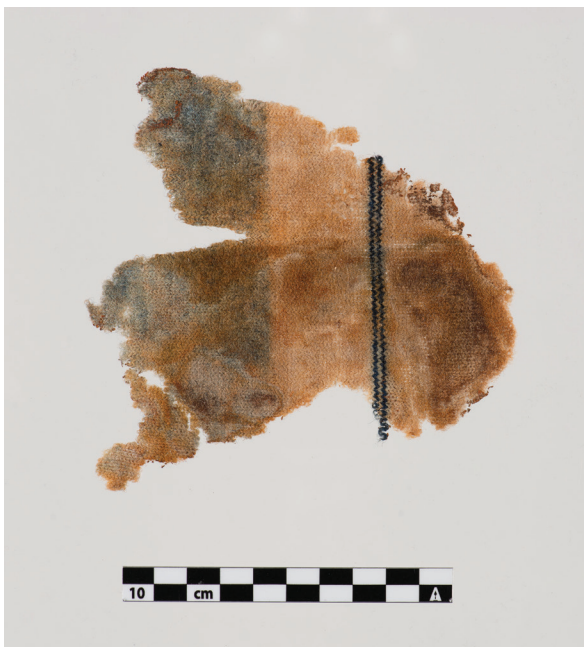
### 89M38J200-7

Figure 6.3.5: Piece of textile sampled from a larger garment found on the lower deck, 89M38J200-7 (Photo: M. Wilson, Parks Canada; RA3981EF).

The piece of textile (14 cm wide) was sampled from a larger garment (ca. 60 cm long) found in 2015 on the lower deck that was left in situ. This piece of beige, knit wool is decorated with two dark blue stripes and a wide light blue band (Figure 6.3.5).

The blue yarns were coloured using indigo in both instances (Kavousanaki 2016). This type of stockinette stitch is not uncommon for sweaters, mittens or scarves (Lafèche 2015b; Mickeljohn 2016:pers. com.). This piece of textile was found in a cabin on the port side, next to boot 89M38J200-8 (Feature 4, sub-operation 38J) and was sampled from a much larger piece left in situ.

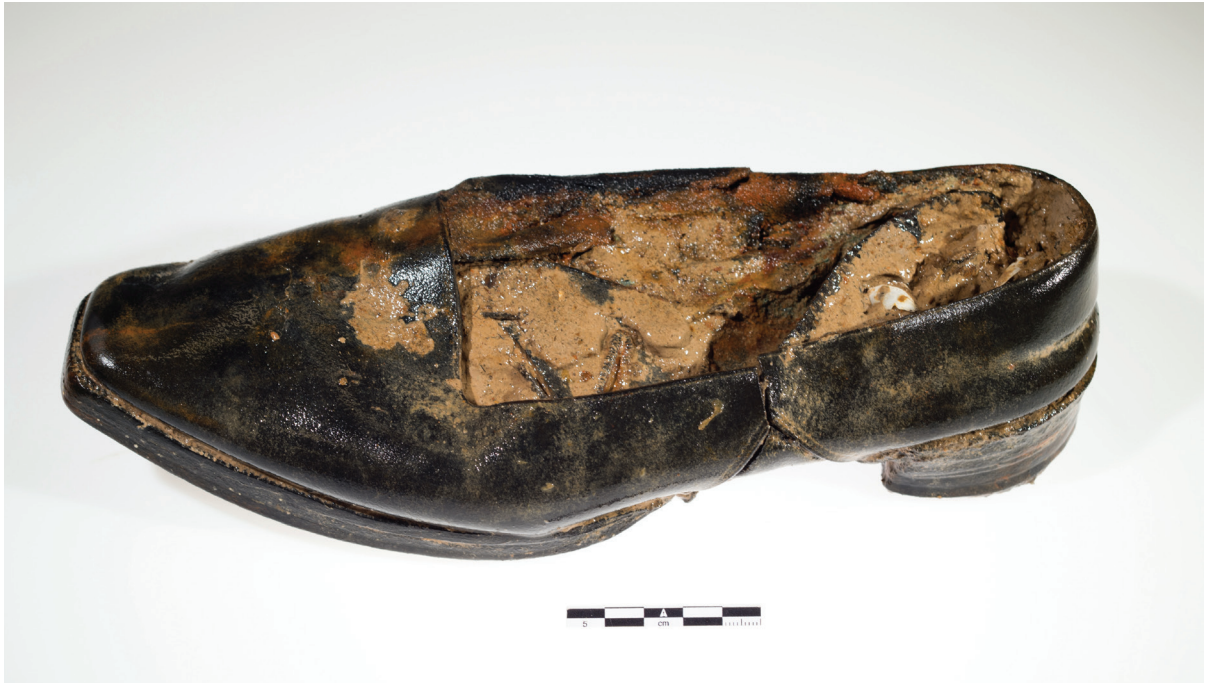
Figure 6.3.6: Largely complete boot, 89M38J200-8 (Photo: T. Boyer, Parks Canada; 89M07545EF).

This largely complete boot is of a hand-stitched welt-type construction, as machinery for sewing leather uppers and sole bottoms was introduced in 1856, a decade after the *Erebus* and *Terror* sailed (Figure 6.3.6) (Pratt and Woolley 2008:71-76; Mickeljohn 2016:pers. com.). The slender sole (possibly rubber) is crooked to fit a left foot (28 cm or 11 in. long). The inside of the boot has a liner and the back is reinforced. The vamp has a pointed, square toe and meets with the quarter at mid-length. This patent leather or “ironed hide” body is completed by what seems to be an integrated gaiter, made of an unknown fabric. The upper part and a thick smooth leather strap with five holes are collapsed inside the boot; this is believed to be part of an attachment system, made to fit vertically along the ankle. The upper seems to have been lined with fur, possibly only its upper edge. Indeed, thick patches of short black hairs were found inside the boot, and identified as seal (*Arctocephalus* sp.) (Lafèche 2016). Tacks are visible around the heel and elsewhere under the sole; X-radiography examination clearly shows small tacks around the sole. This boot must have been well-used by one of the crew members, since the portion of the sole under the ball of the foot is worn out. Based on its quality and design, it is most certainly a fashionable civilian cold weather product belonging to one of the officers (Mickeljohn 2016:pers. com.). This boot was in fact found in an officer’s cabin amidships on the port side (sub-operation 38J), next to the textile fragment (Feature 4).

The boot was found filled with mud, bivalves, some wood splinters and possibly other material. Laboratory excavation of its contents and treatment have been completed. The excavation was undertaken in order to allow sampling of the inner sole and back pieces, all the while limiting contamination as much as possible. Six small 1 cm by 1 cm

leather samples were collected and sent for human DNA extraction and sequencing (Schmerer 2003) at Lakehead University's Paleo-DNA Laboratory. It was expected that some human skin fragments or blood may be found on high friction points in the boot, providing a possible hint to the identity of its wearer. Indeed, a mitochondrial DNA profile was retrieved from the boot samples (Fratpietro 2016). The DNA profile that was sequenced could be indicative of haplogroup P4a (16319A), specifically found in Southeast Asia/Australia, or haplogroup R (16319G), very widely distributed but most common in West Eurasia. This data will be compared with different datasets related to the Franklin expedition in an attempt to find the identity of the bearer.

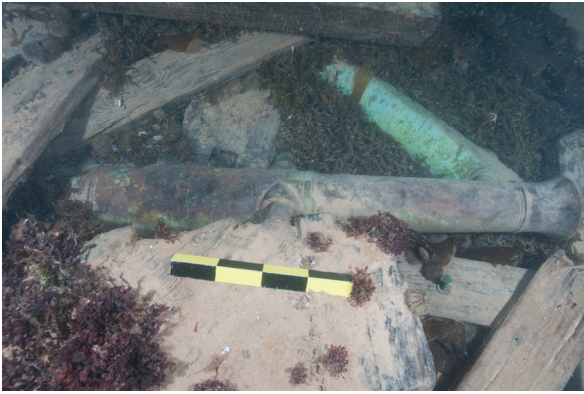
Figure 6.5.2: Light bronze six-pounder cannon raised from the stern debris field, 89M99X1-7 (Photo: T. Boyer, Parks Canada, 89M02750EF).

One of the two light bronze six-pounders from the stern debris field was raised in 2015 (Figures 6.5.1 and 6.5.2). This Blomefield gun has a typical cascabel with two loops made to insert an elevating screw below the button. This "light" six-pounder is named as such because it is significantly lighter than its predecessor, approximately 680 pounds instead of approximately 800 pounds, and thus rapidly became the standard gun type for both marine and land uses after 1812 (McConnell 1988:41-46). Its length, breach to mouth, is 152.4 cm (60 in.), its overall length is 165.6 cm (65.2 in.) and its bore diameter is 9.1 cm (3.58 in.).

- The Roman numeral serial number “MDCV” (1605), although partly obscured by corrosion product, is located on the second reinforcement ring; and
- Between the second reinforcement ring and the muzzle astragal, a large monogram “M” stands for Henry Phipps, First Earl of Mulgrave, Master General of the Ordnance (Blackmore 1976:43-45).

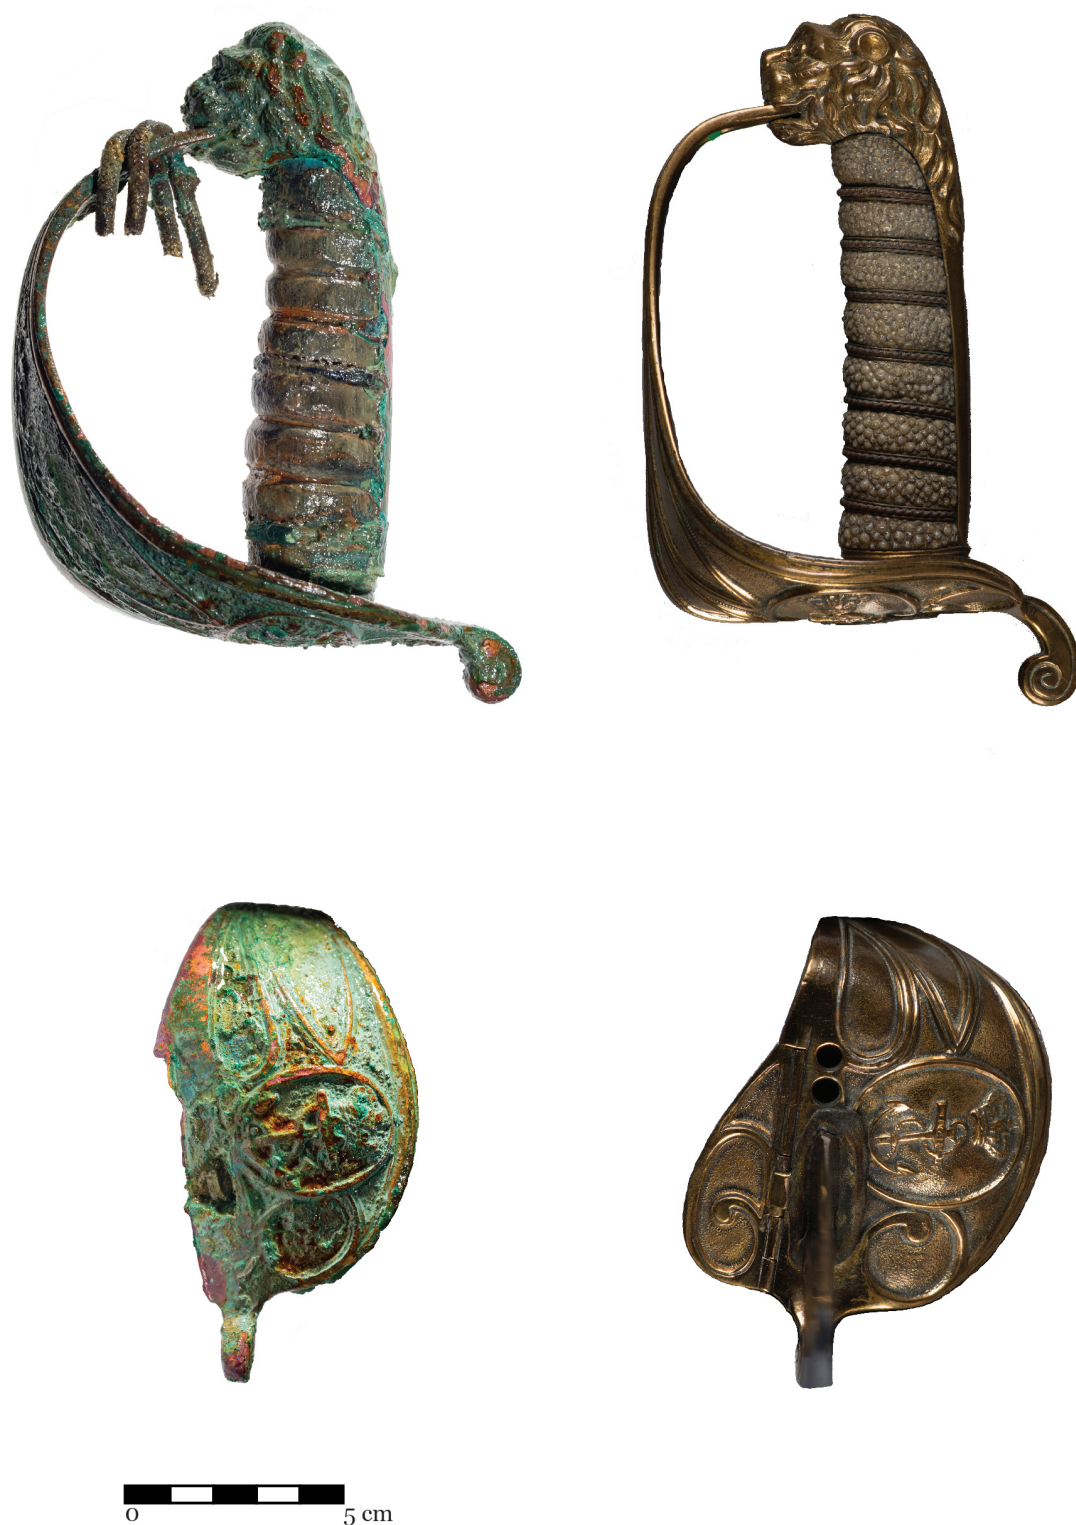
Figure 6.6.2: Comparison of the *Erebus* sword hilt 89M34K200-5 (left) and a similar British Royal Navy officer's sword from Parks Canada's historic object collection, X.75.58.2 (right). Both are 1827 pattern swords. Note that sword hilt X.75.58.2 is approximately scaled to the *Erebus* hilt (Photos: T. Boyer (left) and M. Wilson (right), Parks Canada; 89M07627EF, 89M07630EF, RA3858EF, RA3862EF).

This 1827 pattern Royal Navy officer's sword hilt was located on the port side of the lower deck near the galley (Figure 6.6.2). Its hilt, with a half basket guard, is made of gilt brass and decorated with a typical crown and fouled anchor badge. The folding rear guard section is broken off and missing. Its pommel has the shape of a lion's head. The shark skin cover, degraded or missing, on a wooden core grip, was bound with gold-plated copper (the latter with lead impurities), collectively partly corroded and discoloured. Two strands from the sword knot are still attached to the guard. The sword knot is made of silk with gold-plated silver (with copper impurities) threads woven in; future examination of this cordage might indicate if it has Royal Navy blue or Royal Marine scarlet median strings within the gold borders (Bradley 2015:pers. comm.). A similar sword is held by the National Maritime Museum (NMM, WPN101); another example can be found in Parks Canada's historic object collection (PC, X.75.58.2).

It is noteworthy that the blade is missing from the hilt. It is possible that the blade was broken or corroded away on account of natural processes, or that it has yet to be observed on site. It is also possible that the blade was intentionally separated from the hilt while the vessel was still afloat, possibly on account of Inuit visitation to the ship, although there is no direct evidence to support this supposition. This notion stems from the fact that a sword blade was acquired from Inuit by the McClintock expedition in 1859, somewhere between the Boothia Peninsula and King William Island (Figure 6.6.3). The Inuit knife is now held

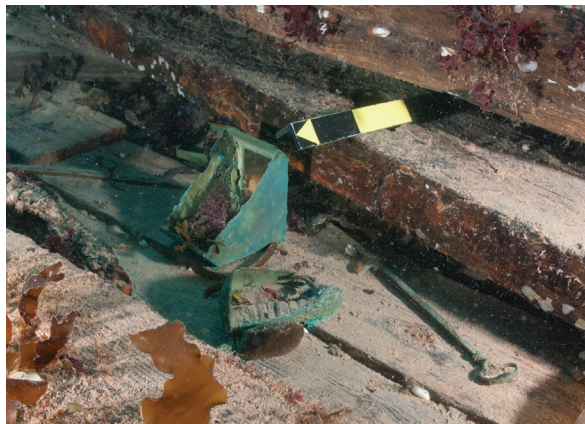
Figure 6.11.1: Artificial horizon in situ on the lower deck. Note that the roof was found upsidedown as in this photo (Photo: T. Boyer, Parks Canada; 89Mo6500EF).

The original artefact observed in situ was composed of two similar glass frames and panes, a plain flat top, and two plain trapezoid sides. The roof was originally used to fit over a rectangular brass tray which would hold liquid mercury. Mercurial artificial horizons were used in conjunction with sextants to determine latitude (whether on land or at sea) at times when the horizon was not visible in low visibility or in the case of Arctic navigation, when obscured by immovable obstacles, such as large ice floes. Captain George Back reported that the Admiralty provided one artificial horizon and a spare bottle of mercury to his 1836 expedition (Back 1838:5). He describes at least two instances of its use amongst the treacherous ice of Hudson Bay:

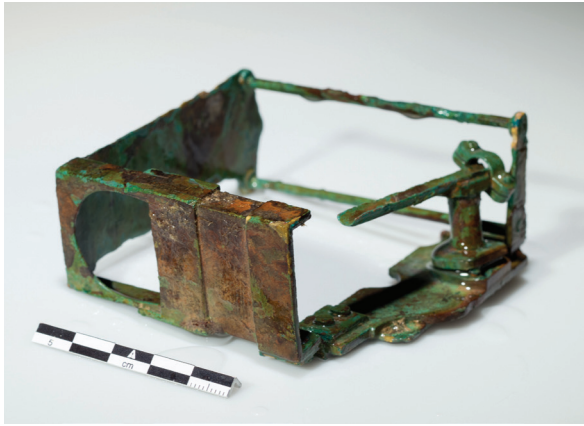
Figure 6.11.4: Artefact made of round-profile brass posts articulated with perforated brass sheets that together form a frame 89M52L200-1 (Photo: T. Boyer, Parks Canada; 89Mo7540EF).

This delicate artefact is made of round-profile brass posts articulated with perforated brass sheets that together form a frame (Figure 6.11.4). The object has an integrated mount for a small, cylindrical component, 0.4-0.6 cm in diameter. Its original orientation (i.e. top) is not yet known. It was found at the extreme aft end of the stern cabin at the transom. Given its refined manufacture,

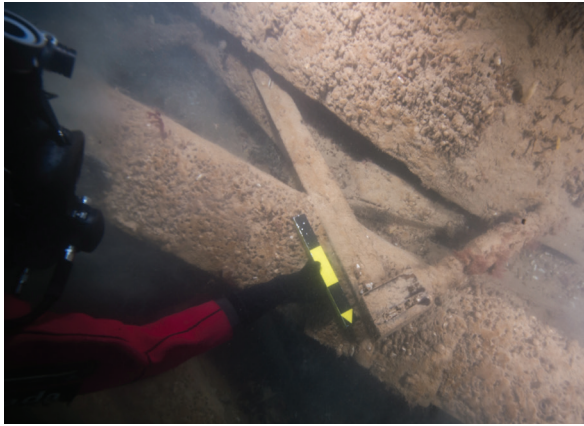
89M99X1-5

Figure 6.12.1: Leg and part of an attached stretcher or skirt found in the debris field at the stern of the wreck (Photo: T. Boyer, Parks Canada; 89M00740EF).

This piece of mahogany furniture consists of a leg and part of an attached stretcher or skirt (Figure 6.12.1). The leg (69.0 cm high) has a square top section and a round (turned) lower section. The stretcher frame piece (1.29 m long, 9.5 cm wide) bears a recess, possibly to accommodate a drawer(s). The end of the stretcher piece has a nipple that suggests it was made to be disassembled. Three wooden fasteners pass vertically through the plank, possibly to attach a table top or to hold

supports for a drawer(s). The overall leg to leg estimated dimension is 1.39 m (4 ft. 6 in), which indicates likely a 2.5 ft.-high, and 5-ft.-wide piece of furniture, likely a table. Whereas this furniture piece was found on the seabed in sub-operation 54N, a similarly-designed leg and stretcher has been observed on the lower deck in the Captain's Cabin, in sub-operation 52M. This leg's design and one dimension (length 69 cm) are similar to furniture leg 89M99X1-5, although its stretcher is 1.06 m long (including a 5-cm-long tenon) and 12.5 cm wide. The overall leg-to-leg dimension of this piece of furniture would have been 1.12 m (3 ft. 8 in.), possibly representing a 4-ft.-wide and 2.5-ft.-high table. Thus, we may well be facing two different pieces of unknown furniture or a single small 5 ft. by 4 ft. table.

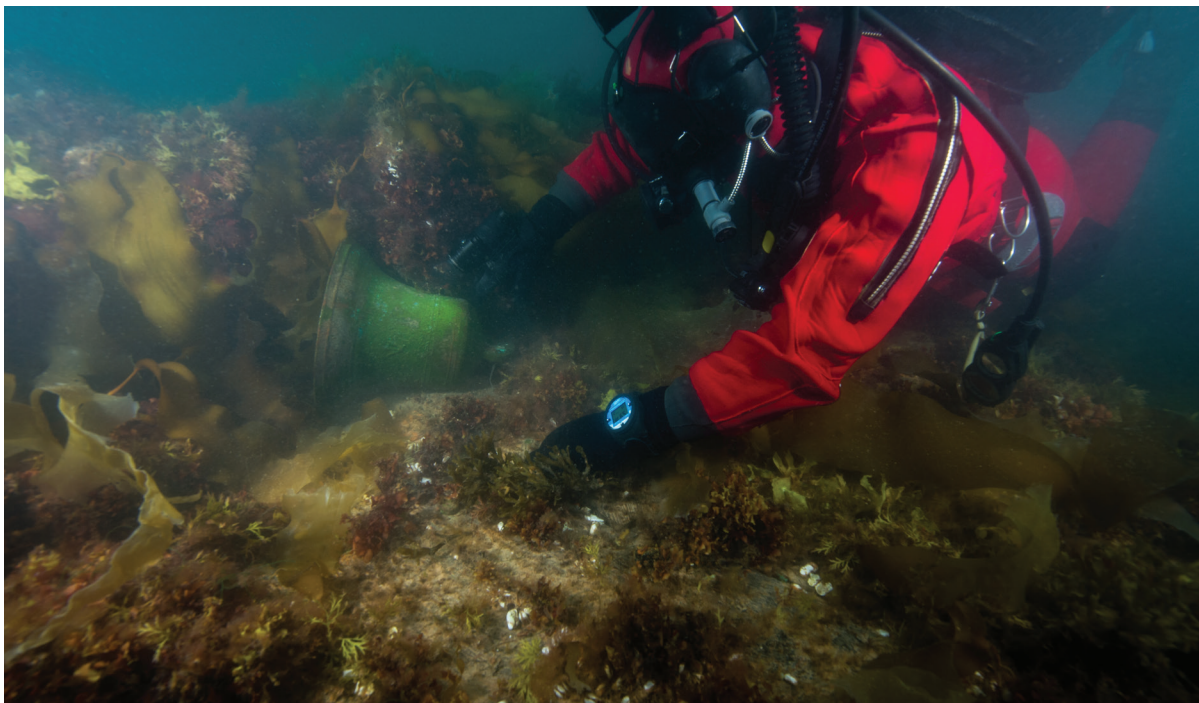
Figure 6.14.1: The bell in situ on the upper deck of *Erebus*, 2014 (Photo: T. Boyer, Parks Canada; 89M00523EF).

This object is certainly one of the most iconic artefact from the collection. It was also the first to be recovered in September 2014 and was found on the starboard side of the upper deck, immediately aft and adjacent to the displaced windlass barrel (Figure 6.14.1). Given its find location and standard practice at the time, not to mention the mounting arrangement for the bell shown in the 1839 profile of *Erebus*, it was almost certainly mounted on an arched metal belfry that straddled vertical timbers bracing the windlass (*Terror and Erebus, Profile (as Fitted)* 1839). A bell is not shown in any plan amendments dating to 1845. *Erebus'* bronze bell has a standard bell shape (37.8 cm diameter; 38 cm total height), although its crown has only two ears instead of the usual six (Figure 6.14.2). Upon close examination it appears that the crown

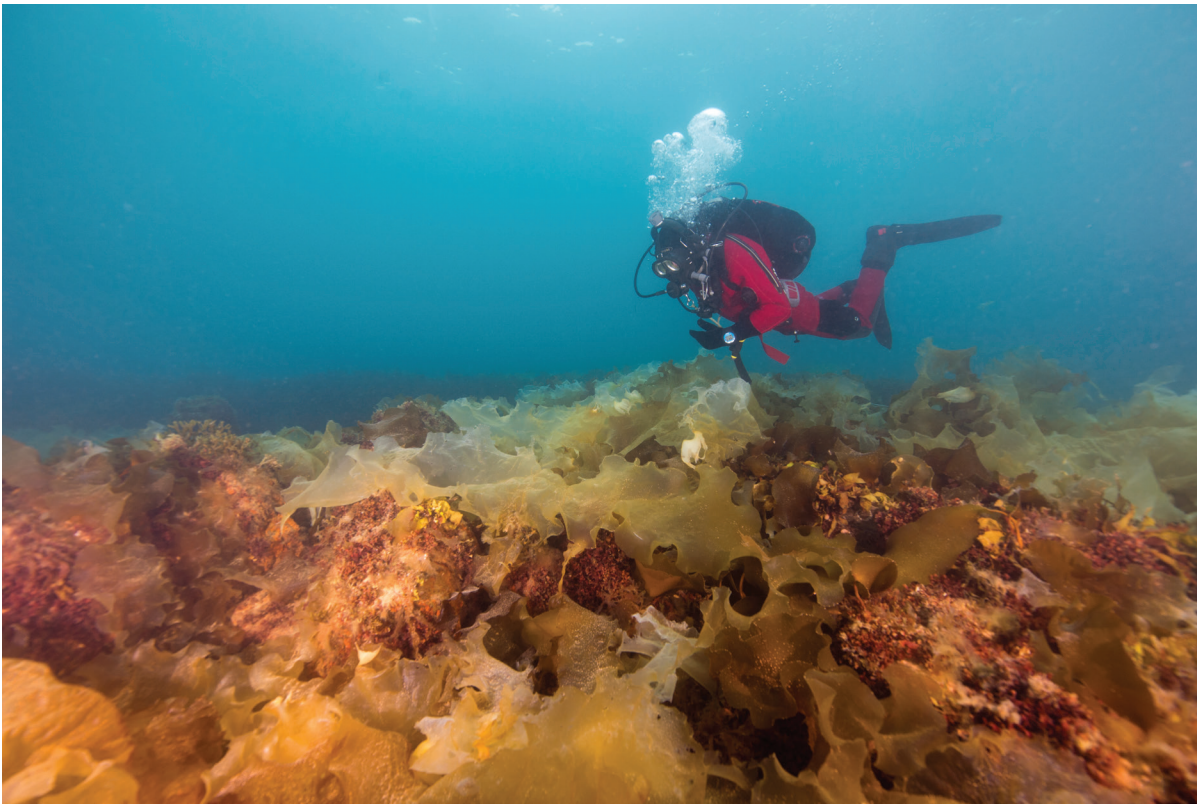
Figure 7.1.1: UAT archaeologist swims above the kelp-covered upper deck of *Erebus* in August 2015 prior to substantial kelp removal (Photo: T. Boyer, Parks Canada; 89M3660EF).

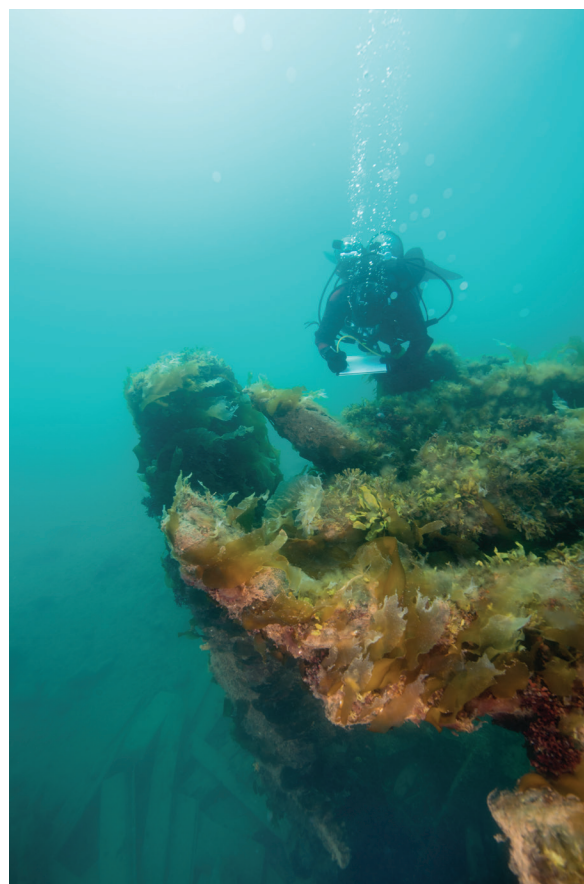
Figure 7.2.1: UAT underwater archaeologist inspects the stern structure of *Erebus*, 2016 (Photo: T. Boyer, Parks Canada; 89Mo8434EF).

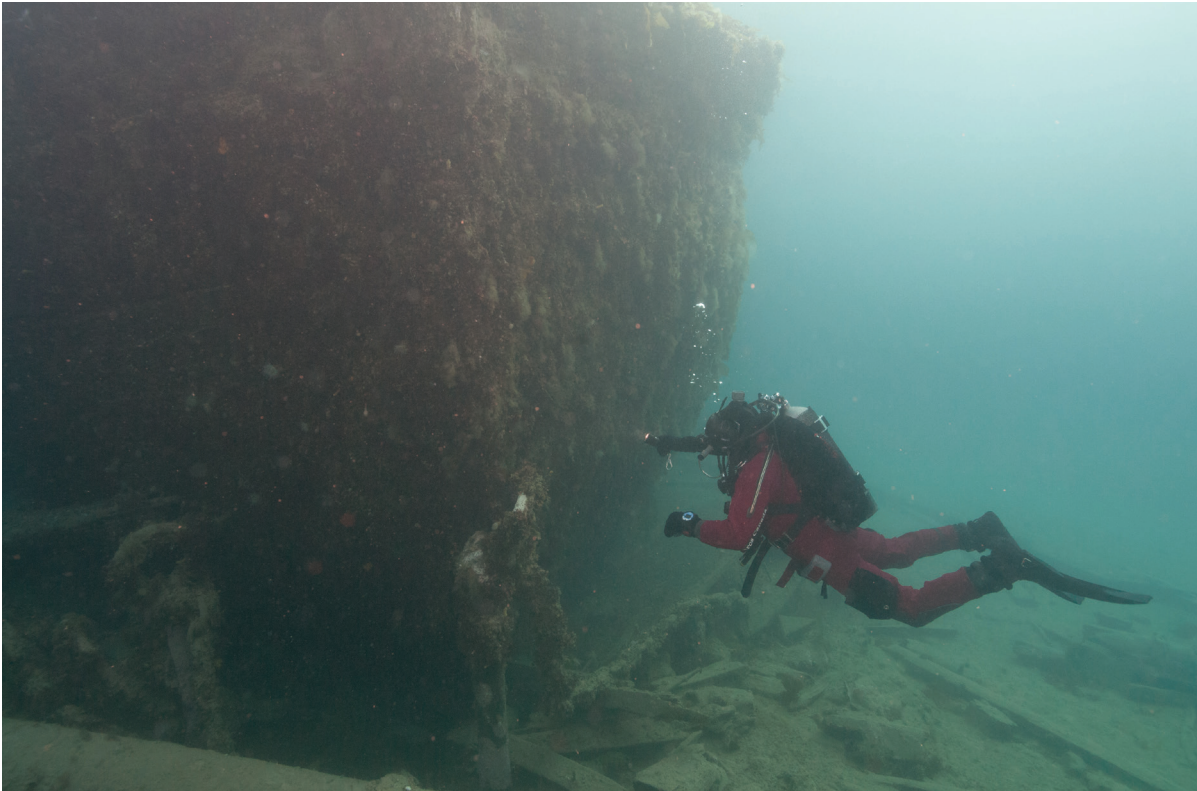
Figure 7.3.2: UAT underwater archaeologist at the bow, showing the two bower anchors and attached chain cables at the heel of the stem. The anchors, upright and partially embedded in the seabed are at bottom left of this image (Photo: J. Moore, Parks Canada; 89Mo6480EF).

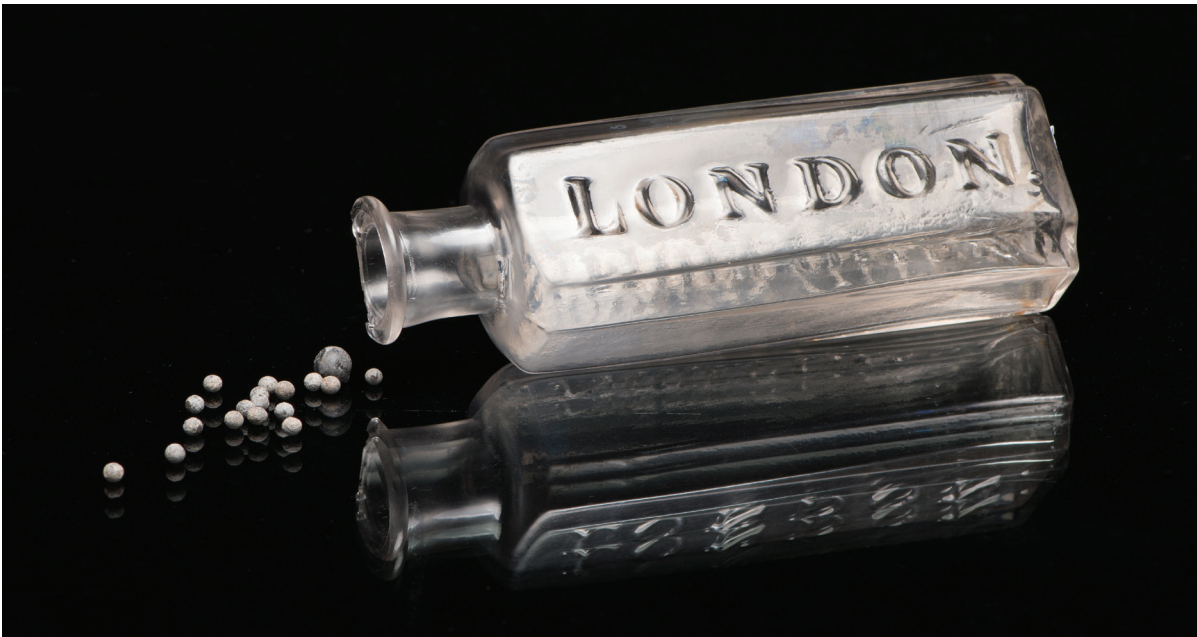
Figure 7.4.1: Pharmaceutical bottle 89M99X1-8, which originally held a preparation made by Samuel Oxley of London, England was evidently later re-used by *Erebus* crew members, quite surprisingly, as a shot flask or container. The wreck promises to yield many more artefacts like this example and thereby unique archaeological insights into events and life aboard the ship (Photo: M. Wilson, Parks Canada; RA388oEF).

This bottle was found in the lower deck forecabin (Feature 2), and filled with an unidentified muddy substance. To our surprise, the bottle contained one lead buck shot (0.65 cm diameter) and 18 smaller lead bird shot (0.32 cm diameter). Detailed content analysis performed by Conservation Science staff also found traces of gum Arabic and potassium bicarbonate (Kavousanaki 2016). The former, also referred to as acacia gum (*Acaciae gummi*), is an emulsifier used in a variety of products in the nineteenth century, including paint, food, ointments and creams. It was also part of every standard Royal Navy medicine chest. Potassium bicarbonate, referred to as *Potassae subcarbonatis* ( $K_2CO_3$ ) is a white salt, soluble in water which forms a strongly alkaline (caustic) solution. It has multiple commercial applications, but was also carried in every standard Royal Navy medicine chest (Royal Navy 1835).

Re-use of glass (and ceramic) containers was frequent in the nineteenth century, but to find such clear evidence of multiple use from the same object through its lifespan is quite remarkable (for example, see Turgeon 1996). For reference, we note that a small mahogany "field" medicine chest (NMM, AAA2224) from *Erebus* or *Terror* was found near Ross Cairn, Point Victory, King William

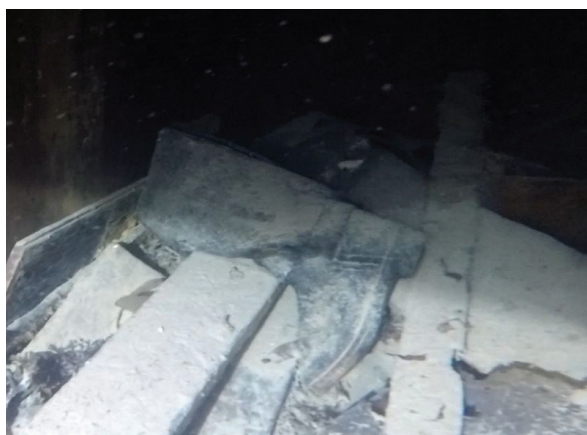
Figure 7.4.2: This sea boot observed in the main hold underscores the excellent preservation conditions and artefact potential within the hull of *Erebus* (Video Still: J. Moore, Parks Canada; 89M2015R005b\_0243).

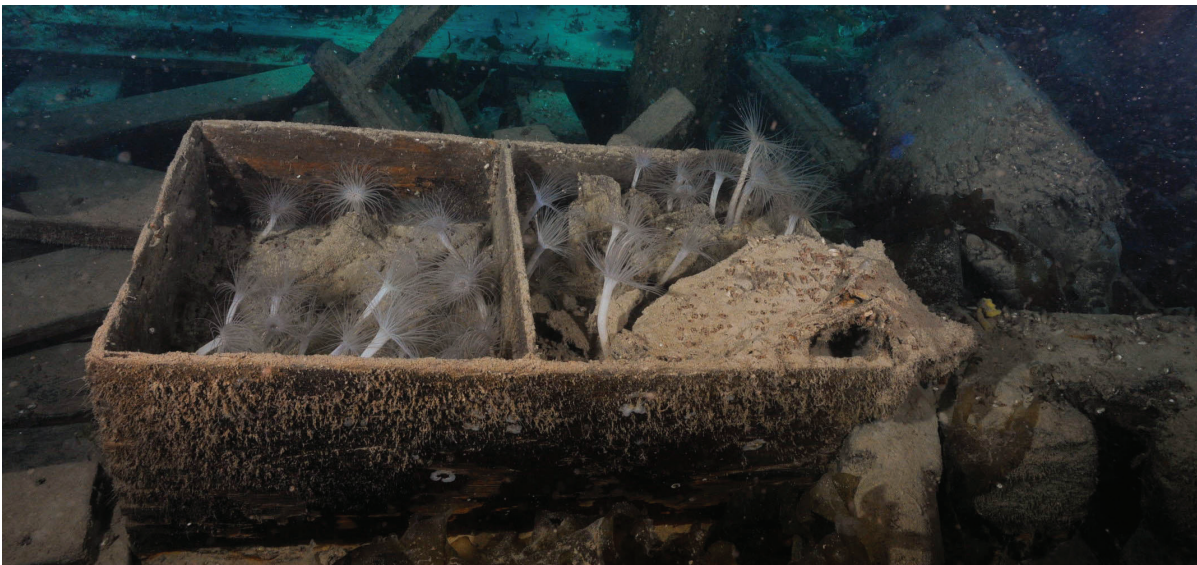
Figure 7.5.1: This well-preserved seaman's chest in the forecabin of the lower deck appears to have its original contents in situ, albeit partially covered by silt and anemones. Future excavation of this feature has the potential to reveal fascinating insights into the lives of the two men who shared this locker (Photo: M.-A. Bernier, Parks Canada; 89M06932EF).

would become accessible by either removing or consolidating part(s) of the collapsed upper deck. The galley area is also of interest but it is generally devoid of physically compartmented spaces. Some elements, like an intact seaman's chest, are visible yet out of reach at present; it would offer a unique insight into the life of the lesser known figures of the expedition (Figure 7.5.1). The Sick Bay needs to be further explored because it is well sheltered at the bow and on account of perennial interest in the decline of the health of the crew.

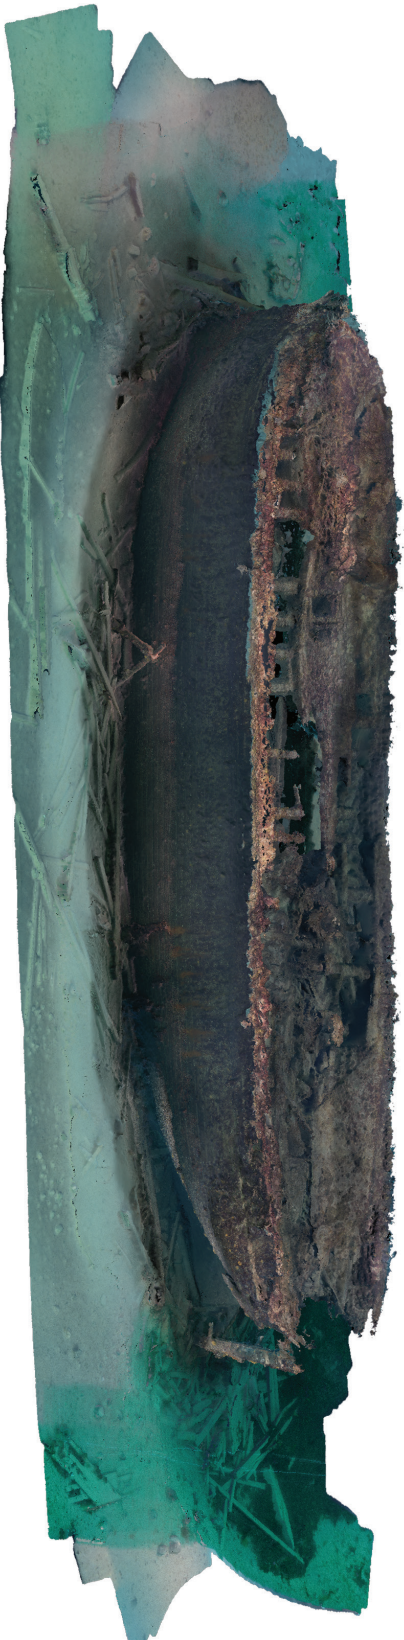
Figure 7-5-3: Preliminary artistic reconstruction of *Erebus* under sail (top) based on both historical and archaeological evidence, the latter including a photogrammetric model of the wreck of *Erebus* with the bow at left (bottom). Future archaeological study of the wreck of *Erebus* will permit additional scientific reconstructions of the ship, its fittings, and operation, both externally and internally. This photogrammetric view of the intact hull underscores the efficacy of advanced recording techniques and the wreck's outstanding archaeological potential (Illustration: F. Werthman, Parks Canada; Photogrammetry: T. Boyer, Parks Canada).

but also justified in the context of the observed impacts of the harsh environmental conditions present in this part of the Arctic. Less intrusive documentation will need to be utilized in more disturbed areas or in pockets harder to access that are not as exposed to the impact of the elements. Documentation with remotely operated tools will likely be the norm for interior zones that offer limited physical accessibility. All the same, the recording will need to be flexible and adapted to the desired objectives and the time restrictions imposed by the situation and the environment. Already, the recording methodology developed during the last three years has embraced this reality, using three-dimensional techniques (multi-beam and photogrammetry) for site mapping, direct survey methods and basic baseline and datum points to support the traditional hand mapping of artefacts (Figures 7.5.2 and 7.5.3). These methods are interrelated through a grid system based on the Parks Canada alpha-numerical methodology which in turn is integrated in a GIS. This flexibility permits the use of just about any recording method, whether traditional or high technology, to provide the required results given the time at hand. In turn, this assembled and synthesized archaeological data is translated into physical models, conceptual reconstructions and archaeological interpretations (see Figure 7.5.3).
