# Wrecks of HMS Erebus and HMS Terror

*HMS Terror Underwater Archaeological Survey April 2017*

*HMS TERROR UNDERWATER ARCHAEOLOGICAL SURVEY*  
*APRIL 2017*

UAT Report: 2018-01

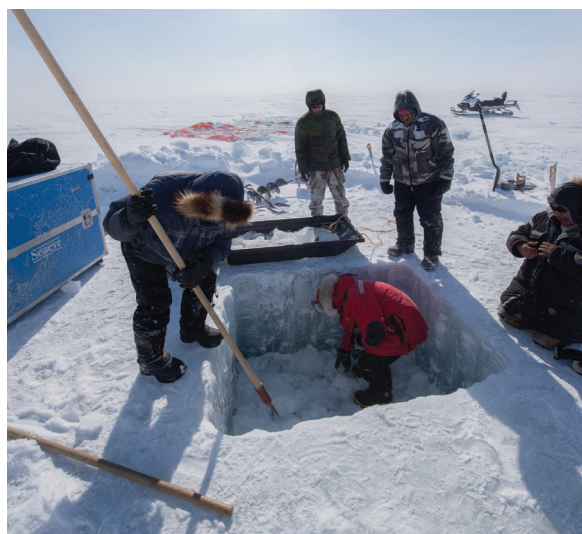
Figure 3.2.2: Excavation of the ROV access hole through thick sea ice (Photo: T. Boyer, Parks Canada; 90M00606EF).

All team members worked on setting up the camp and most importantly digging the access hole through the ice on April 24 and 25 (Figure 3.2.2). A series of short ROV test dives were completed on April 25. The team then conducted five ROV dives over the course of three days (April 26 to 28) to document the wreck using video, still photos and sector-scanning sonar imagery (Table 3.2.2). The camp was dismantled and the site cleared on April 29; that day, UAT and GN staff returned via Twin Otter to Cambridge Bay, while HTA members and CAP staff made their way back to Gjoa Haven by snowmobile.

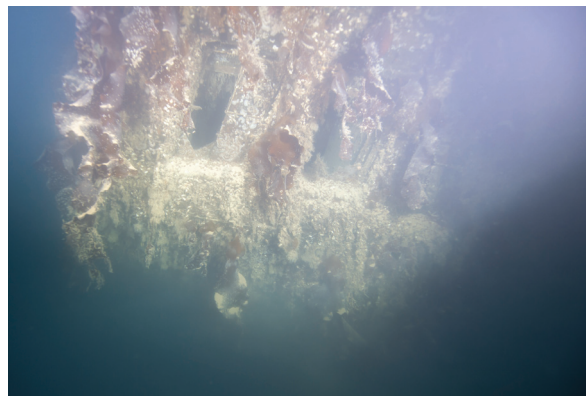
Figure 4.1.1: *Terror*’s stern gallery (Photo: T. Boyer, Parks Canada; 90M00785EF).

The stern gallery is fitted with four double windows, each equipped with four glass panes divided by vertical and horizontal muntins, the rigid wooden frames that support and divide the panes (Figure 4.1.1). From port to starboard, the first external window has its lower left corner pane broken; its muntins and the three other panes are intact. The second window is completely broken; its vertical and horizontal muntins are gone, and only a few glass fragments are preserved along the bottom edge of the frame. The third window is also missing its muntins, although the bottom right glass pane is in position. The fourth and last (starboard) window is intact but covered by sediment and some vegetation. The propeller trunk in the great cabin (as depicted in an 1845 *Illustrated London News* engraving) can be observed through the broken gallery windows.

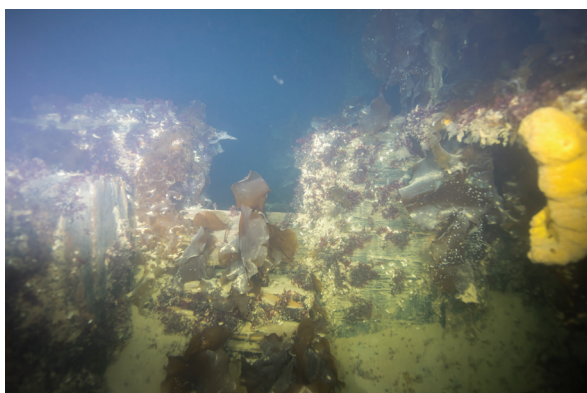
Figure 4.1.2: A boarding port from port side amidships (Photo: T. Boyer, Parks Canada; 90M01061EF).

HMS *Terror*’s bulwarks seem largely intact considering all data available to date. The ice channels running along both sides of the hull also appear to be largely intact. The four boarding ports on the port side of the wreck detected with side-scan sonar in 2016 were also confirmed with the ROV in 2017. Their shape and location are consistent with those shown in 1837/1845 profile plans of *Terror* (Figure 4.1.2). Interestingly, the boarding port on the port side amidships is also equipped with steps atop the ice channel.

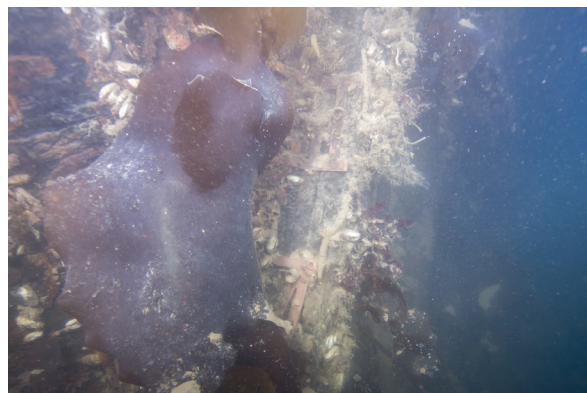
Figure 4.1.3 Rudder post of *Terror* with copper alloy draft marks "XII" and "XIII" (Photo: T. Boyer, Parks Canada; 90M01494EF).

Based on the side-scan sonar and MBES data, the propeller trunk seems filled with wooden chocks. However, this is less than clear based on available ROV photos and video. Thus, although *Terror's* propeller does not seem to be mounted in position within the propeller aperture, this feature needs to be examined further. On the other hand, it is clear that the ship's rudder is not mounted in position on the rudder post. This very distinctive fitting is actually stowed on the port side ice channel between the fore and mainmast shrouds; its lifting sheave is visible. Interestingly, draft marks "XII" and "XIII" are partly visible on the port side of the rudder post (Figure 4.1.3).

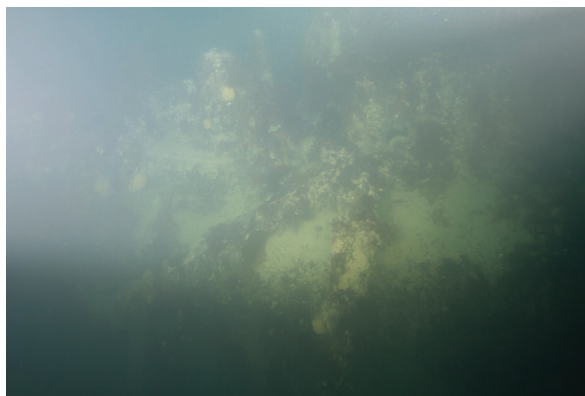
Figure 4.2.1: *Terror's* port bower anchor still in its stowed position (Photo: T. Boyer, Parks Canada; 90M01294EF).

Prior to 2017, there was little substantial information on the positions of the different anchors on HMS *Terror*—as many as 12 based on the 1839 *Terror* and *Erebus* profile. Side-scan sonar data from 2016 suggested that an anchor might be located on the seafloor on each side of the bow. As well, a line or chain seemed to be extending forward from the hull to the port-side anchor on the seafloor. In 2017, the two bower anchors were found to be both still in position and hanging from their catheads. The port side bow anchor is catted at the bow, next to the foremast shroud plate, with its crown pointing aft (Figure 4.2.1). Its upper fluke is inserted through a boarding port. The anchor shackle is located under the cathead, facing forward, and the anchor chain extends from it to the hawsehole farther ahead. The iron anchor stock is unfolded and points straight down. The bower anchor on the starboard side is catted as well, although with its stock still folded and attached. The starboard bower anchor chain

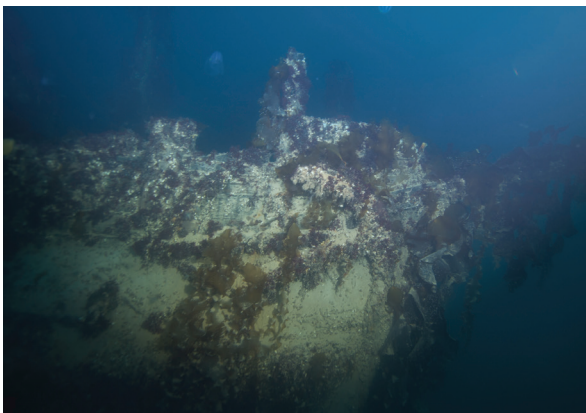
Figure 4.2.2: Two small anchors catted in opposite directions, at the extremity of the ice channel on *Terror*'s port quarter (Photo: T. Boyer, Parks Canada; 90M00781EF).

Two stern anchors are present and secured on the port quarter ice channel, and at least one (possibly two) was observed on the opposite (starboard) side (Figure 4.2.2). The two anchors on the port side are partly overlapping and pointing in opposite directions, rigged at the extremity of the ice channel. No other anchors have been observed on the port-side ice channel or on the upper deck to date. The same could not be verified for the starboard side. This brings the total number of known anchors on the site to five, instead of the eight anchors shown on *Terror*'s 1837/1845 plans. Captain Crozier sent back "2 anchors and cables" to lighten his ship after having loaded all the supplies he could from the supply ship *Barretto Junior* at the Whalefish Islands in July 1845 (Crozier 1845). This would have brought the total number of anchors to six, if none were lost or jettisoned during the expedition. It is worth noting some of the anchors located on the wreck or the seafloor may remain undetected. Given that most of the structures and artefacts observed are at least partly covered in kelp and/or sediment, and on account of the limited visibility and ambient light, it is indeed possible that some anchors have been missed (see Figure 4.0.3).

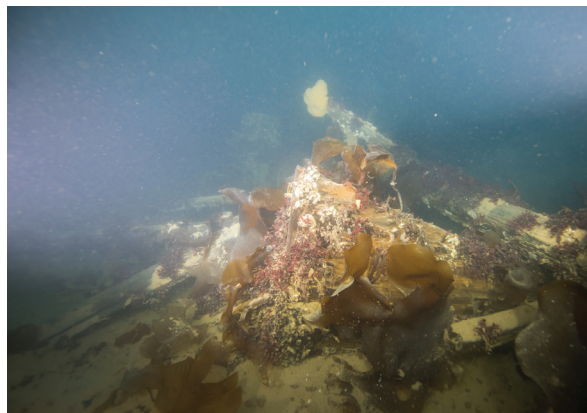
Figure 4.3.1: Forward companionway hood, mostly collapsed, facing forward (Photo: T. Boyer, Parks Canada; 90M01372EF).

The forward companionway's hood is largely collapsed, with some spars resting on top of it. Its port-side aft corner post is still standing, and it has a brass hinge on its face, likely for the door that opened to the port side (Figure 4.3.1). This post was observed during a dive in 2016 (Dagneau 2016:07). The starboard-side half of the forward companionway area is unobstructed by debris and represents the largest opening observed thus far on the upper deck. Although this fore hatch and its associated companionway are absent from 1837/1845 *Terror* plans, they closely match those on 1839 plans. Reportedly the MV *Martin Bergmann*'s crew used this opening in 2016 to introduce a small ROV into the wreck (Watson 2017:330–332).

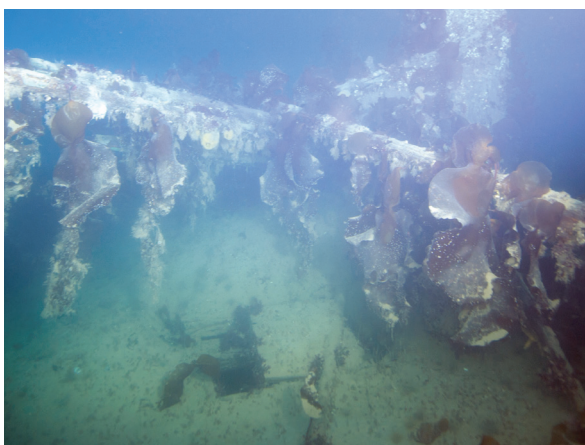
Figure 4.3.2: Main hatch, mostly covered with sediment, with a narrow opening, visible in front of the main mast (Photo: T. Boyer, Parks Canada; 90M0751EF).

The next opening on *Terror*'s upper deck is the main hatch, located forward of the mainmast (Figure 4.3.2). Although clear of any debris, this large hatch is almost entirely covered by sediment, except for a narrow opening on its forward edge. Its entire outline is however traceable through the overlying sediment cover and seems to agree with 1839 plans. None of the companionway structures depicted on the 1837/1845 plans seem present.

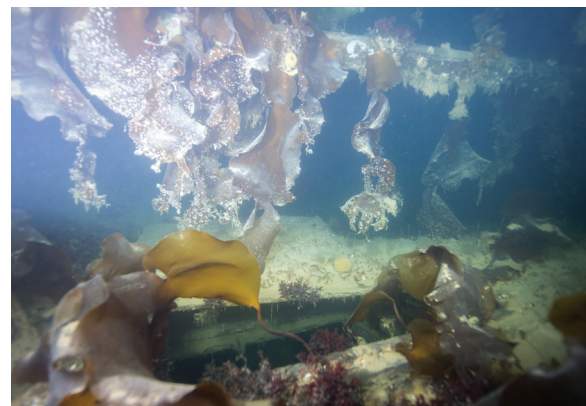
Figure 4.3.4: Officers' mess skylight, or corresponding modified hatch slightly open on its port side (Photo: T. Boyer, Parks Canada; 90M1139EF).

Based on the upper deck ship plan, the next opening on *Terror*'s upper deck moving aft is a skylight located above the officers' mess. This opening is almost completely covered in sediment (Figure 4.3.4). Its roof seems to stand much lower than the nearby captain's cabin skylight. This may indicate this elevated skylight was replaced by a standard hatch and coaming. The hatch is topped with a wooden board that is slightly displaced to starboard, thus leaving a narrow (ca. 25 cm) opening along the port side frame.

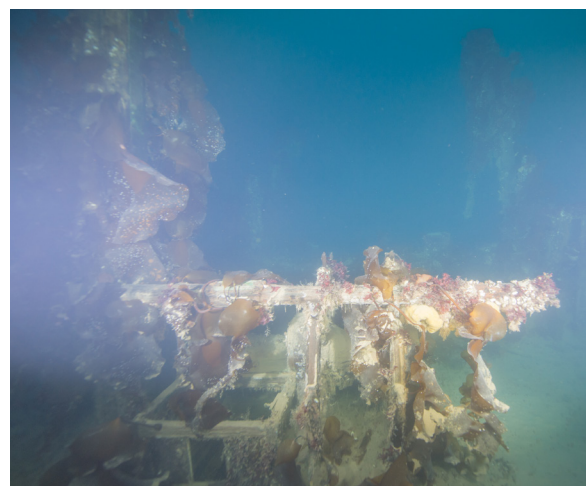
Figure 4.3.5: Captain's cabin skylight and double-wheeled helm (Photo: T. Boyer, Parks Canada; 90M01238EF).

At the stern, the captain's cabin skylight and frame are generally intact but the uppermost, port-side vertical frame is missing (Figure 4.3.5). This distinctive skylight has at least one of its window panes missing, on the port side. This opening is just forward of the double-wheeled helm that still stands on its pedestal. As noted above, the configuration of the hatches and skylights on the upper deck, and notably the helm's mounting position close against the captain's cabin skylight head ledge are all consistent with the *Terror*'s 1837/1845 or 1839 plans (Moore and Dagneau 2017:23).

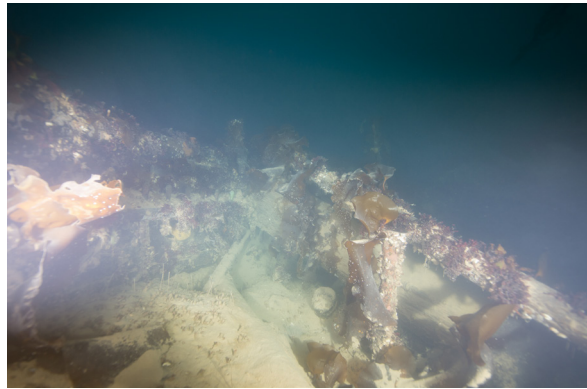
Figure 4.4.2: *Terror*'s bowsprit heel, stepped in a manner consistent with the *Terror*'s 1845 modifications (Photo: T. Boyer, Parks Canada; 90M1711EF).

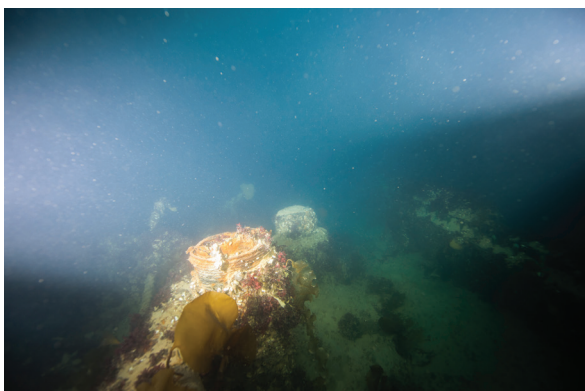
Figure 4.4.3: Fore mast stump, looking aft. The windlass' port side carrick bitt is visible in the background (Photo: T. Boyer, Parks Canada; 90M1315EF).

The foremast is preserved to a height of less than 1 to 2 m above the upper deck. The remaining structure observed both through diving and ROV operations appears more like an empty corrugated iron tube (Figure 4.4.3). It is possible that an iron cable was used for serving the mast if it was sprung. For this reason it was first misidentified in 2016 as a large funnel. One large upper rigging component was documented on the starboard side close to the foremast. Its heel rests on the starboard bulwark and points upwards, and its (original) upper extremity rests on the seafloor at depth. This rigging component is likely a lower yard (foreyard or mainyard), as it is fitted with a large iron yard

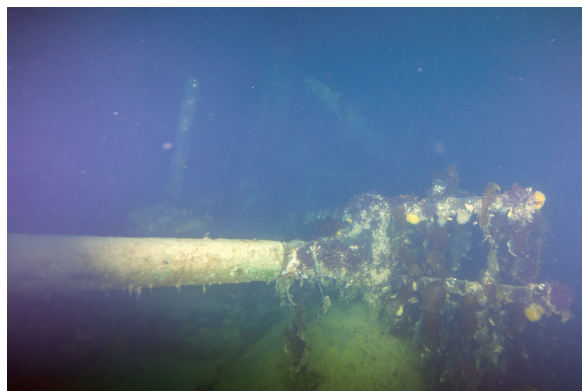
Figure 4.4.5: Possible mizzen topmast with its upper end partly resting on the starboard bulwark (Photo: T. Boyer, Parks Canada; 90M01633EF).

Another large mast component approximately 8 m long may be associated with the mizzenmast. This topmast sits across the upper deck next to the mizzenmast, with its upper end, consisting of a trestle tree and cross-tree (a platform for the top), partly resting on the starboard bulwark and partly outboard (Figure 4.4.5). The top portion of the suspected topmast is covered with a copper alloy plate similar to the one observed on the mizzen, in this case, to prevent chaffing from the gaff's jaws.

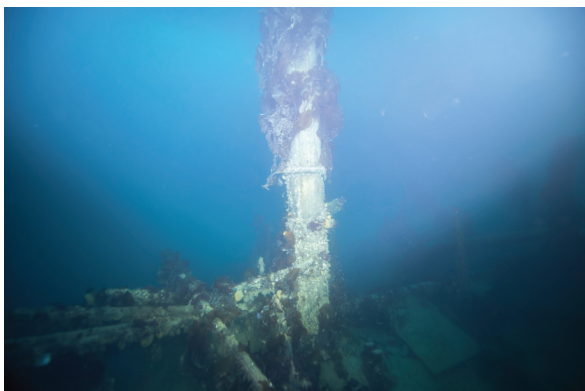
Figure 4.4.4: Mainmast, viewed from the port side forward (Photo: T. Boyer, Parks Canada; 90M0741EF).

*Terror's* mainmast is preserved approximately to 7 m above the upper deck, with its broken head at a depth of 12 m. The mast is fitted with multiple reinforcing mast bands throughout its in situ height (Figure 4.4.4). A copper alloy lightning rod is inserted on its aft face, following Harris' Patented Lightning Conductor for Ships specifications (Harris 1840). Two vertical stanchions with a U-shaped head are situated on each side (yet slightly aft) of the mainmast; these are supports for the Massey Patent bilge pump cranks. There is also a pair of small yards running fore-and-aft, forward of the mainmast, that probably correspond to a (retractable/extendable) studding sail yard; the top yard part is meant to slide out on the bottom yard part, to extend the studding sail on both sides.

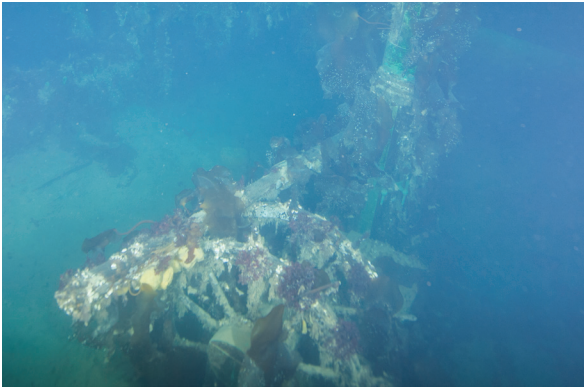
Figure 4.4.6: Mizzenmast, ship's wheel and captain's cabin skylight viewed from the starboard stern (Photo: T. Boyer, Parks Canada; 90M01620EF).

The mizzenmast is preserved to a height of 5.5 m above the upper deck and is at a depth of approximately 13.5 m (Figure 4.4.6). It is fitted with a lightning conductor of similar design to that of the mainmast. The mizzenmast also appears to be made of two different sections; the lower portion is wider in diameter, and equipped with a spider band. This all-metal pinrail of copper alloy forms a collar around the mast and is fitted with multiple belaying pins. It can be discerned in a daguerreotype portrait of Lieutenant LeVesconte on *Erebus* (1845). The upper portion of the mizzen, slightly narrower, is inserted in the lower portion through a "saddle," likely for the spanker boom to sit on. The mast is protected by copper sheathing just above the saddle, where the spanker's jaws would rub on the mast.

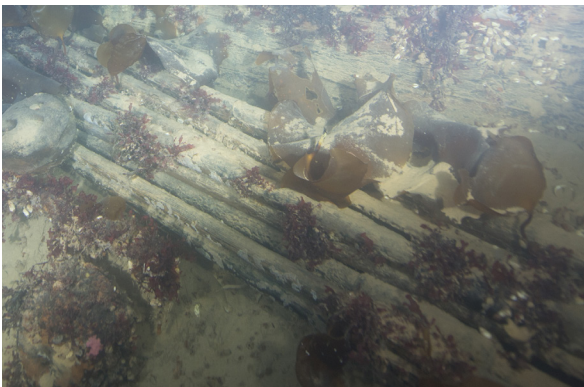
Figure 4.4.7: Six to eight oars stored on the port side mainmast shroud plates (Photo: T. Boyer, Parks Canada; 90M0953EF).

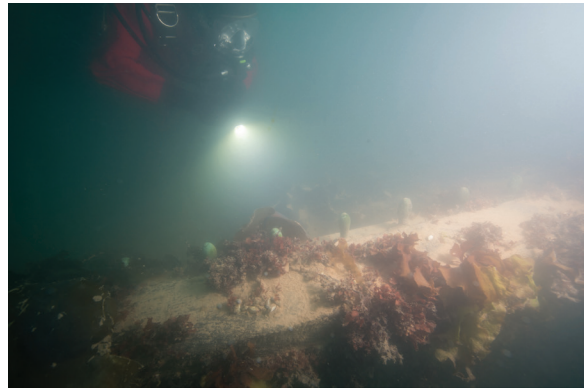
Figure 4.4.8: Pinrail (or pin rack) on the port side amidships with belaying pins in position (Photo: T. Boyer, Parks Canada; 90M00164EF).

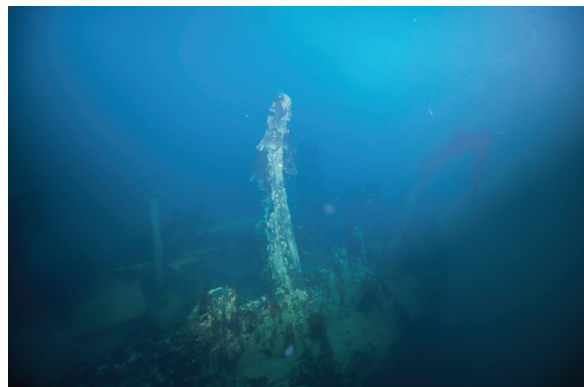
Figure 4.5.1: Pair of davits on the port quarter (Photo: T. Boyer, Parks Canada; 90M00755EF).

Although mostly damaged, two pairs of boat davits survive on both sides of the wreck, as well as one pair at the stern, yielding a total of five pairs observed to date. The side davits are not of a type depicted in the mid-ship section plan of *Terror* from 1839 that have straight uprights; rather they have curved heads as depicted by the 1848 midship section of HMS *Investigator*, and by contemporary artwork showing *Erebus* and *Terror* in 1845 (for example, Stanley 1845a; 1845b; Figures 4.5.1 and 4.5.2). Each davit is composed of a curved davit post affixed to the exterior of the bulwarks and an associated davit stanchion fitted inside the bulwark. Despite the discrepancy between their

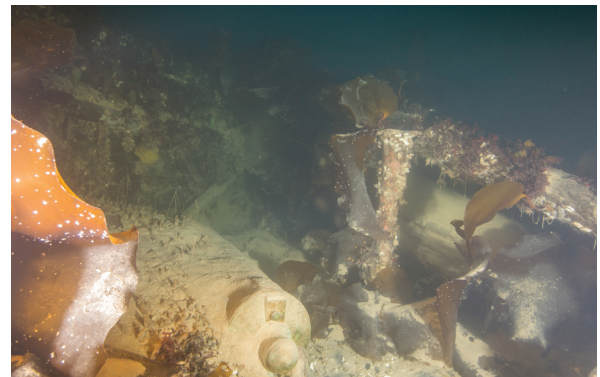
Figure 4.6.1: Bronze cannon at the bow. A grey metal pipe is visible between the gun and the bowsprit (Photo: T. Boyer, Parks Canada; 90M1708EF).

The MV *Martin Bergmann*'s crew first reported a bronze cannon at *Terror*'s bow following an ROV dive to the site in 2016 (Watson 2017:330–332). Although the cannon could not be relocated during the 2016 UAT archaeological dives, it was recorded during the 2017 ROV operations. The bronze cannon lies prone on the upper deck on the port side of, and more or less parallel with, the bowsprit heel (Figure 4.6.1). While mostly buried, its cascabel and vent patch are clearly visible, demonstrating that the breech is towards the stern and

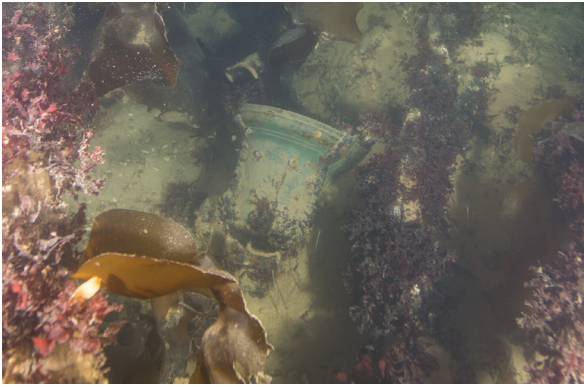
Figure 4.6.2: *Terror's* bell, bedded in silt and nestled amongst wooden debris between the forward companionway and the windlass (Photo: T. Boyer, Parks Canada; 90M01792EF).

by the crew of the MV *Martin Bergmann*—situated between the windlass and the forward companionway, lying on its side on the sediment covering the upper deck, and amongst wooden debris (Figure 4.6.2). Its overall shape is similar to HMS *Erebus's* bell (89M99X1-1) but no dates or markings on it have been observed given its partial burial (Moore et al. 2017:116–118).

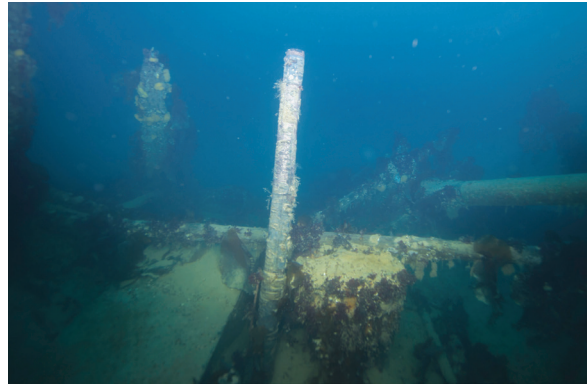
Figure 4.6.3: Possible funnel located between the aft companionway (left) and the capstan (right) (Photo: T. Boyer, Parks Canada; 90M1128EF).

One of the most prominent features of the *Erebus* wreck site, its capstan, is a feature also found on *Terror*. It stands upright on the upper deck in the space between the main and mizzenmasts (Figure 4.6.3). Although it appears to be intact, not much

similar feature has been observed projecting out of the sick bay of the wreck of *Erebus*. The second pipe (ca. 40 cm in diameter and about 1 m high) located aft of the forward companionway, is covered by iron corrosion product. Although its location suggests it should be a pump tube, its shape and material makes it more likely a funnel for the Frazer Patent stove or the Sylvester heating apparatus below.

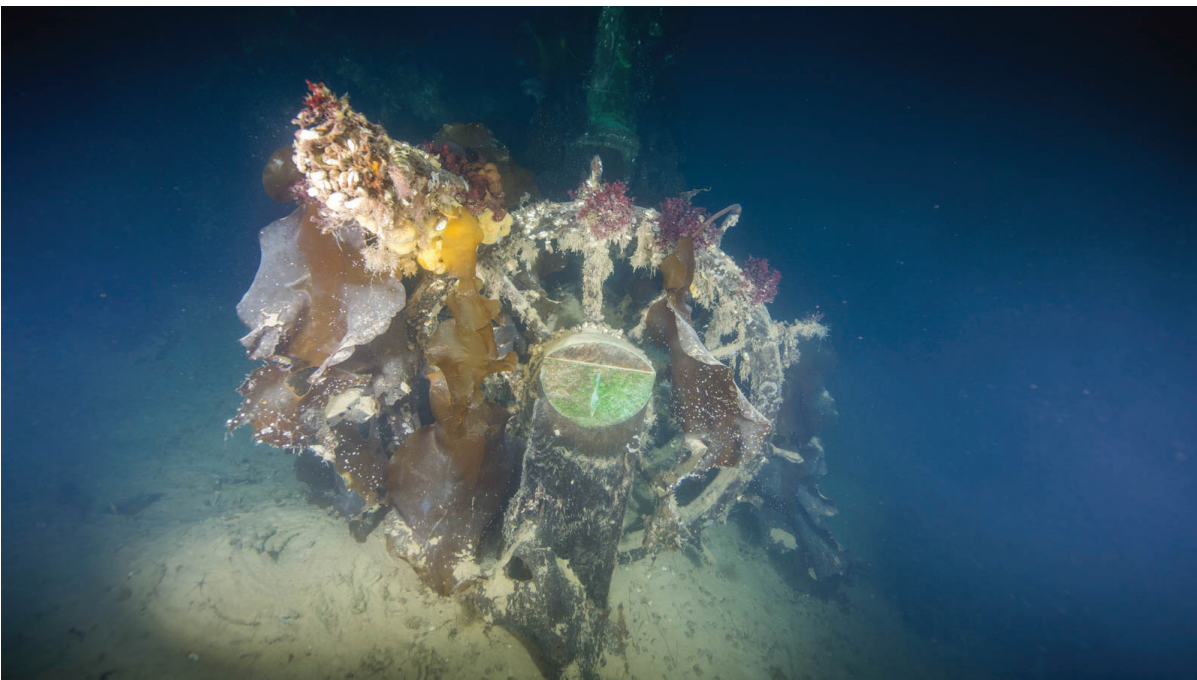
Figure 4.6.4: *Terror's* double-wheeled helm, looking forward. Its barrel aft face is copper sheathed, and fitted with an inclinometer (heel indicator) (Photo: T. Boyer, Parks Canada; 90M01609EF).

can be said at this point about it, as it is largely covered by marine growth and sediment. Another important and amazingly well preserved feature on *Terror's* upper deck is its double-wheeled helm, located aft of the captain's cabin skylight (Figure 4.6.4). It still stands on its pedestal, with remains of the tiller rope still wrapped on the barrel. The steering device is partly obscured by vegetation and a fore-and-aft spar that fell on top of it. Interestingly, the aft face of the pedestal is fitted with an inclinometer (heel indicator). As noted above, the helm's mounting position close against the captain's cabin skylight head ledge is consistent with the *Terror's* 1837/1845 and 1839

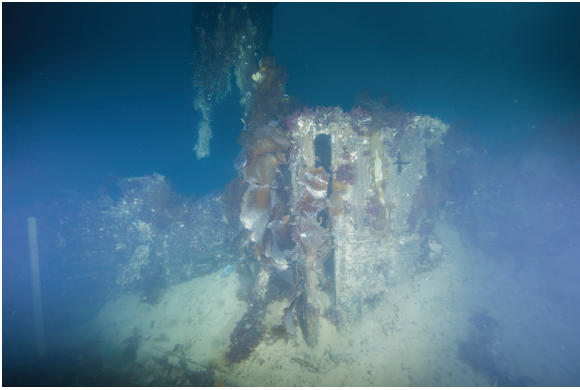
Figures 4.6.5: Starboard side water closet, looking aft to starboard. Its door is partly open (Photo: T. Boyer, Parks Canada; 90M01596EF).

The starboard side water closet has its sliding door only slightly open. The side wall of the cabin has a star shaped opening, presumably for lighting and ventilation. The port side water closet has its door completely open (or missing); one can see a white (possibly painted) shelf, as well as a toilet seat, chest, or bench inside. These two spaces are the most elevated structures of the wreck, along with the remaining main and mizzenmasts and the davits. Their state of preservation is quite astonishing and very promising.

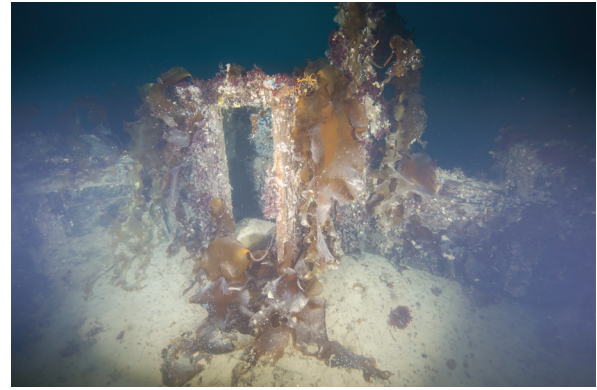
Figures 4.6.6: Port side stern water closet, looking aft towards the port side (Photo: T. Boyer, Parks Canada; 90M1570EF).

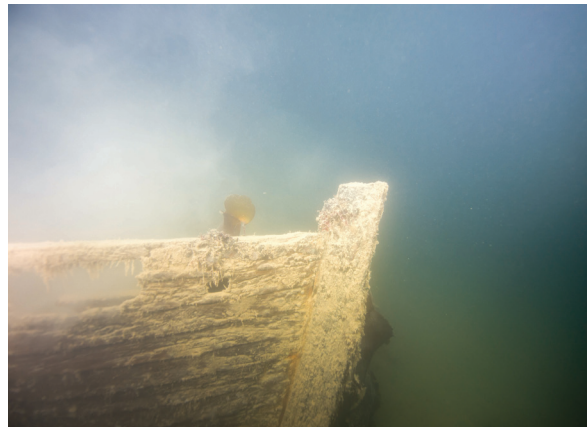
Figure 4.7.1: The bow of the boat with its stem at right (Photo: T. Boyer, Parks Canada; 90M1515EF).

its bow facing north-northwest (ca. 310° True). It is in good condition with the exception of its upper strakes and weather board. The clinker-built boat has a curved, V-shaped stem, gunwales fitted with square oarlocks, and a square transom with a distinctive cut-out boom support. The stem of the boat was examined in detail. Due to silt cover it is not possible to state if any identifying markings typical of the period, such as the boat’s length and

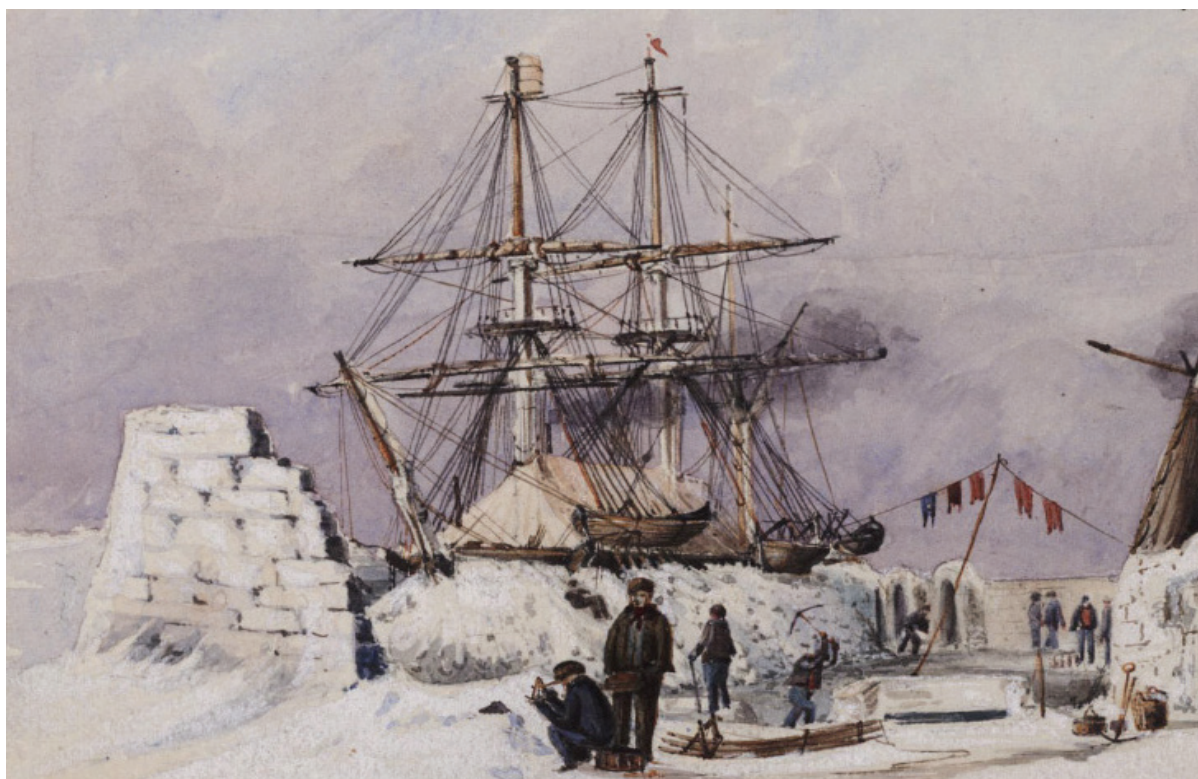
Figure 4.8.1: “H.M.S. Terror January 1837”, by Owen Stanley, showing the *Terror* in winter quarters during Sir George Back’s 1836-1837 expedition into Hudson Bay (Courtesy: The Thomas Fisher Rare Book Collection, University of Toronto, F7383).

The presence of vertical stove funnels, including one within the capstan bars swing space, winter hoods on the companionways, and possible covering structures on the forward boarding ports all seem to indicate the ship was left in winter quarters (i.e. in a cold weather configuration) (Figure 4.8.1). This suggestion is also supported by the presence of two fore-and-aft spars, both situated

At this stage, it is unclear what combination of forces or circumstances, both natural and human, brought *Terror* into Terror Bay. But based on the preliminary data presented within this report, it appears more likely that *Terror* was in a winter quarters configuration rather than ready for navigation in open water.
