# Wrecks of HMS Erebus and HMS Terror

*Underwater Archaeological Survey of HMS Terror and  
Excavation of HMS Erebus in 2019*

UAT Report: 2021-01

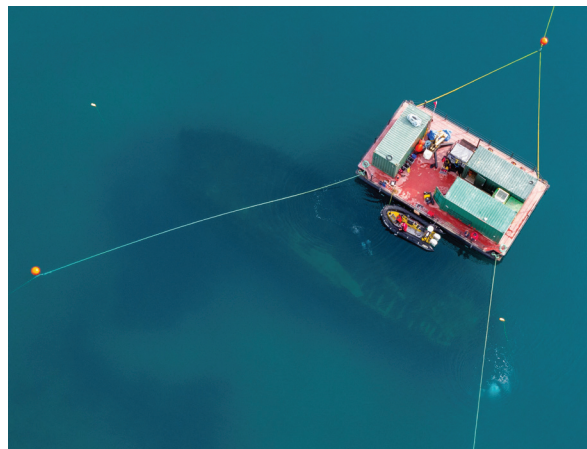
Figure 1.4.2: Support barge *Qiniqtiryuaq* being positioned over the *Erebus* site (Photo: T. Boyer, Parks Canada; 89Mo9878EF).

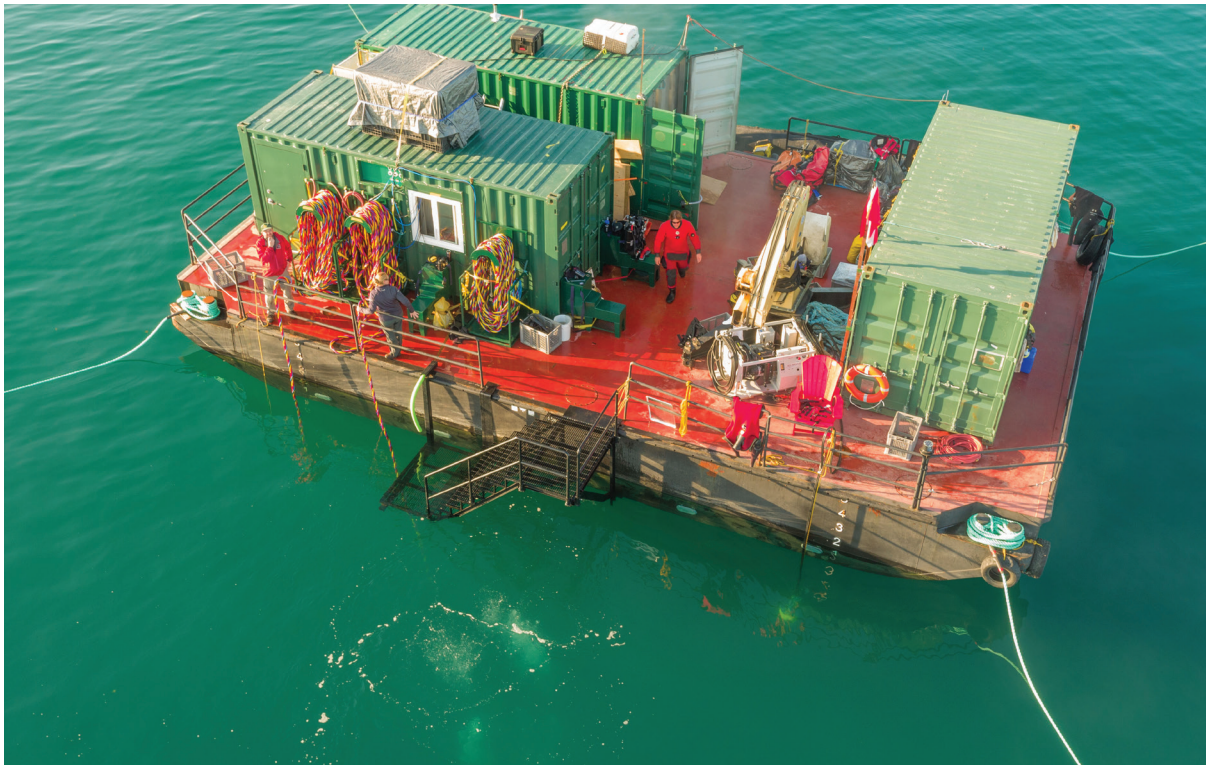
Figure 3.1.1: Diving and excavation support barge *Qiniqtiryuaq* over the *Erebus* site (Photo: T. Boyer, Parks Canada; 89M09958EF).

Parks Canada's 15-m support barge *Qiniqtiryuaq* acted as the diving and excavation platform at the *Erebus* site, while anchored over the wreck using a four-point mooring system (see Figure 3.1.1). Over the years since 2016, it was gradually equipped with three modified 20-ft shipping containers, plus a hydraulic crane and dive stairs. A dive container comprises all dive controls for surface supply and scuba diving, as well as emergency communication and first aid equipment, including a hyperbaric recompression chamber. Air and treatment gasses are stored outside in high-pressure K-bottles in adjacent cages. An equipment container is used for general equipment storage, and to house the main electrical power generator and low pressure compressor(s) for surface supply diving. UAT's high pressure air compressor and hydraulic power unit are also stored in this

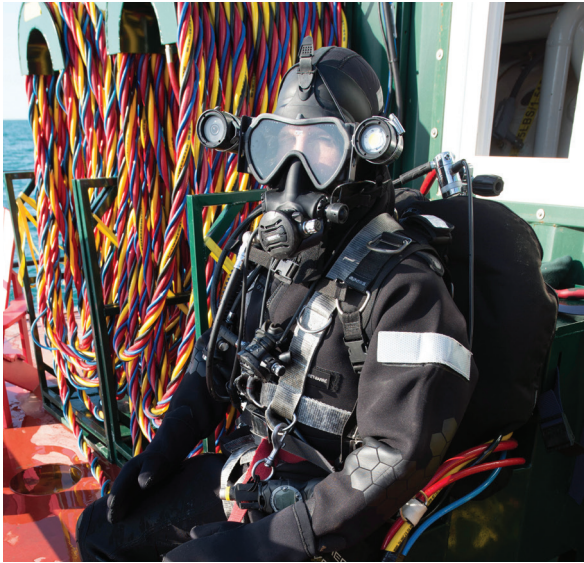
Figure 3.5.1: Underwater Archaeologist Alexandre Poudret-Barré equipped with lightweight surface supply gear on, prior to diving (Photo: J. Moore, Parks Canada; 89M10362EF).

The work on *Erebus* was carried out primarily using lightweight surface supply diving methods, although scuba was also used on occasions, following the same configuration as for *Terror*. In surface supply diving configuration, the dive team comprised a minimum of seven persons: two divers; two dive tenders; a dive supervisor; and stand-by diver and tender. In a few cases, an additional third diver would work on scuba. Each surface supplied dive employed the following equipment: a 3-person OTS dive panel; OTS Aquacom MK2 surface communications box; OTS Spectrum full face mask with Apeks regulator; hardwired 3-way communications system; AXSUB video camera and dive light; buoyancy compensator and backpack; 100 cubic ft. bail-out tank feeding both the main and a back-up second stage regulator; and finally a hot-water suit or drysuit (Figures 3.5.1 and 3.5.2).

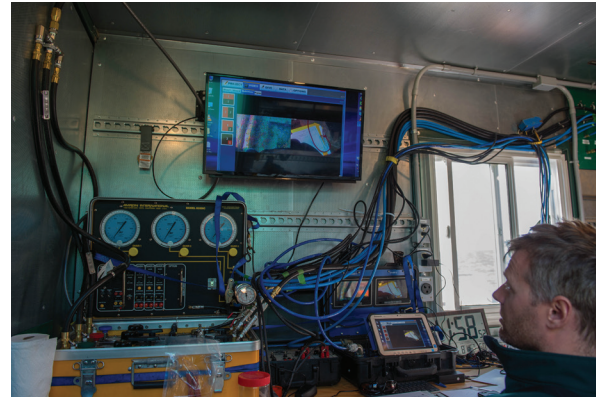
Figure 3.5.2: Diving Systems Technologist Joe Boucher supervising a dive on *Erebus*, from within the dive container (Photo: T. Boyer, Parks Canada; 89Mo9964EF).

Diving umbilicals were composed of an air hose, pneumofathometer hose, communication line, video/light cable, and hot water hose.

Breathing air was supplied from a low-pressure diesel compressor with an associated volume tank. Banks of high-pressure breathing and treatment gases were stored in large K-bottles on the barge adjacent to the dive control container, as a back-up air supply and to run the hyperbaric chamber, if need be. The dives were carried out from the support barge *Qiniqtiryuaq* moored directly over the wreck of *Erebus*. Most dives were made using hot water suits fed by a Monkey Heater hot water system on the surface. This system helped to maximise bottom time for each dive given the cold water environment. Only no-decompression dives were performed and dive times adhered to the DCIEM tables (1992). Given the shallow depth of *Erebus*' lower deck and the comfort provided by the hot water system, the amount of bottom time for a single dive could often reach 2 hours, sometimes 3 hours.

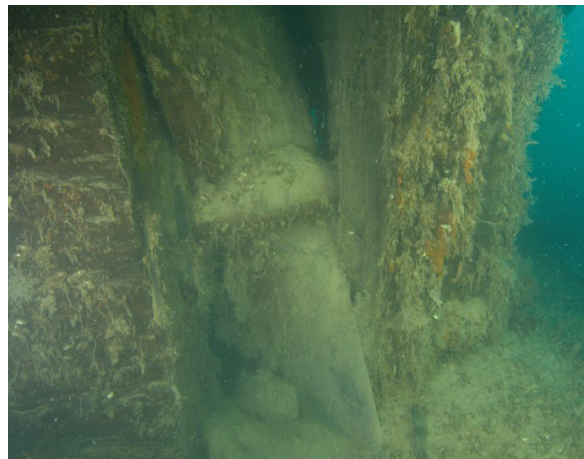
Figure 4.1.2: *Terror*'s propeller in its working position within the propeller aperture (Photo: M.-A. Bernier, Parks Canada, 90M02819EF).

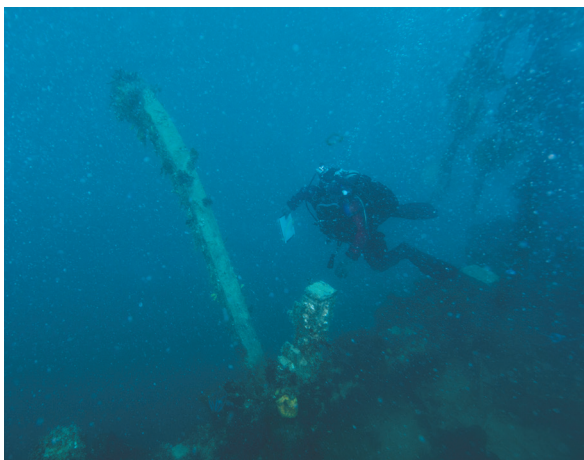
Figure 4.1.3: Mostly complete davit on the starboard side of the upper deck, abreast the mizzen mast (Photo: A. Poudret-Barré, Parks Canada; 90M2129EF).

There are two pairs of boat davits on each side of the wreck, as well as one pair at the stern. As noted in 2017, the side davits are not of a type depicted in the midship section plan of *Terror* and *Erebus* from 1839 that have straight uprights; rather they have curved heads as observed in multiple examples of artwork depicting *Erebus* and *Terror* during the first weeks of the expedition, and in a later 1848 midship section of HMS *Investigator* (NMM 1848; Stanley 1845; Figures 4.1.3 and 4.1.4). However, their locations are consistent with the *Terror*'s 1837/1845 upper deck plan (NMM 1839a). Each side davit is composed of a curved davit post affixed to the exterior of the bulwarks and an associated davit stanchion fitted inside the bulwark.

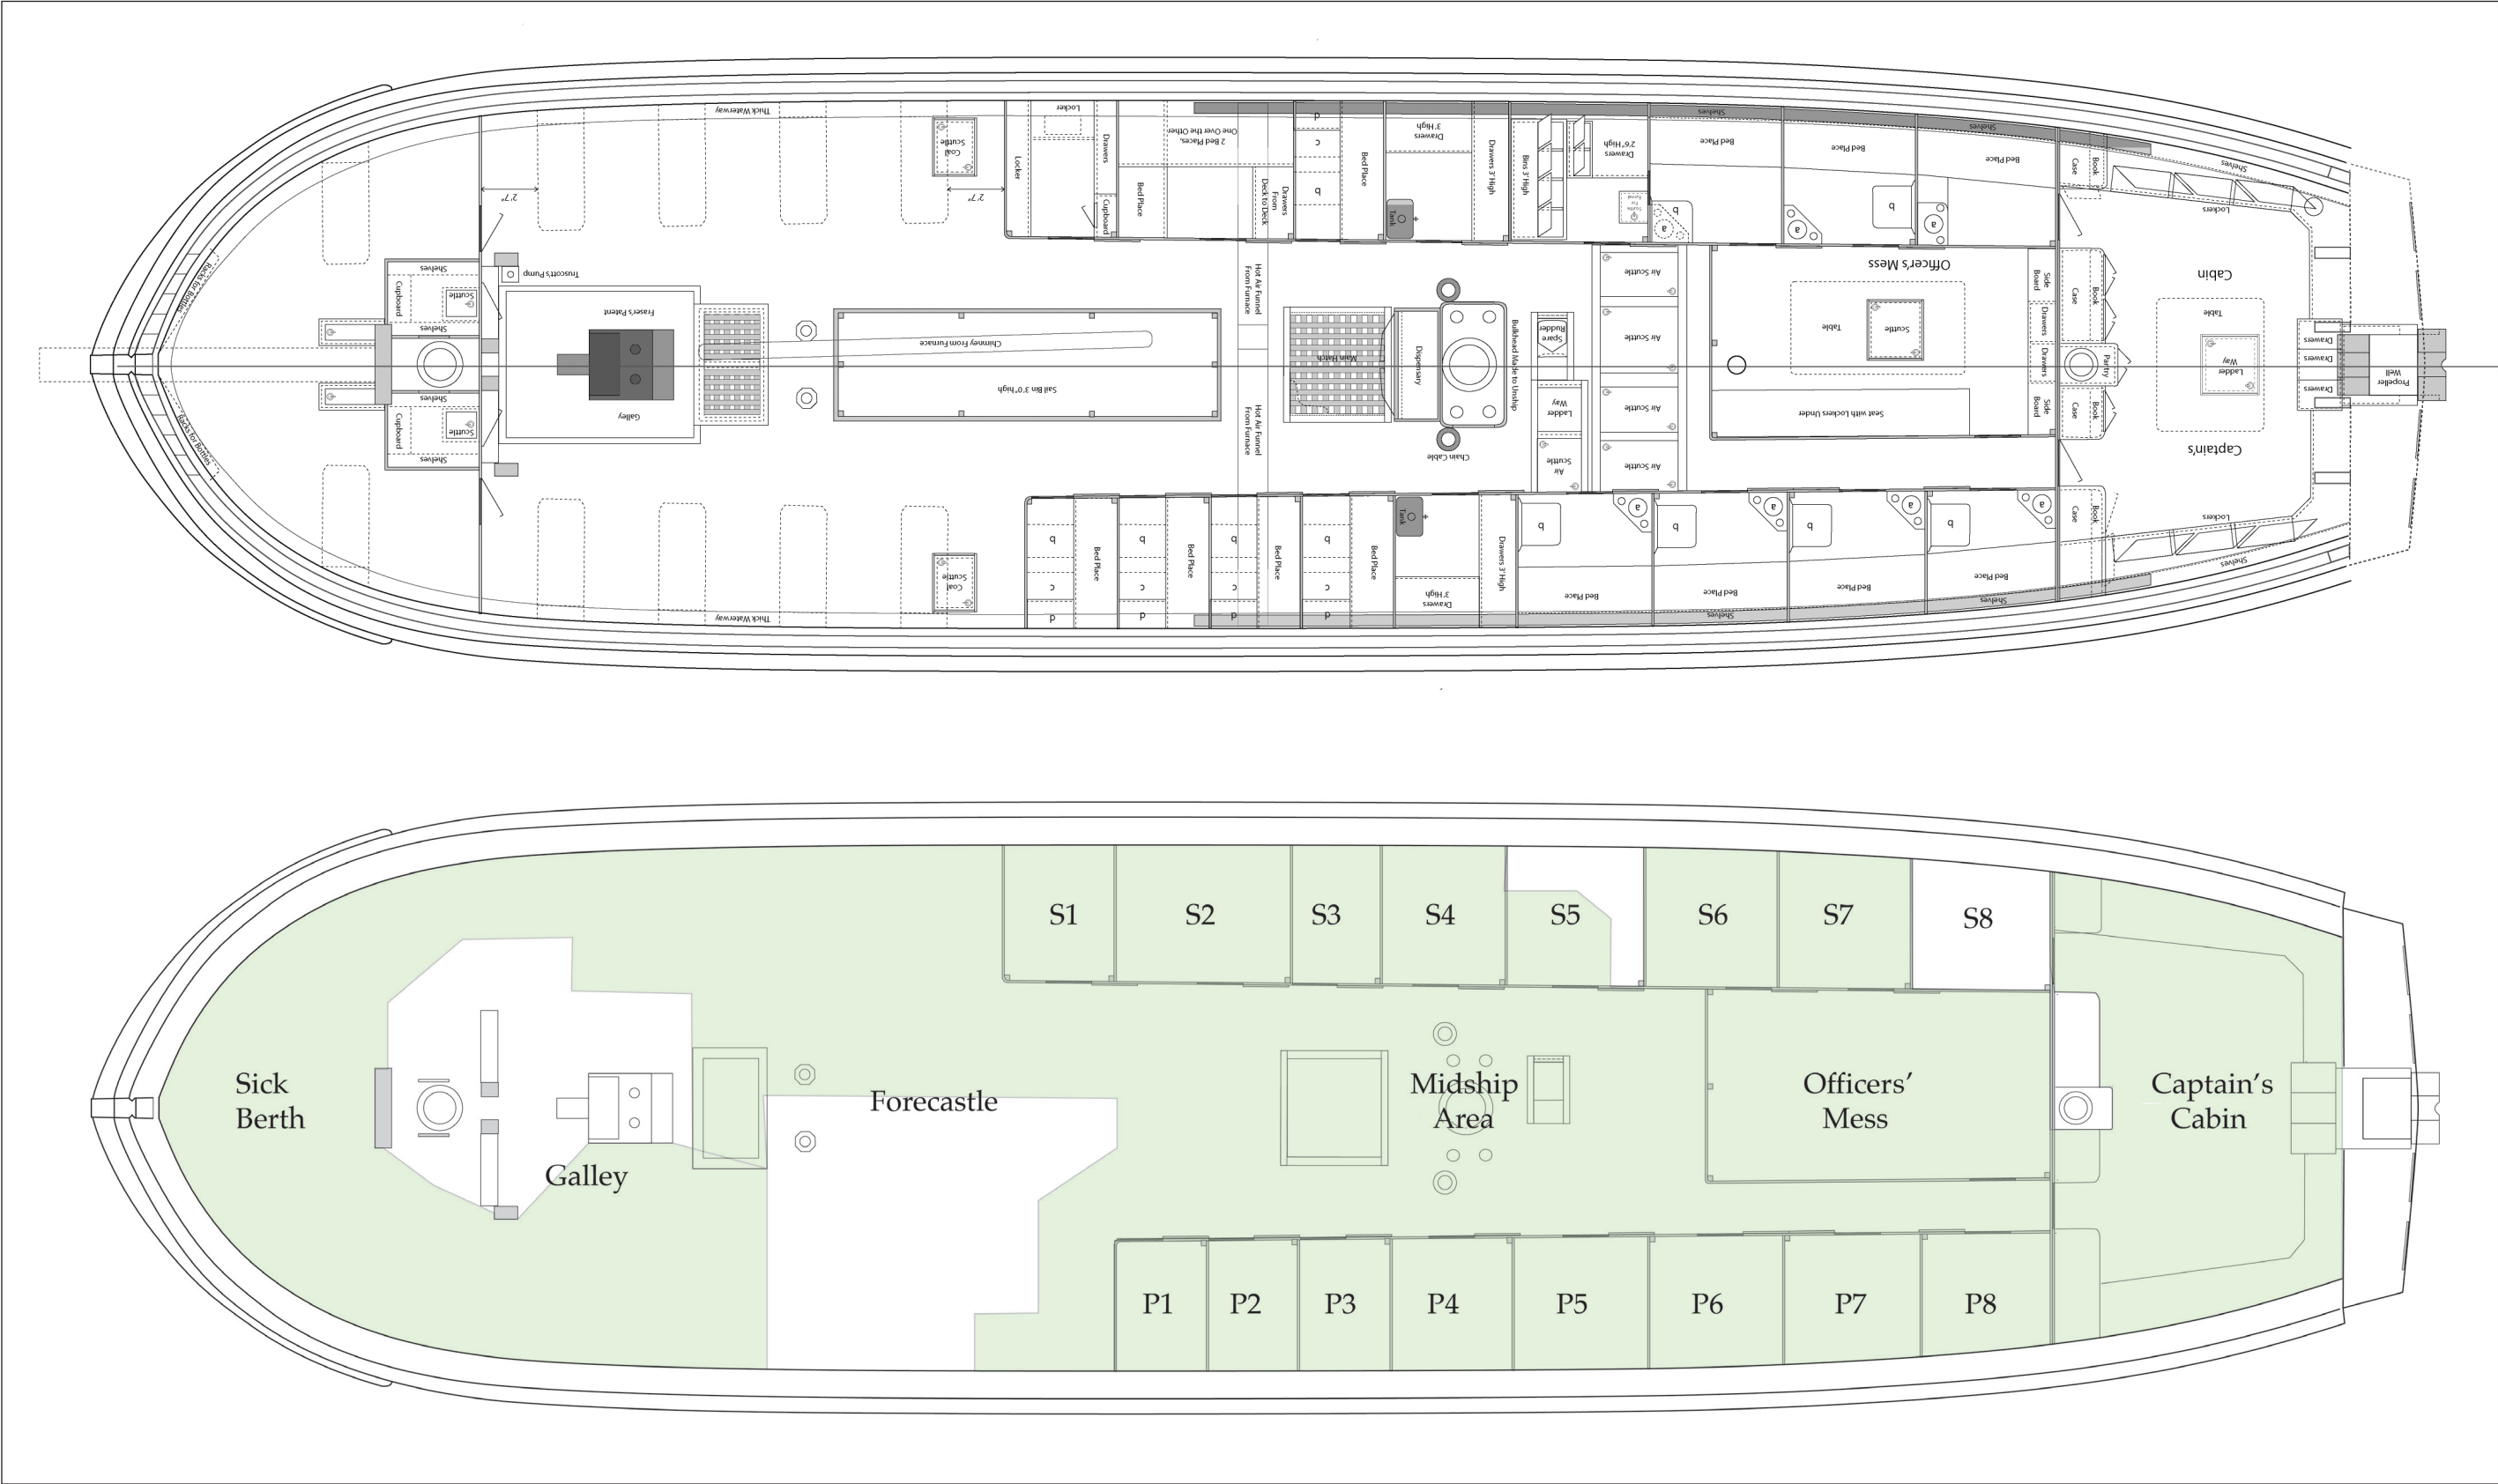
Figure 4.2.4: Top: *Terror's* lower deck reconstruction by Matthew Betts, based on the *Plan of the Terrors Lower Deck*, and *Profile of the Terror*, including modifications from both 1837-1839, and 1845 (Drawing: M. Betts, 2016); Bottom: Key map of *Terror's* lower deck showing ROV video coverage and naming and coding of discrete spaces. The outline of the vessel is based on *Terror's* ship plans (NMM, 1837a; 1837b; Betts 2016). Bulkheads and features are drawn based on archaeological data (Drawing: C. Dagneau and R. Harris, Parks Canada).

*Terror's* lower deck general configuration follows closely the *Terror's* ship plans (NMM 1837a; 1837b) as well as a reconstruction made by Betts (2016; Figures 4.2.1–4.2.4). However, there are a few noticeable dissimilarities worth mentioning. The first discrepancy is that there is no in situ bulkhead between the forecastle and sick berth, as was the case during Ross' 1839–1843 Antarctic Expedition, and as observed on *Terror's* lower deck plan (Betts 2016; NMM 1837b). Indeed, these were designed to be removed. Second, there are only eight cabins on *Terror's* port side, instead of nine on the ship plan, while the number of cabins shown on the starboard side is the same at eight. Lastly, there are no lateral bulkheads and no visible cupboards next to the foremast and galley, and no bulkheads at all around the mainmast and bilge pumps; these partitions were either removed (as they were designed to be) or have collapsed (Figure 4.2.4).

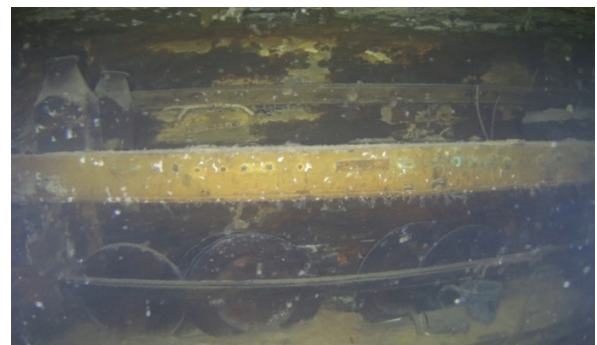
Figure 4.2.5 Shelving on the port side of *Terror's* forecastle, containing dinner plates, soup plates, and different types of containers (Video: R. Harris, Parks Canada; 90M02814EF).

- Shelving between deck knees is present throughout, and holds a great number of ceramic dinner plates (at least 16) and soup plates (6), glass bottles of different types (22), and other artefacts in lesser number, such as cups, jars, and potential tin cans (Figure 4.2.5);
- One of the mess tables is still in place, and it is located on the port side next to the galley. At least two mess table supports are visible elsewhere (Figure 4.2.6);
- Between 19–20 seamen's chests are observed, a number that is consistent with the number of mess tables. Many chests seem to have migrated from the forecastle aft towards the main hatch area, possibly during the sinking of the vessel;

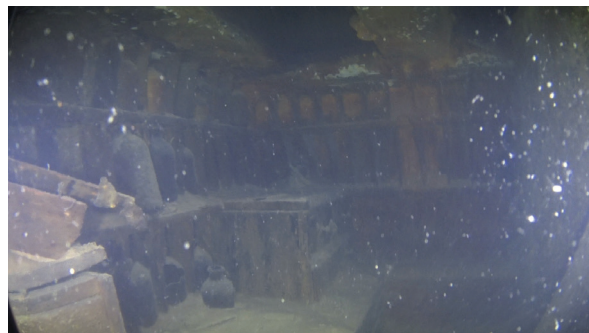
Figure 4.2.7: Port side and aft walls are covered with shelving and alcoves in storage room P1 (Video: R. Harris, Parks Canada; 90M02755EF).

Moving from bow to stern, the first cabin space on the port side, cabin P1, is a storage room. A furniture piece with four drawers is located on the aft wall. Two smaller and narrower pieces of furniture sit on it (Figure 4.2.7). The port side and aft wall are covered with shelving and alcoves, containing more than 18 bottles of different types, although mostly cylindrical, short-neck bottles. One of them bears a seal on its body and its stopper is

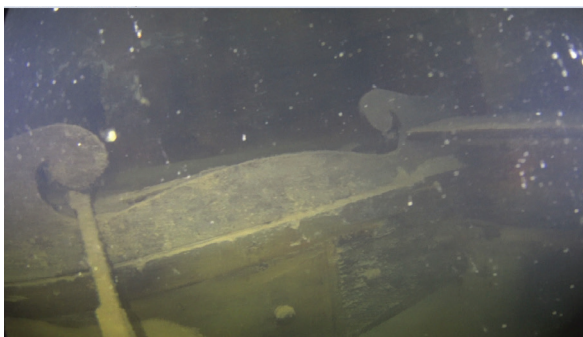
Figure 4.2.8: Fitted bed with four drawers underneath in cabin P2 (Video: R. Harris, Parks Canada; 90M2761EF).

Cabin P2 is fitted with a bed place along its aft wall, with an intact lee board (bed rail), and four drawers underneath (Figure 4.2.8). There is a chair in the middle of the space. Part of the starboard (inner) cabin wall has collapsed. A chamber pot is in the forward port side corner of this space. A few bottles, an ink well and a possible epaulette (two buttons at least) are on different shelves. Cabin P3 also shows a possible (relatively short) bed place oriented longitudinally, with four drawers below (Figure 4.2.9). A chair lays in the doorway. Most of the shelving on the aft wall has collapsed, and there are no obvious discernable artefacts. Cabin P4 seems to display the same basic layout as bed cabins P5 to P8, with its possible bed place along the ship's wall (port side) and four drawers underneath (Figure 4.2.10). However, it is not clear if the said furniture is a bed or not. A few bottles, plates, tumblers, and stemware were observed. According to *Terror's* lower deck plan, this space could be the Captain's Steward's pantry, but it could also be a bed cabin.

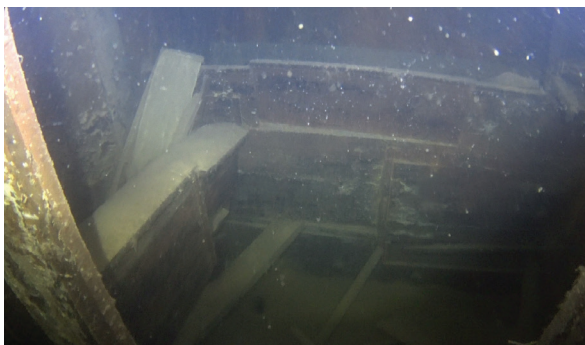
Figure 4.2.9: Possible bed place (top right) and drawers underneath in cabin P3 (Video: R. Harris, Parks Canada; 90M2759EF).

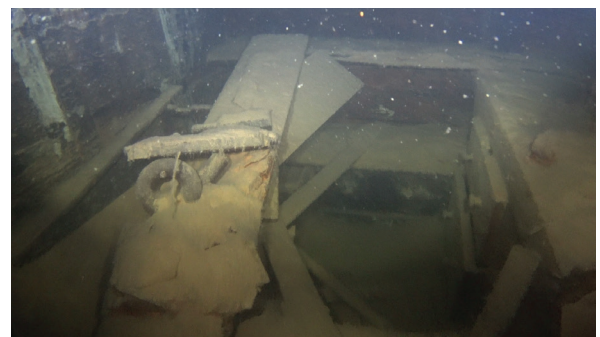
Figure 4.2.10: Fitted bed (middle) and furniture (right) with drawers underneath in cabin P4 (Video: R. Harris, Parks Canada; 90M2763EF).

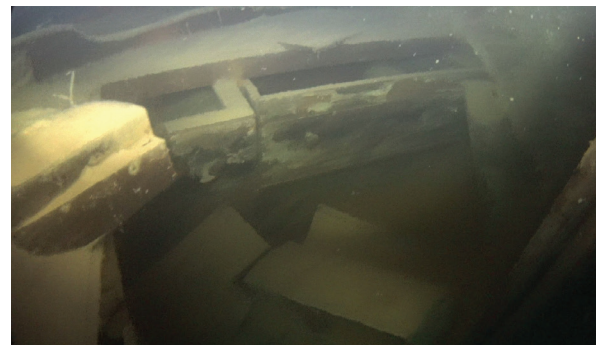
Figure 4.2.11: Fitted bed (top), drawers and sextant box (left) in cabin P5 (Video: R. Harris, Parks Canada; 90M2766EF).

Cabins P5–P8 are without doubt bed cabins (Figures 4.2.11–4.2.14). They all present the same configuration with slight variations: a fitted bed place with four drawers underneath along the ship's hull side, consistent with *Terror's* lower deck plan; shelving along the hull side between deck knees; and corner shaving tables (which may be hidden in cabins P6 and P7). Fitted furniture resembling desks or dressers are observed along the aft walls of cabins P5, P6, and P7, but not in cabin P8. The latter is probably equipped with a removable table. According to the "Plan of the Terrors Lower Deck", these four cabins, P5–P8, are believed to correspond to Lieutenants' and the Master's bed cabins (Betts 2016; NMM 1837b). The most notable artefact observed through ROV video is a sextant box in cabin P5 (Figure 4.2.11).

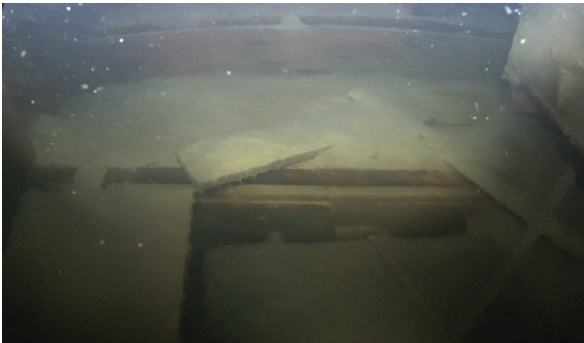
Figure 4.2.12: Fitted bed place and drawers in cabin P6 (Video: R. Harris, Parks Canada; 90M2769EF).

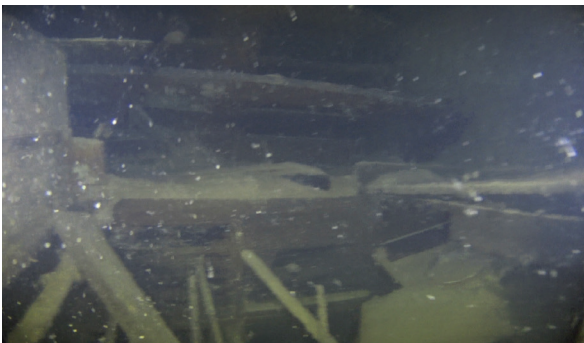
Figure 4.2.13: Bed place with drawers and wall shelving in cabin P7 (Video: R. Harris, Parks Canada; 90M2770EF).

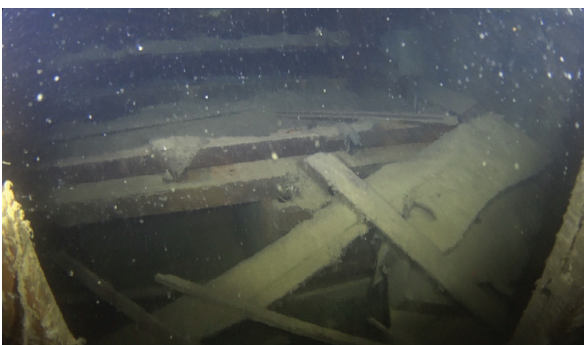
Figure 4.2.14: Bed place with collapsed bed rail in cabin P8 (Video: R. Harris, Parks Canada; 90M2772EF).

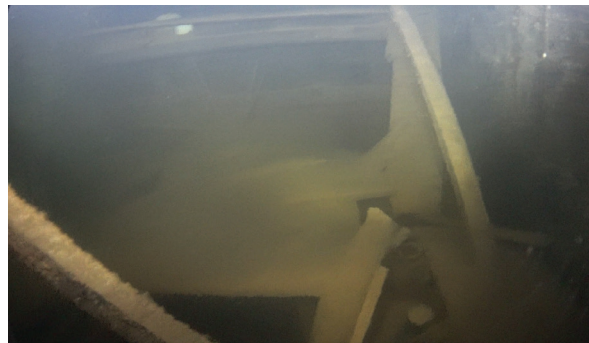
Figure 4.2.15: Cabin S1 is either a storage room or a mess place. There is no visible bed place (Video: R. Harris, Parks Canada; 90M2774EF).

Travelling from bow to stern again, this time on the starboard side, cabin S1 is either a storage room or mess place (Figure 4.2.15). Unidentified fitted furniture and shelving are present on the (outer) starboard and forward walls; small shelves are also observed high up on the aft wall. Some of the artefacts include a small cask on deck, a

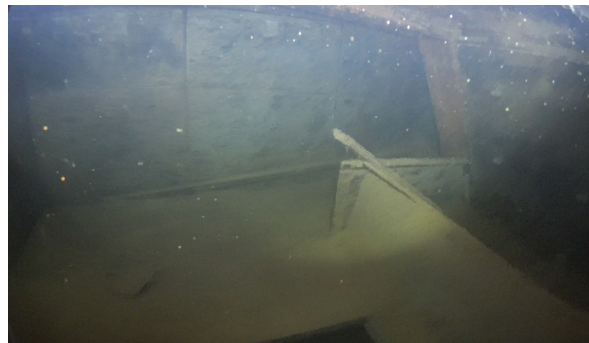
Figure 4.2.16: Two of the three bed places in cabin S2, with fitted drawers on the starboard and forward walls (Video: R. Harris, Parks Canada; 90M2778EF).

Cabin S2 is a wide space that allows for two superimposed beds along the long axis of the vessel, and a third, transverse bed along the forward wall (Figure 4.2.16). Large storage drawers are fitted along the starboard and aft walls, over

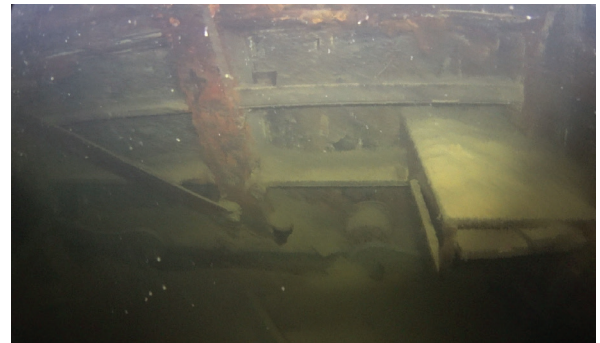
Figure 4.2.19: Shelving on either side of a deck knee, along the starboard side of cabin S6 (Video: R. Harris, Parks Canada; 90M2786EF).

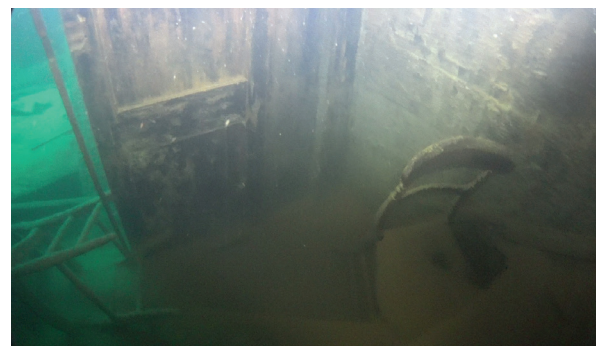
Figure 4.2.20: Two chairs in bed cabin S7 (Video: R. Harris, Parks Canada; 90M2788EF).

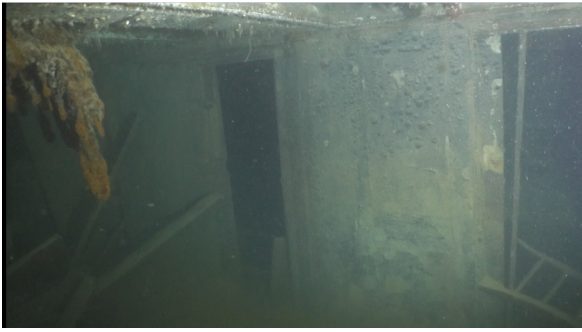
Figure 4.2.21: Cabin S6 and S7 doorways viewed from the center of the Officers' Mess (Video: R. Harris, Parks Canada; 90M2802EF).

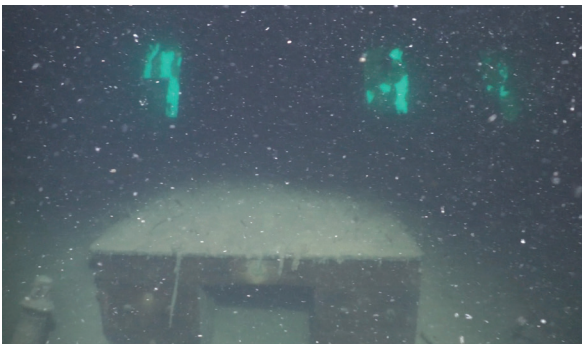
Figure 4.2.22: Captain Crozier's writing desk in the Captain's cabin (Video: R. Harris, Parks Canada; 90M2797EF).

The most prominent feature of the cabin is a large rectangular writing desk, centered on and up against the propeller trunk (Figure 4.2.22). It is fitted with two drawers on either side of a central chair space. An armchair still upright is next to it on its port side. In the middle of the cabin floor is a large table, resting upside down, with its five turned legs visible. A suspected stove was observed on the starboard side of the desk, with its flue rising through the upper deck. More enigmatic is an estimated 3m-diameter, hoop-like circular wooden object, located on the port side of the cabin (Figure 4.2.23). It is of laminated wood construction and rests partly on the port-side lockers, and partly on deck. It is marked by the letter "D". Similar circular wooden objects of unknown function were found in *Erebus*' hold/bread room in 2016 (Moore et al. 2017:76). It is postulated that this could have been part of a portable observatory. The shelves on the starboard side are mainly empty except for what appear to be degraded book bindings. A heating duct was observed in the back of one of the starboard-side shelves. A hinged door leading to Crozier's bed cabin is open, but the doorway remains partly obstructed by collapsed wooden panels.

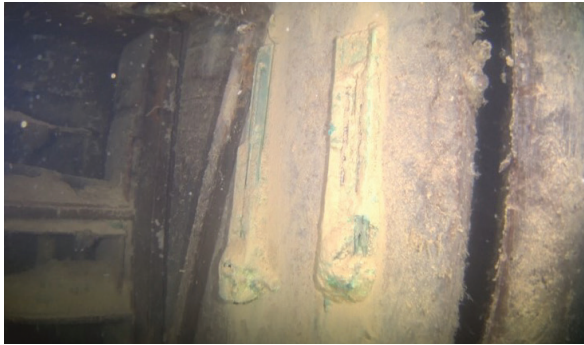
Figure 4.2.25: Potential thermometer and barometer, hanging on the wall next to the Captain's cabin door (Video: R. Harris, Parks Canada; 90M2816EF).

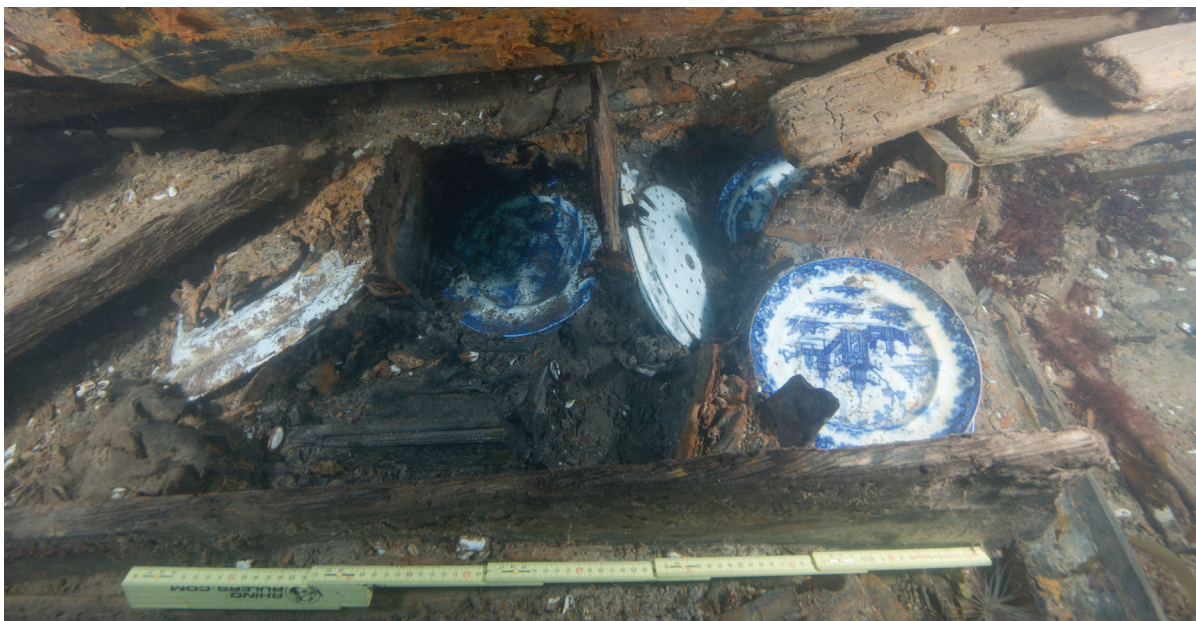
Figure 5.1.1: Storage compartment 38J201/40J203 within the presumed Captain's Steward's pantry containing, amongst many other things, a set of 47 ceramic pieces (Photo: C. Dagneau, Parks Canada; 89M10406EF).

Different potters' marks, and multiple batches of variable quality are observed. The assemblage includes 22 dinner plates of two shapes, eight soup plates, four serving bowls, three lids, six platters, and four strainers. As opposed to the Blue Willow ceramics found in the forecabin bearing cut marks and/or graffiti, and likely used by the crew (Moore et al. 2017:89–92), those found in the presumed Captain's Steward's pantry may have been owned by Sir John Franklin (or his officers?) and used for day-to-day meals at his table. The flow blue was also a more fashionable production for the period, popular c. 1840–1860 (Samford 1997:24–25).

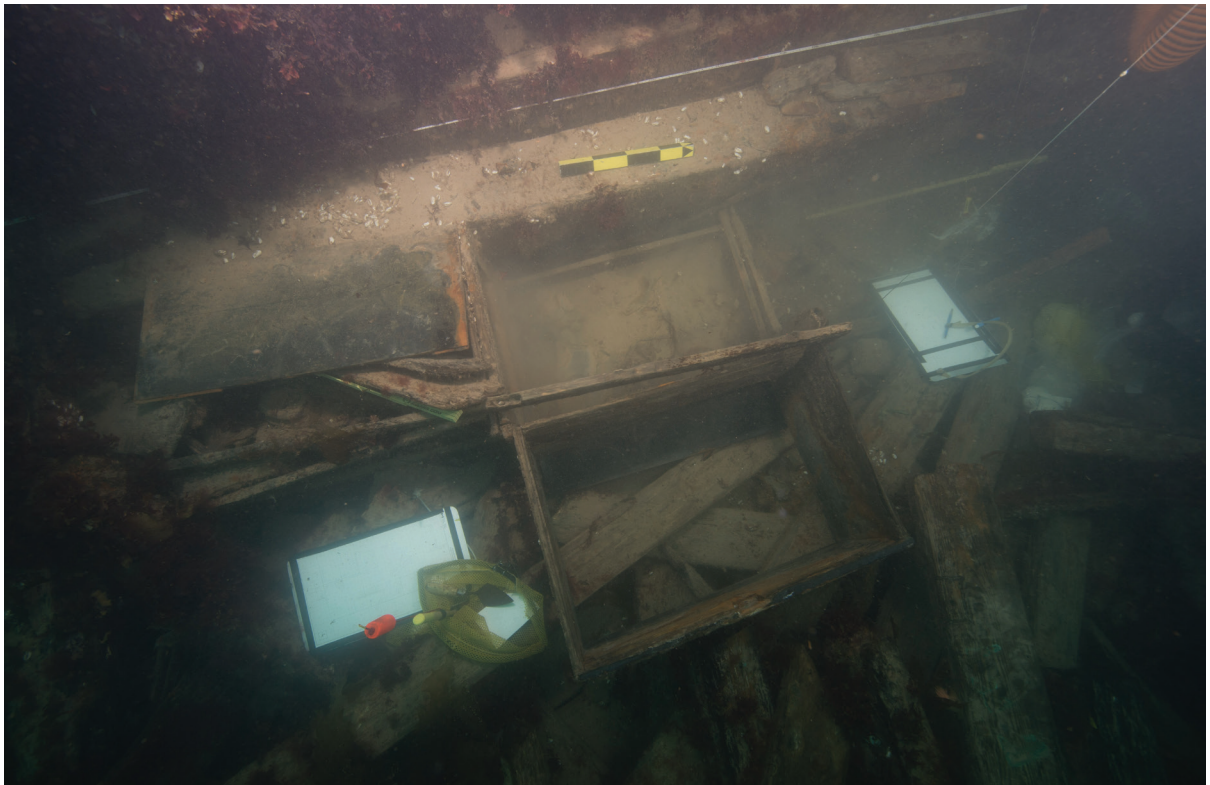
Figure 5.1.5: Presumed Third Lieutenant's cabin during 2019 excavation showing a drawer under the bed place that has just been opened after its excavation, exposing an unexcavated drawer that contained a box of epaulettes encapsulated in sediment (Photo: T. Boyer, Parks Canada; 89M10435EF).

Two of the four drawers under the bed were completely excavated. Surprisingly, they contained very few artefacts compared with the Captain's Steward's pantry (Figure 5.1.5). Both drawers, including the closed lower drawer, were found to be

filled with dense sediment that had evidently been deposited over many years. The bed frame and its lee board were missing, exposing the bed place's chest of drawers. The upper excavated drawer (lot 40J200-201) contained a mix of artefacts, including rigging material and cabin fittings that had fallen both from the upper deck and from within the lower deck itself. In contrast the closed, lower drawer (lot 40J204) presented a completely sealed context but was largely empty, with the exception of a well-preserved pair of epaulettes, still in their box (Figure 5.1.6).

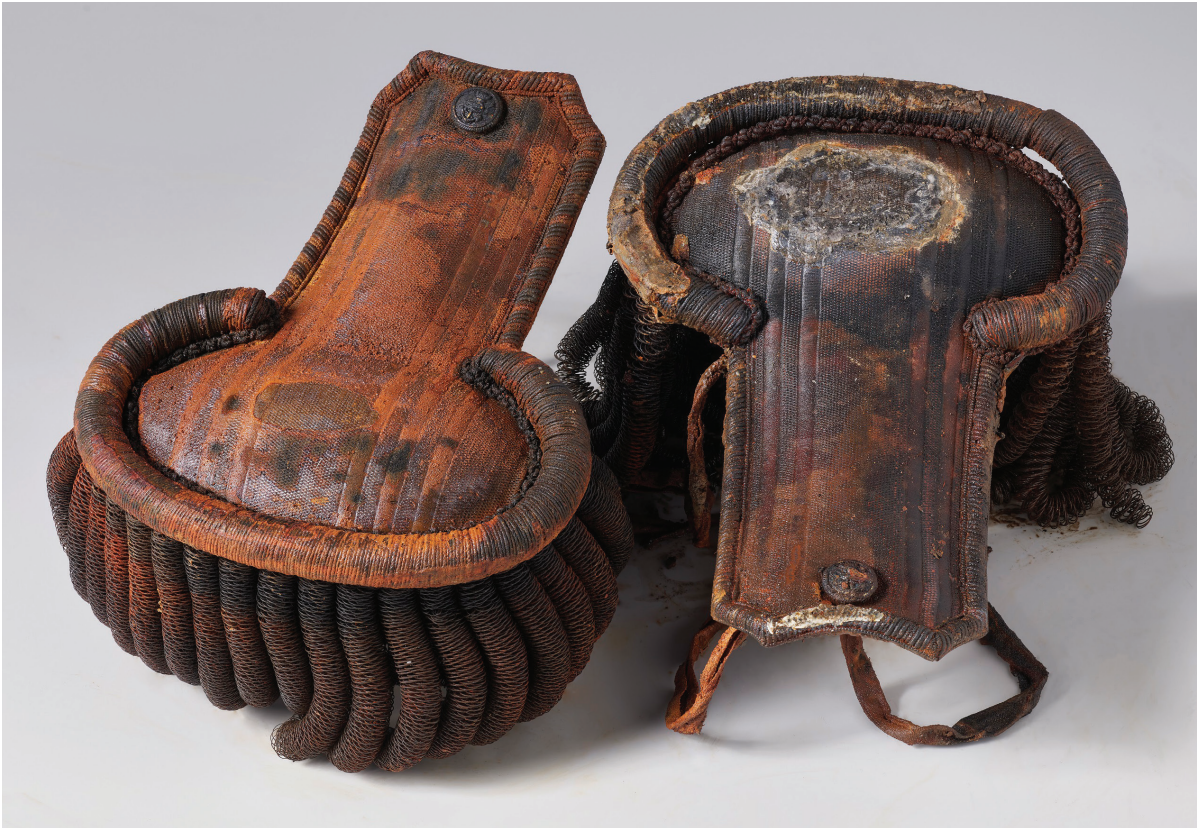
Figure 5.1.6: Pair of lieutenant's epaulettes (89M40J204-5 and 6), found in their box, in a drawer under the suspected Third Lieutenant's bed place (Photo: M. Wilson, Parks Canada; RA9916EF).

It is believed that this cabin was occupied by Third Lieutenant Fairholme and so based on available evidence, the epaulettes belonged to him (O'Byrne 1849). Indeed, in a letter to his father sent from the Whalefish Islands in 1845, Fairholme (1845a) complained about the cool air coming down the aft ladderway opposite his cabin doorway. While we might have expected these very epaulettes to have been depicted in Fairholme's 1845 daguerrotype portrait (NMM 1847), he mentioned in a letter home that out of convenience he actually sat for his portrait wearing Fitzjames' dress coat and not his own (Fairholme 1845b; Ryan 2017; Figure 5.1.7).

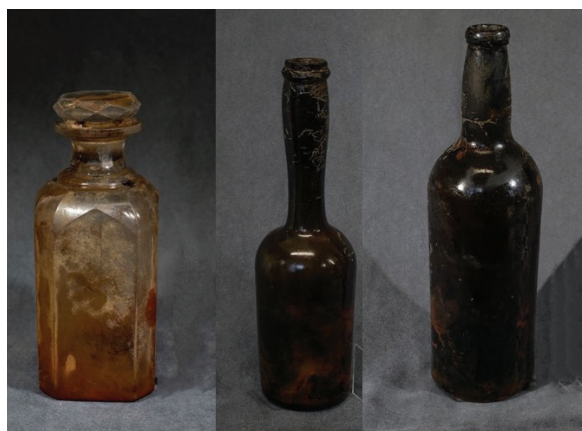
Figure 5.1.8: A decanter, a Worcestershire-style bottle and four wine bottles were recovered from the officers' mess area (46L200). The bottles are not shown to a common scale (Photos: C. Dagneau, Parks Canada).

The work in sub-operation 46L was limited to mapping and surface collection of bottles readily accessible without the need to excavate per se. This area is located forward of the officers' mess skylight, where structures and artefacts from the officers' mess are accessible. A decanter (or *eau de toilette* bottle) with its stopper in place, observed in 2017, as well as four wine bottles and a Worcestershire-style condiment bottle, were recovered from this area, most of them corked (Figure 5.1.8). It should be noted that the possible decanter had been seen in different locations in previous years within the area of the Officer's Mess, so its final recovery location is not where it would have originally been stored. It is difficult to infer anything from this space at the moment, given that this excavation unit was barely touched. However, both the bottles and their contents will be subject to detailed chemical analysis as were those recovered from other areas, in order to determine possible contents and/or provenance.

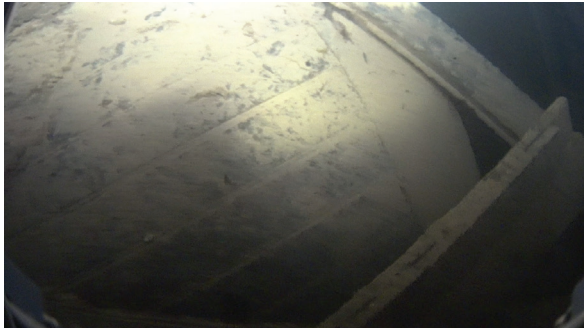
Figure 5.2.1: *Erebus*' boiler in the engine room (Video: R. Harris, Parks Canada; 89M11230EF)
