## HMS EREBUS UNDERWATER ARCHAEOLOGICAL SURVEY 2018

Charles Dagneau and Jonathan Moore  
Underwater Archaeology Team, Parks Canada

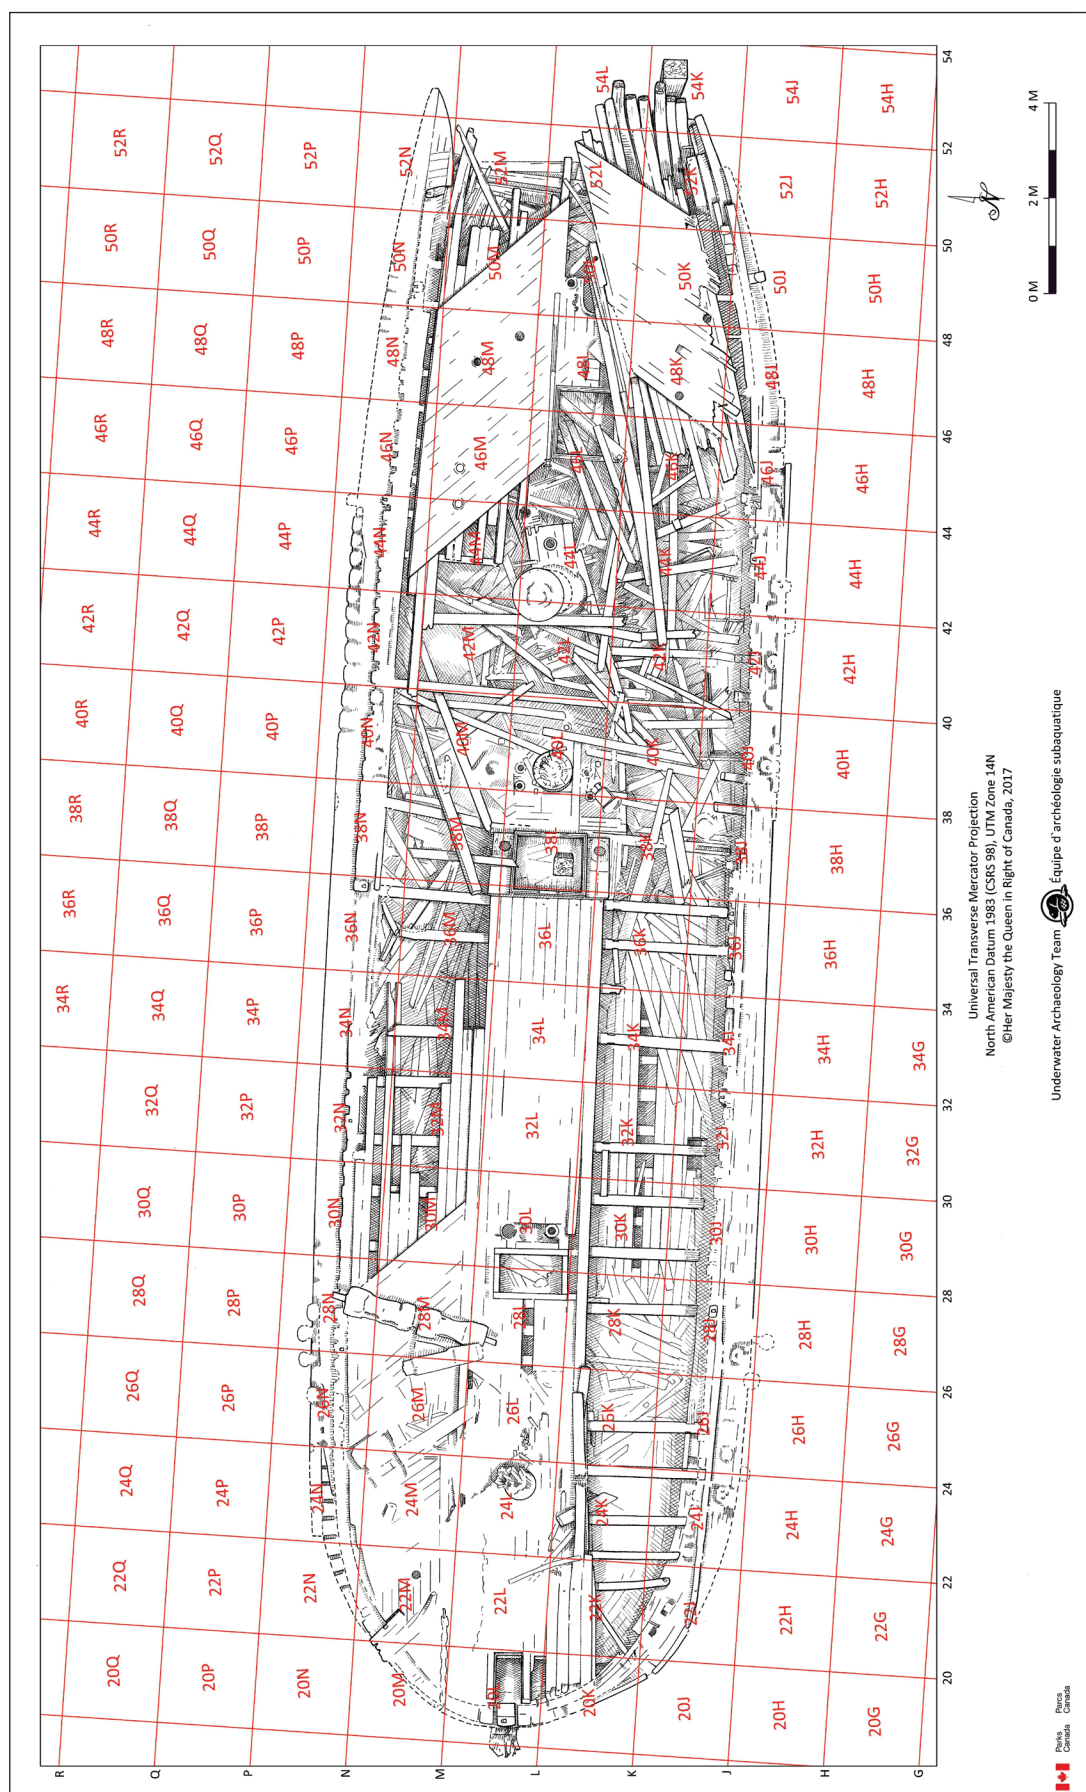
Figure 5.5: Site provenience grid superimposed over the upper deck site plan of HMS Erebus, 2016. This site plan does not reflect the most recent changes to the upper deck observed in 2018 (Image: B. Lockhart, Parks Canada; Drawing: C. Pillar, Parks Canada; 89M-2017-101-1).

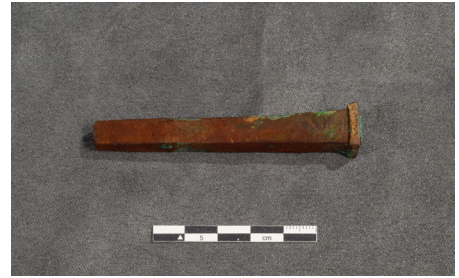
## NAIL (89M28N100-5)

This small forged nail, with its tip snapped off, has a square shank and a square flat head. It was probably used to affix layers of upper deck planking together. The artefact, marked with a broad arrow, was found on one of the upper deck beams.

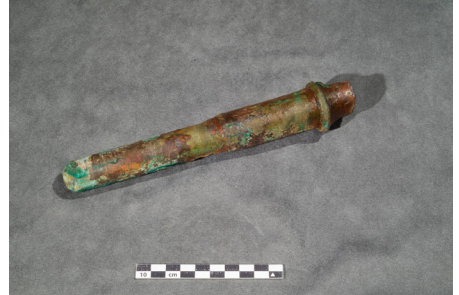
## BELAYING PIN (89M28N100-4)

Belaying pins were used to secure the various ropes of the rigging, such as those used to control the sails. The use of bronze instead of wood is an indication of the quality of the equipment used for the Royal Navy, generally. This broken example was found on the upper deck. Its upper end has snapped off.
