Around Town: The Archaeological Invest-
igation of Four Structures in Dawson
City, Yukon

by Peter J. Priess

1987

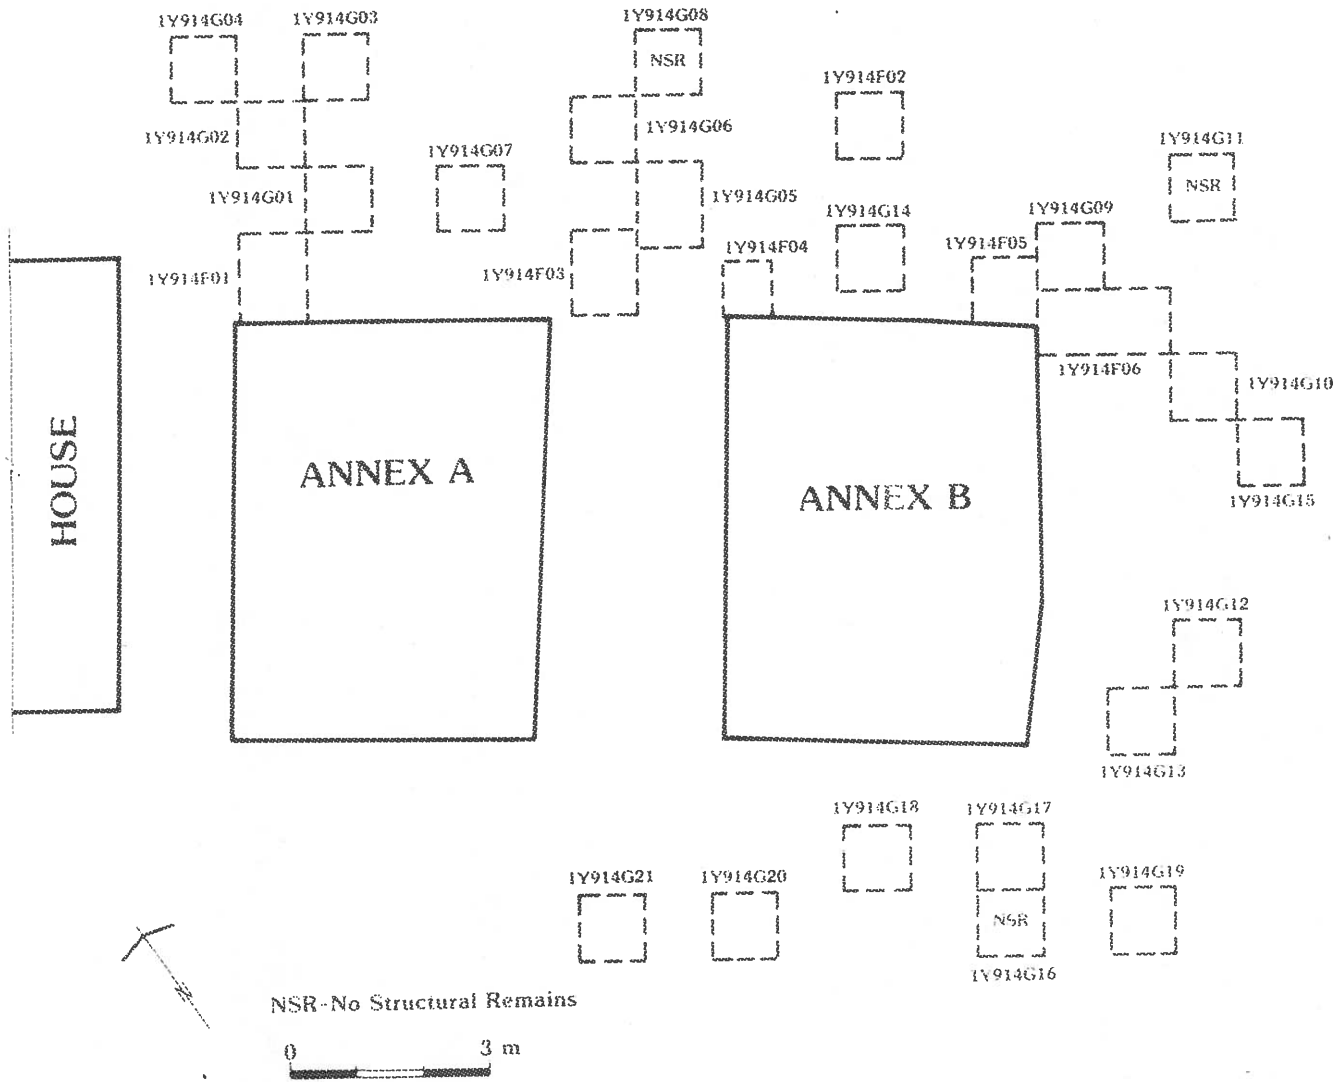
Figure 1.3. Building plan and location and identification of excavation units. (Drawn by D. Elrick)

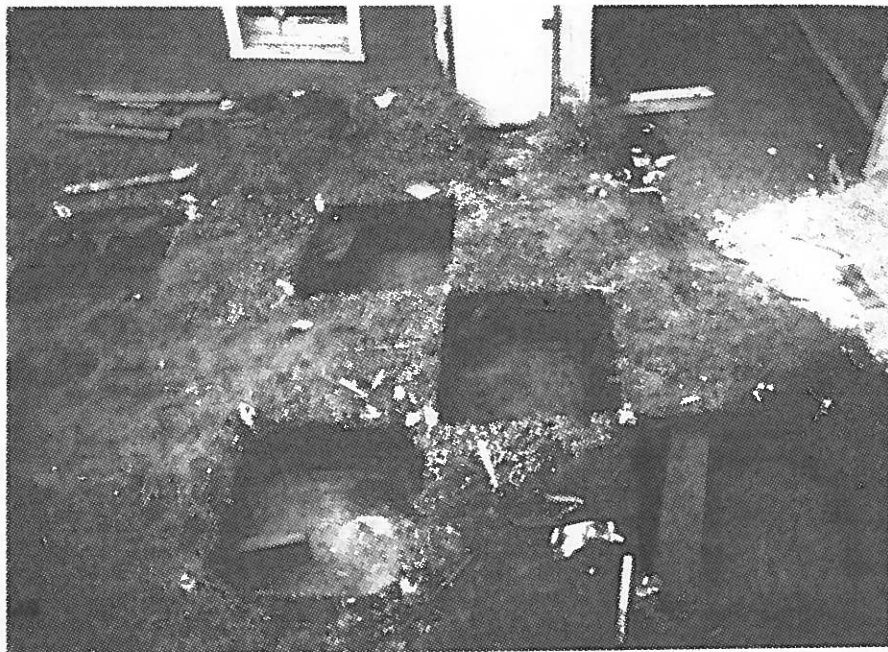
Figure 1.8. Excavations north of Annex A. (Photo by B. Ross)

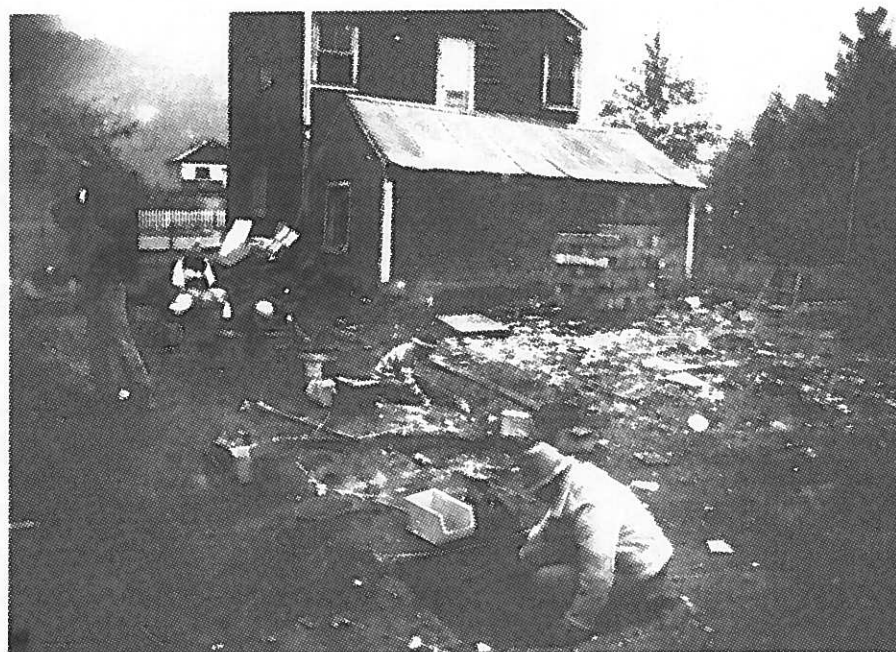
Figure 1.9. Excavations south of Annexes A and B. Note that Annex B has been moved from its original location. (Photo by B. Ross)

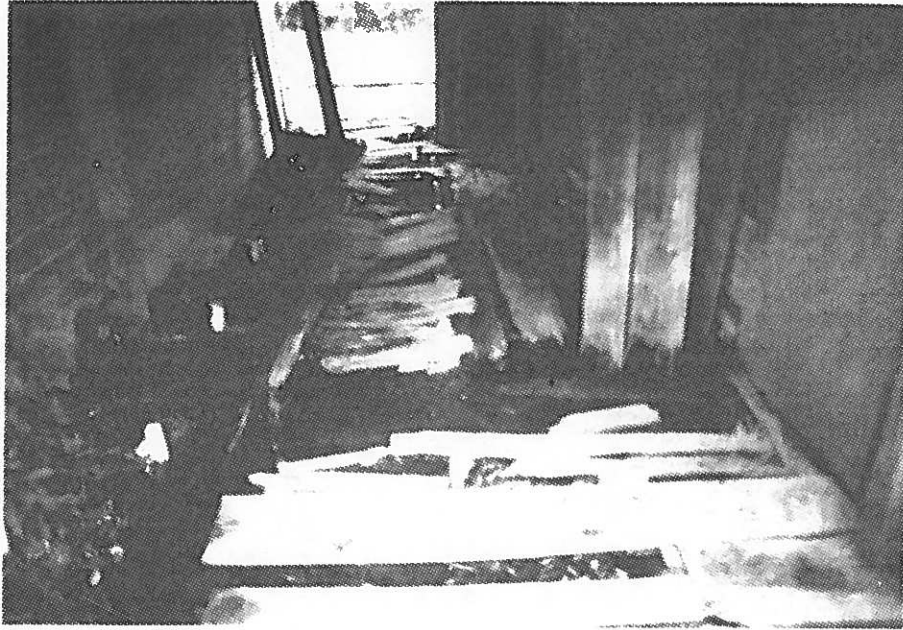
Figure 1.10. Boardwalk remains between annexes, looking north. (Photo by B. Ross)

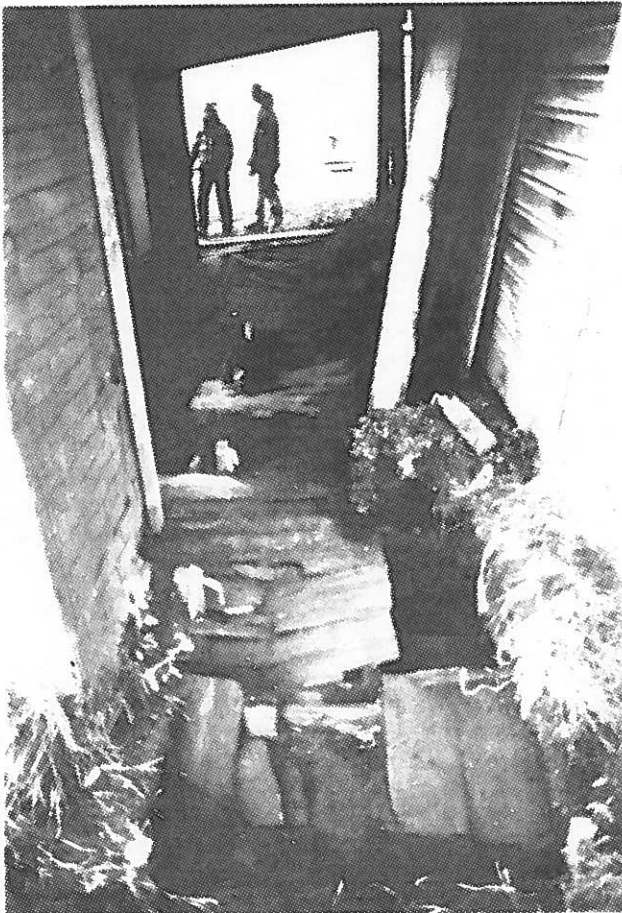
Figure 1.11.

Boardwalk remains between annexes, facing south.
(Photo by B. Ross)

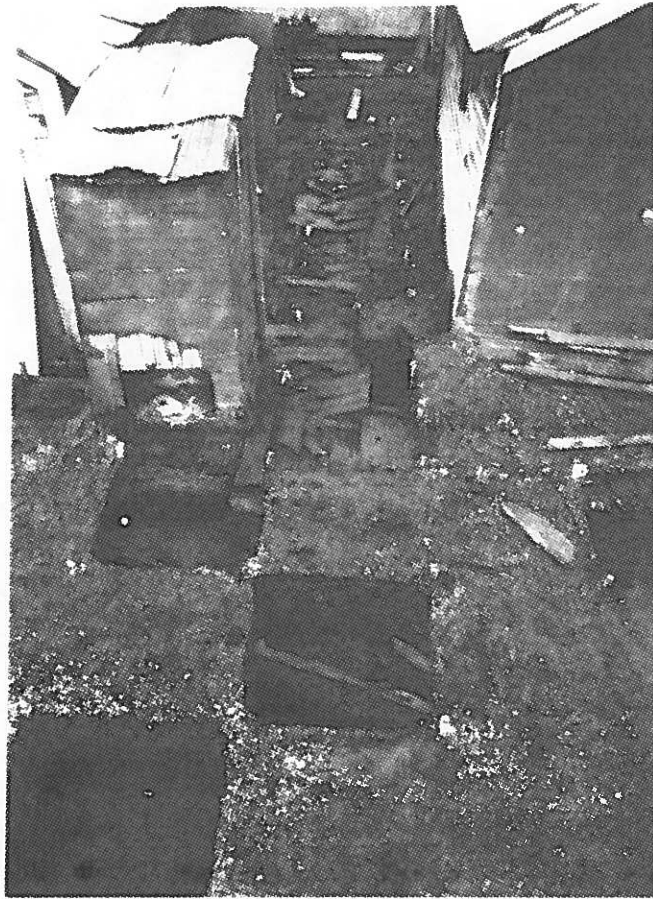
Figure 1.12.

Excavations north of annexes, also note boardwalk between annexes (cf. Fig. 1.11). (Photo by B. Ross)

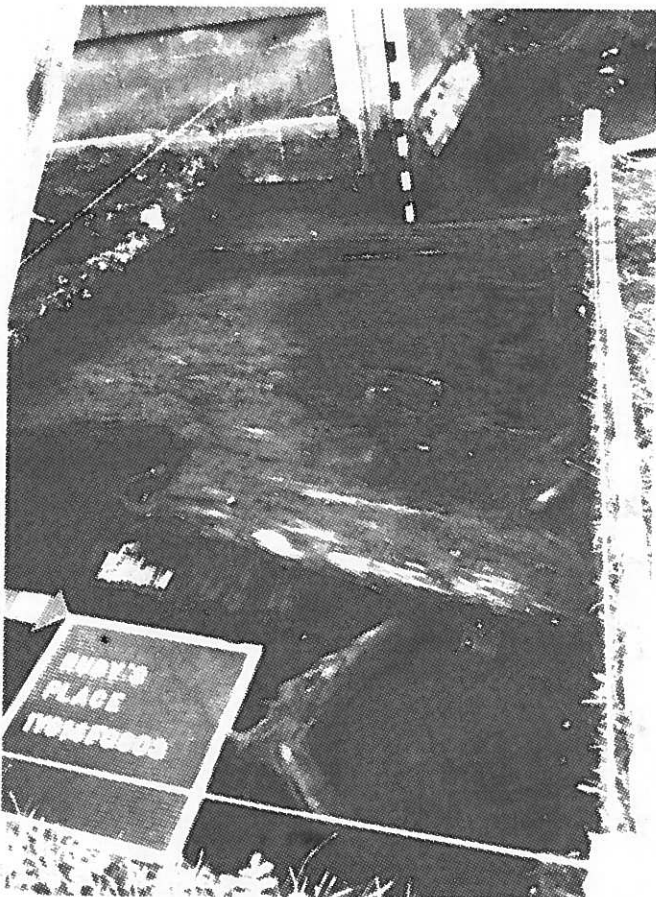
Figure 1.19.
1Y914F06, planview of
flooring remains. (Photo
by M. Gagnon)

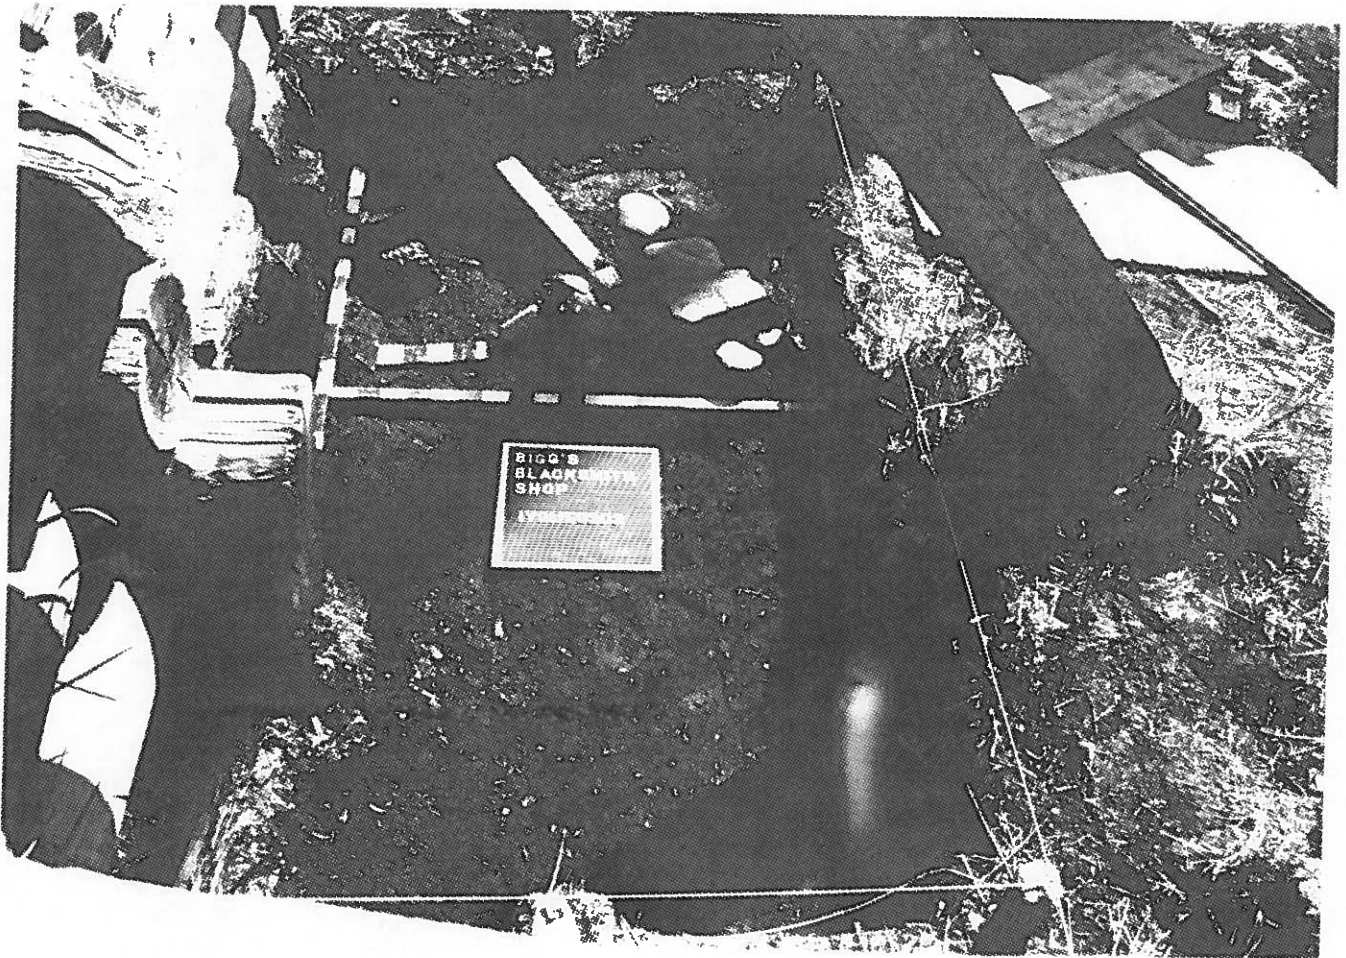
Figure 2.24. 1Y911E02 (identification board is incorrect), boardwalk plank. (Photo by B. Ross.)

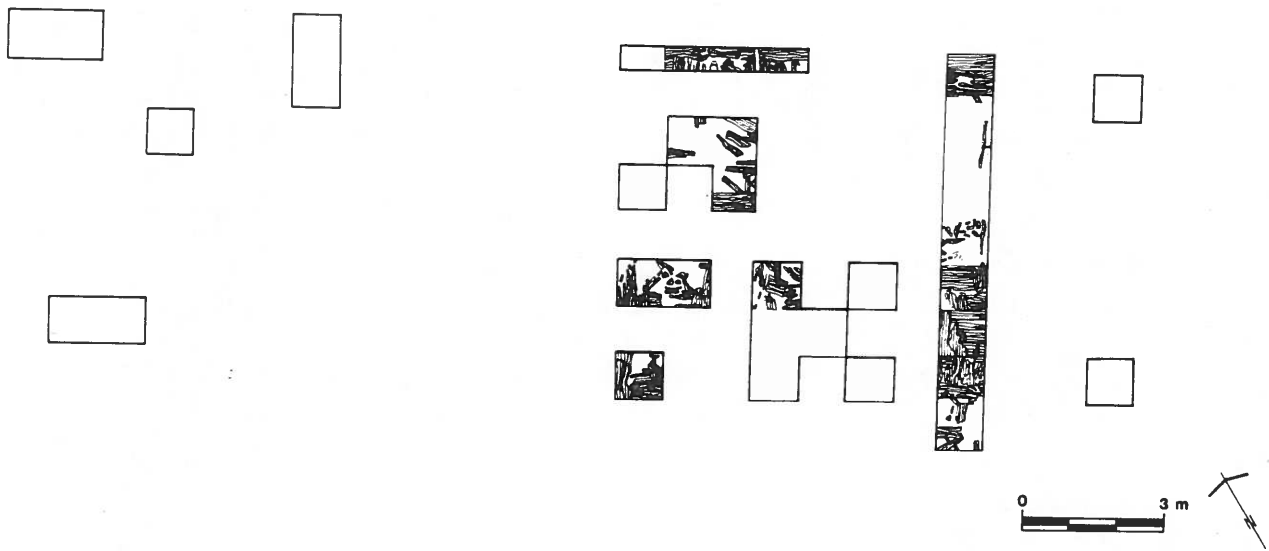
Figure 3.4. Flooring remains. (Drawn by D. Elrick.)

The floor was extensively deteriorated and fragmentary but enough remained to indicate two layers of planking (Figs. 3.4, 3.15). Unfortunately orientation of the planking remains was not consistent but with joists oriented north-south it is unlikely if not impossible to have the first layer of floor planks also oriented north-south. However, in a number of instances, planking remains con-

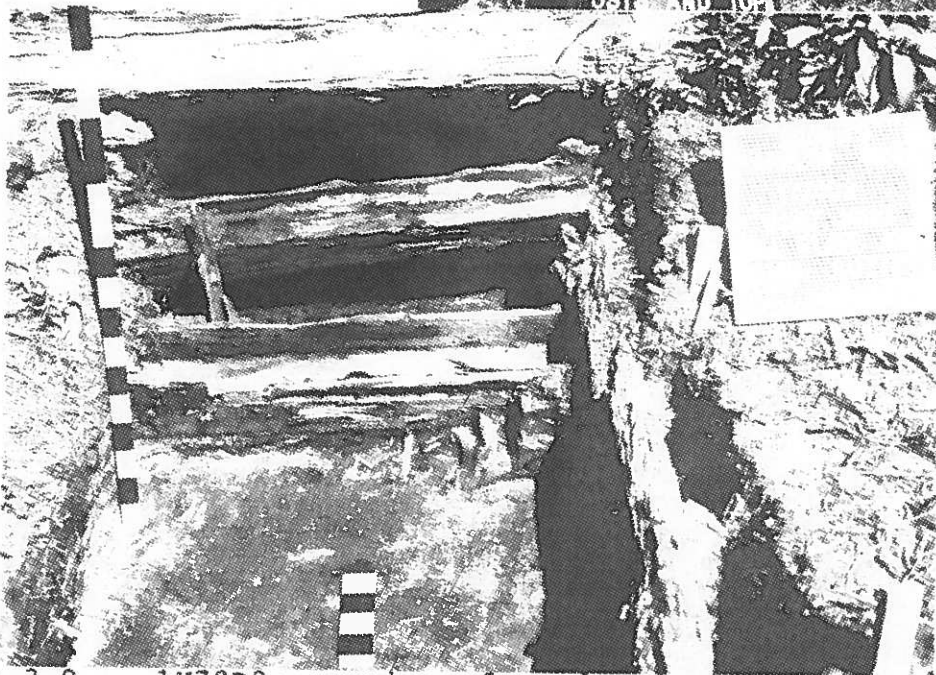
Figure 3.9. 1Y70D2; remains of wooden drain, sill and joist (beam across top belongs to West's Machine Shop in next lot). (Photo by B. Ross.)

Drain (Figs. 3.9-3.11, 3.14, 3.21)

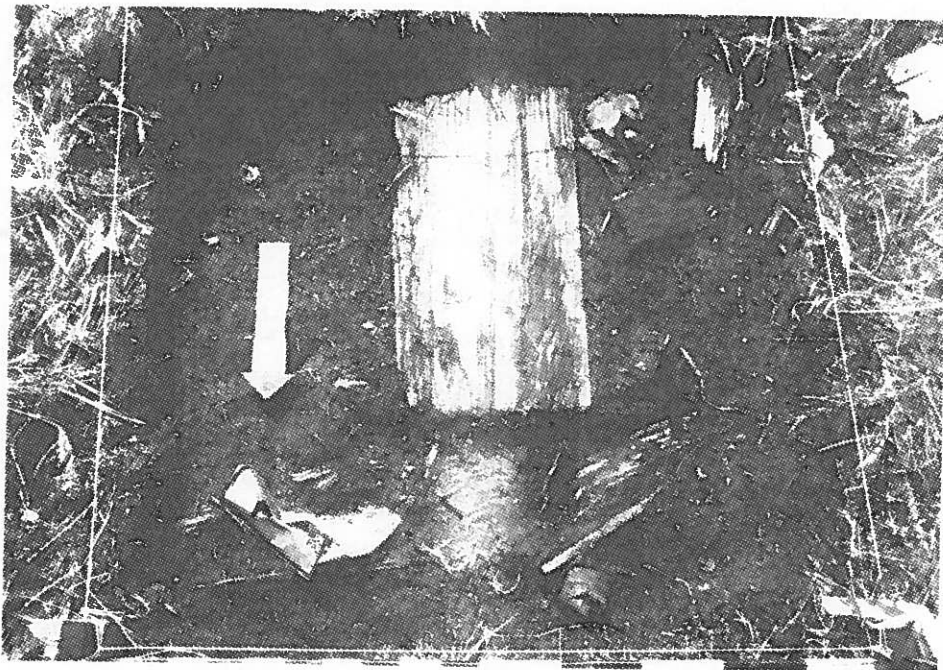
Figure 3.12. 1Y70Y1; planview of bottom of first lot, showing single plank and scattered artifacts. (Photo by S. Keen.)

Flooring (Figs. 3.4, 3.8, 3.12-3.15)

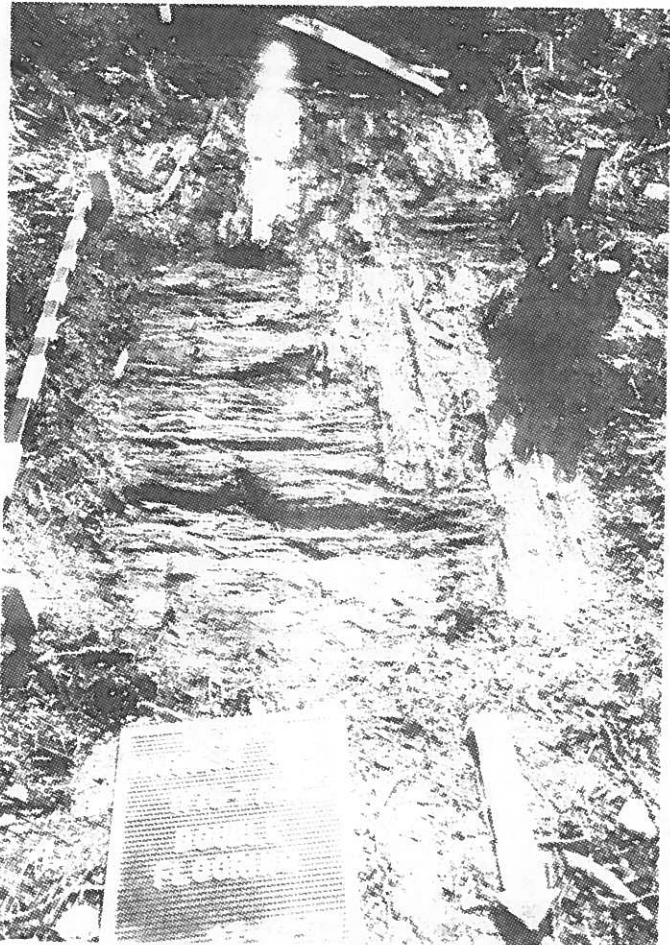
Figure 3.15.

1Y76D1, 1Y77D1; section of double flooring with upper layer extensively deteriorated. (Photo by B. Ross.)

The floor consisted of a double layer of edge butted planks (Fig. 3.15), probably an initial layer oriented east-west and a second layer oriented north-south. According to remains in 1Y76H, the planks were laid with their end joints alternating on a joist - every second joint appeared on the same joist - and each plank was nailed down on each joist with two 8.5 cm nails. The bottom layer consisted of planks measuring 19 cm wide and roughly 3.4 cm thick (length was not determined for these planks). The upper layer planks were 10.2 cm wide and 2.1 cm thick. Elsewhere there were planks up to 27 cm wide and 5 cm thick. Variations in width would not be an inconvenience but any variation in thickness would result in an uneven surface. Variations in perceived thickness may be the result of deterioration and difficulties in obtaining accurate measurements. The planking was machine sawn.

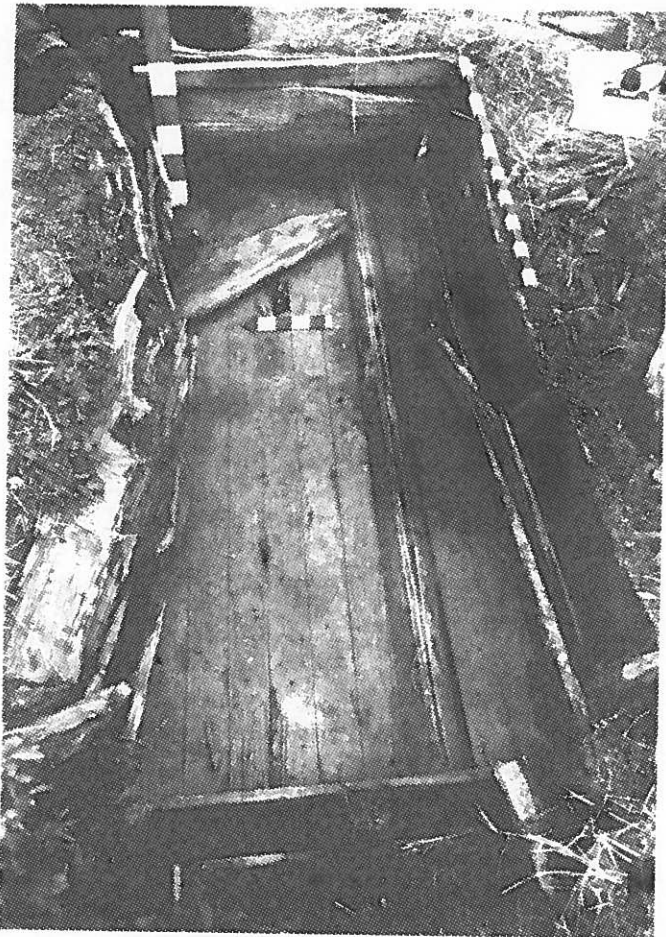
Figure 3.19.

1Y46T1, general view of wood-lined pit (feature No. 1) after removal of fill. (Photo by B. Ross.)

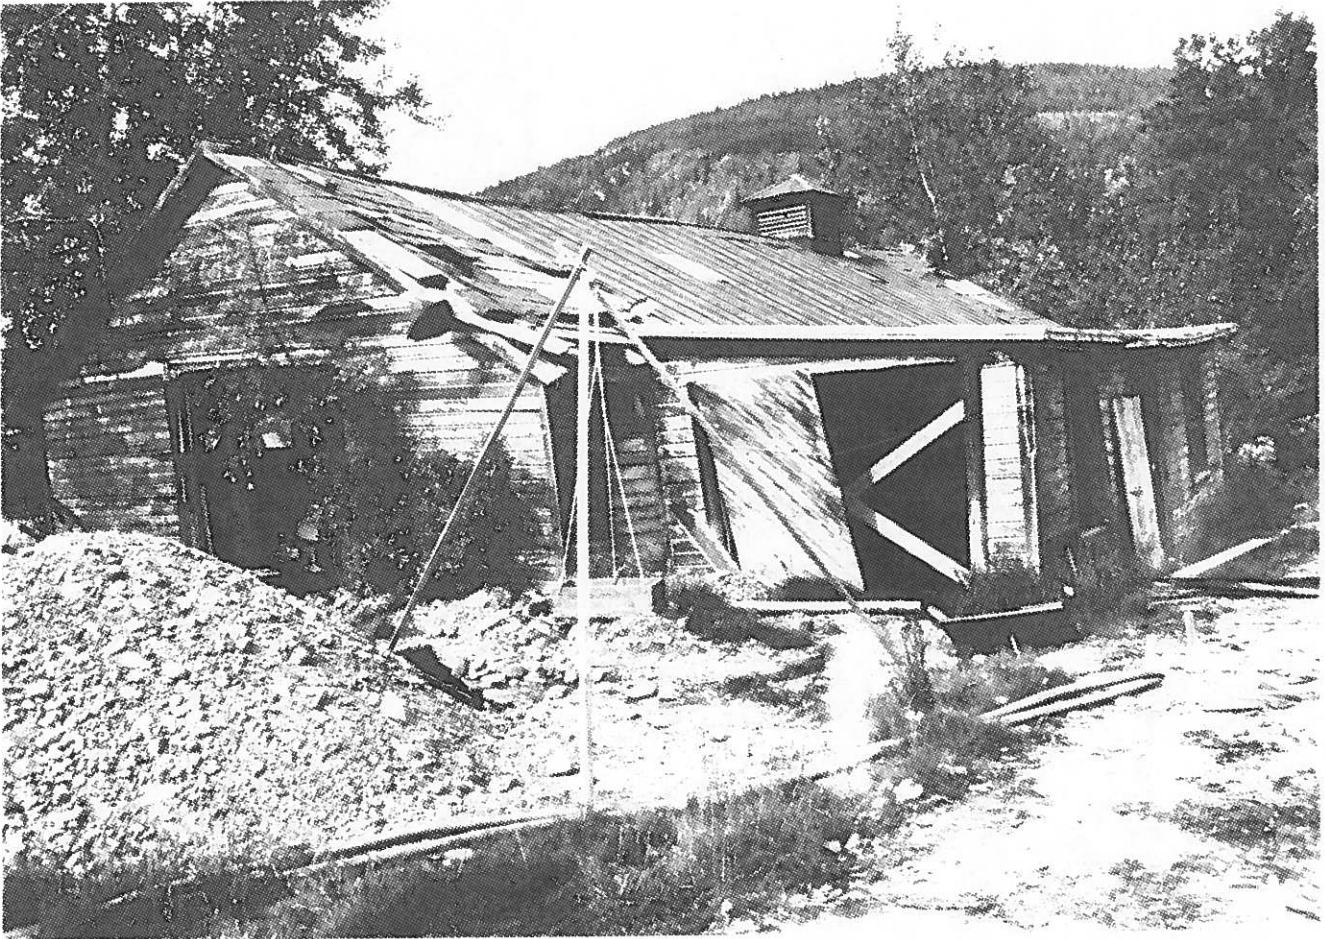
Figure 4.1. East end of extant stable and harness room.
(Photo by B. Ross)

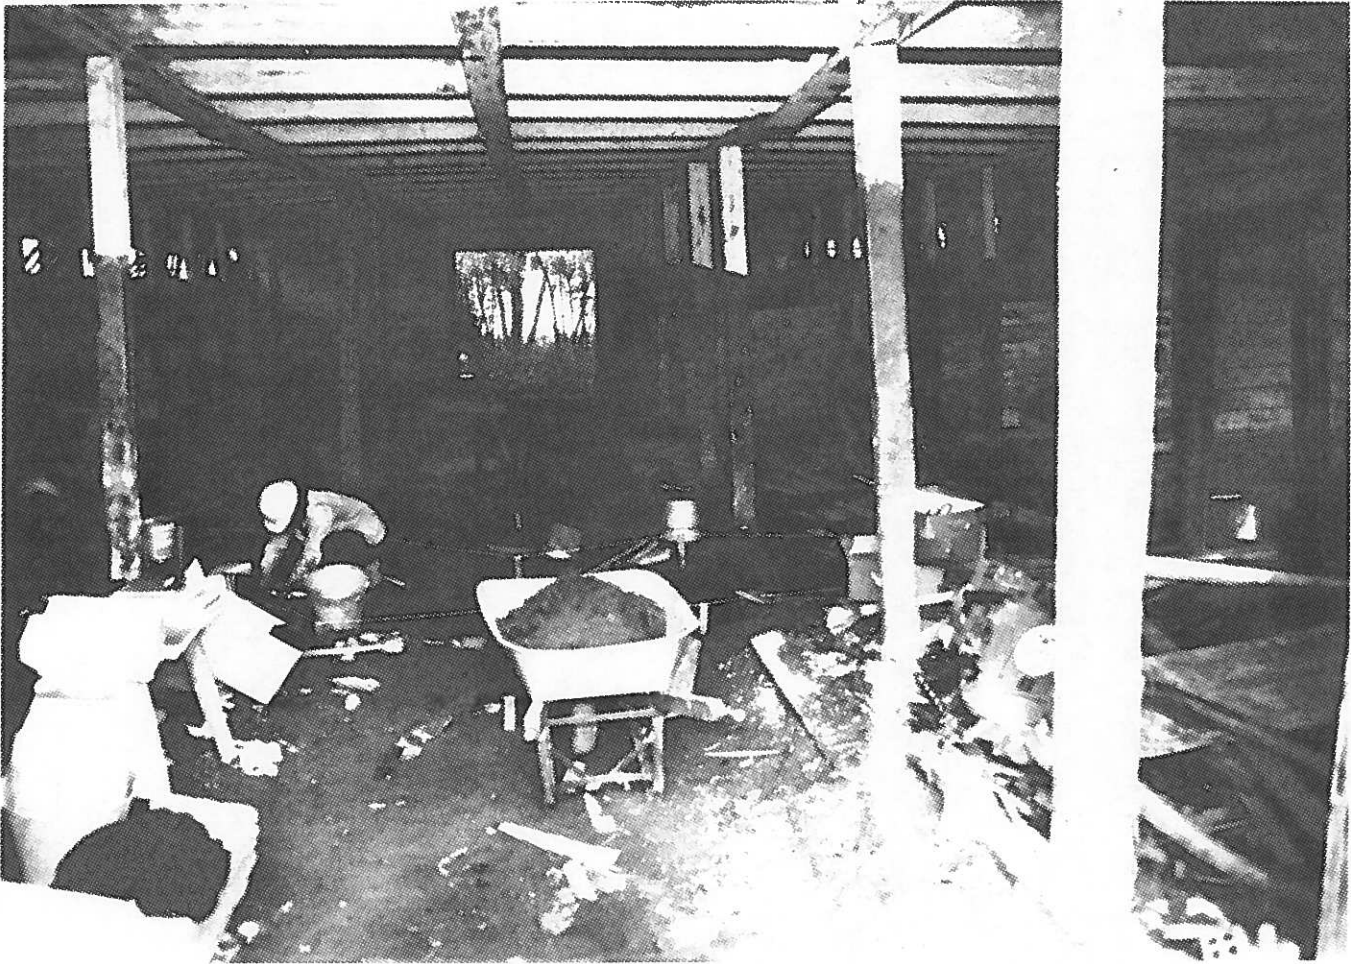
Figure 4.26. General view of excavations inside extant structure. (Photo by B. Ross.)

East-west oriented sills are also present in the the archaeological test trench across the middle of the stable and through the harness room (Figs. 4.26, 4.27). A sill was present under the north walls of the stable and harness room. Sills were also present on either side of the aisle (Figs. 4.33-4.36) to provide footing for the posts. However, these interior sills appeared to be resting on a layer of flooring (Figs. 4.34, 4.36). The situation is further confused by the presence of two sills, one above the other, under the north wall of the harness room. The
