Trigger for Atomic Holocaust

Aircraft Detection on the DEW Line

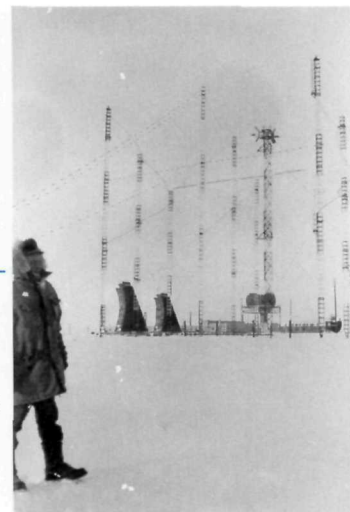
Royal Canadian Air Force officer T.H. Collins stands before a doppler antennae towering over the DEW Line Main Station at the Hall Beach in 1955. Photo courtesy Dept. of National Defence DND-CPU-PCN 1660.

Line with two kinds of electronic detection gear, a powerful gap-filler radar and a doppler radio detection system known as the "McGill Fence," developed under the leadership of McGill University physicist John S. Foster.¹ The fence operated on the DEW Line and the Mid-Canada Line, another link in the air defence system on the 55th parallel.

Transmitting and receiving gear connected to a set of 100-meter radio masts equipped each DEW Line station. Radio transmissions

between stations emitted lobes of electromagnetic radiation reaching from the ground to 30,000 meters. Station recording devices detected passing airplanes when they disturbed the energy field. The system provided intrusion warning, tracked aircraft, supplemented radar sightings, and covered gaps between radar stations. The system was an innovative and inexpensive solution to the need for automatic air traffic notification.
